3PS – 153 MACQUARIE STREET, PARRAMATTA

TRENCH REPORT – AREA A & AREA A SOUTH

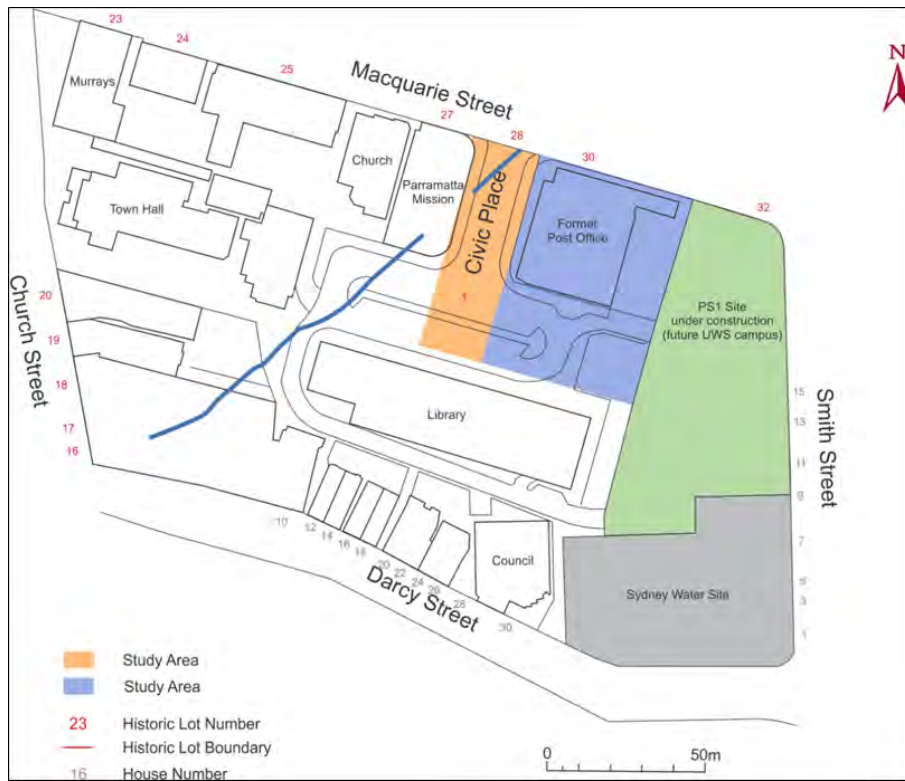
Figure 1.1: Detail of the study area with historic lot boundaries and street numbers.

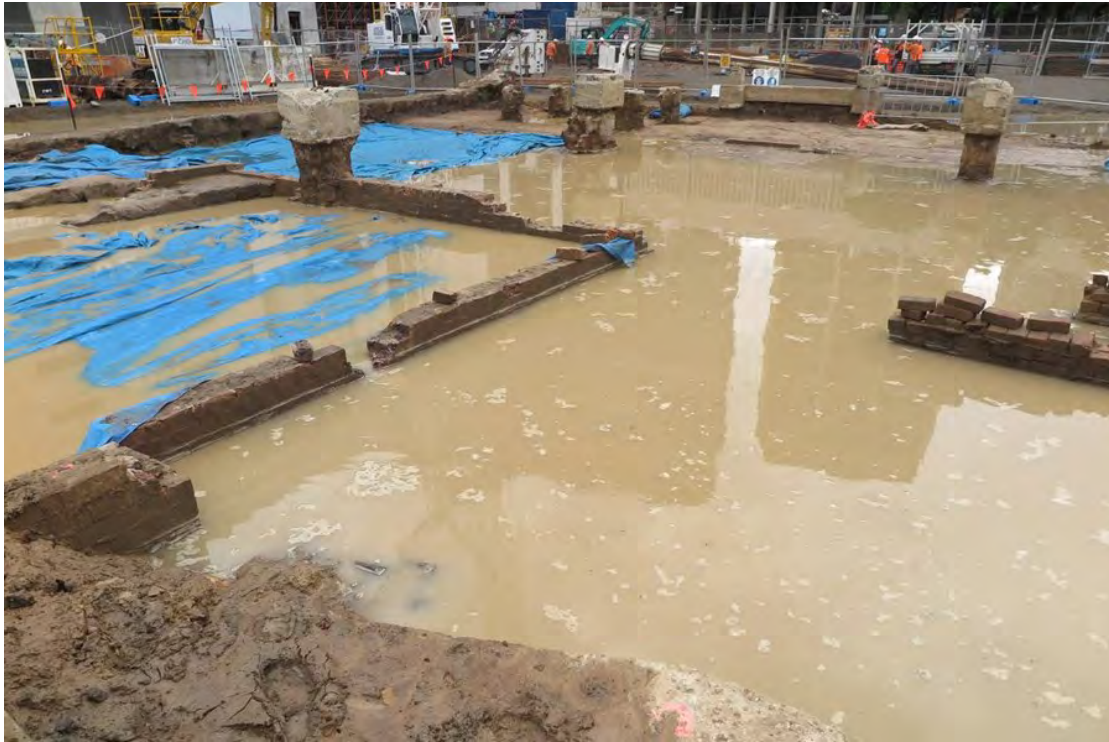
Figure 1.3: Flooding after heavy rain in the northwest corner of Area A. The bricks in the right mid-ground are the remains of the brick sump (16187). House 4 is below the blue tarpaulins. View southeast. Photo taken 22/1/2016. IMG_5040.

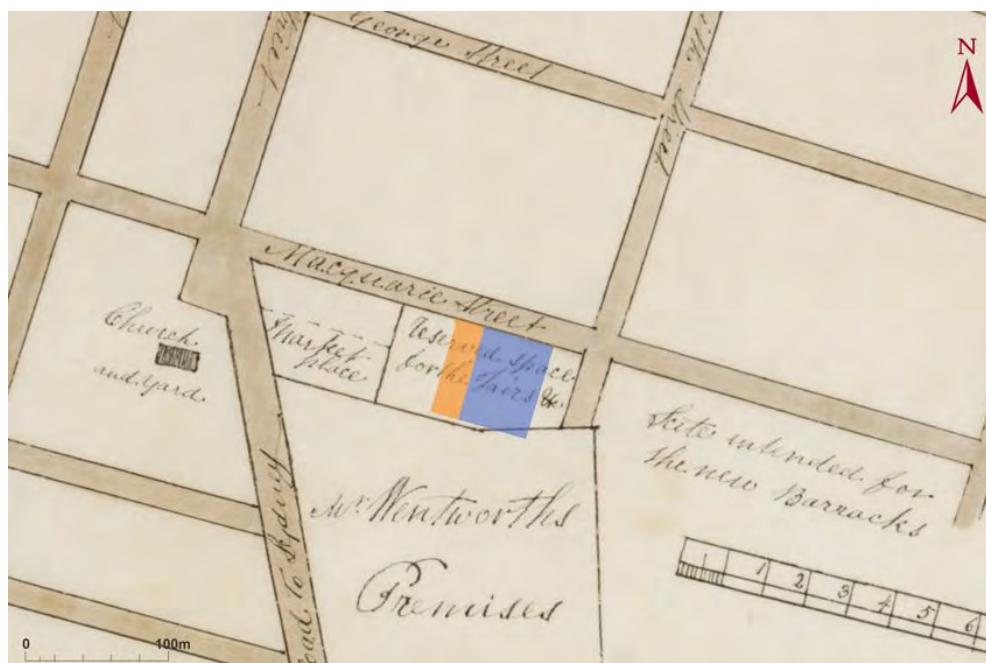
Figure 2.3: Detail of 'Plan of the Township of Parramatta in New South Wales 1814', showing scaled study area (3PS) in blue (Areas A, B & C) and orange (Area D). The site was reserved space for the fairs. SLNSW M2 811.1301/1814/1.

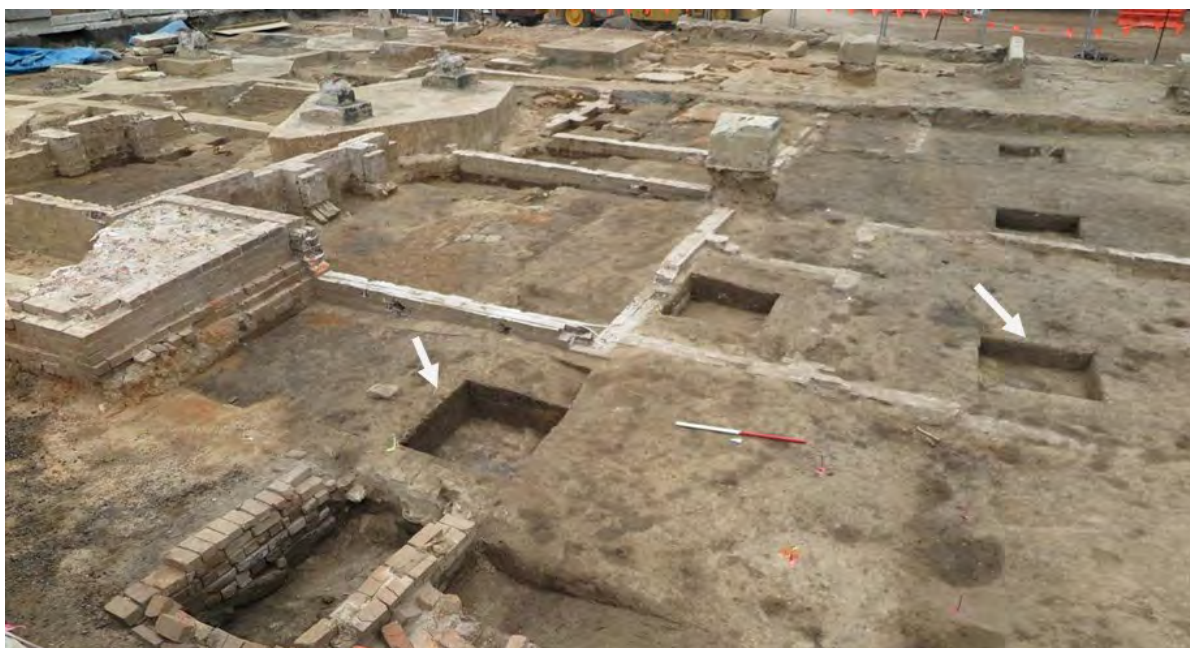
Figure 4.1: The modified topsoil (16120) arrowed, across the rear yard area of House 4 where twenty 1m x 1m grid squares were selected at random and were manually excavated. The topsoil within these squares was 100% wet sieved. View east. Scale 1m. IMG_4128.

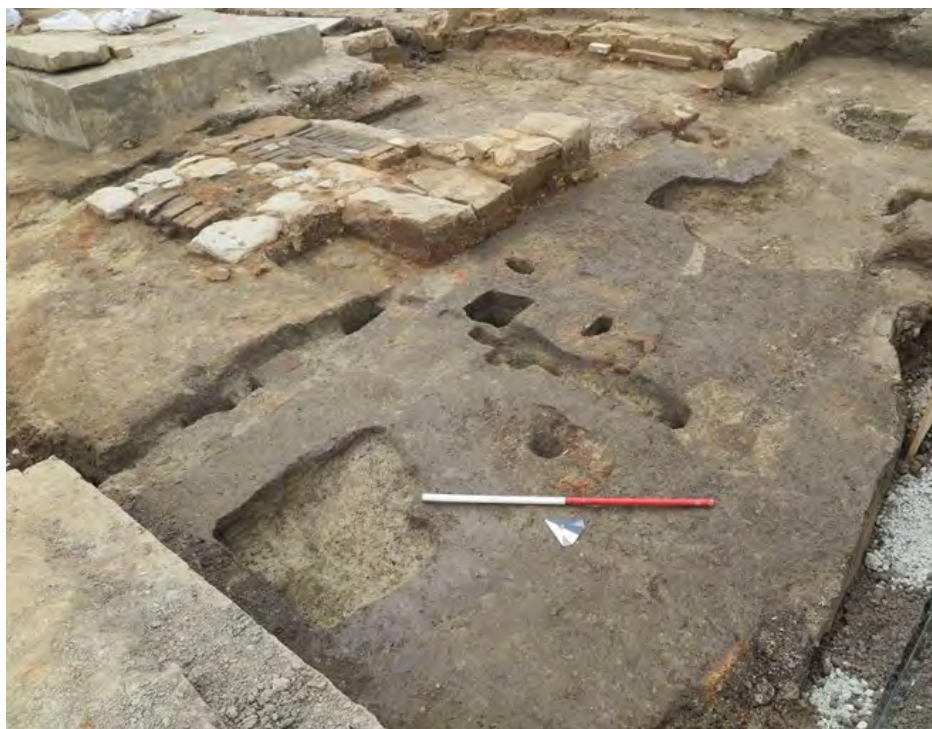
Figure 4.2: In the foreground, archaeological features along the south verandah area of House 4 cutting the original dark grey topsoil (16224). Below the topsoil is the paler yellow-brown subsoil (16190). View northeast. Scale 1m. IMG_5170.

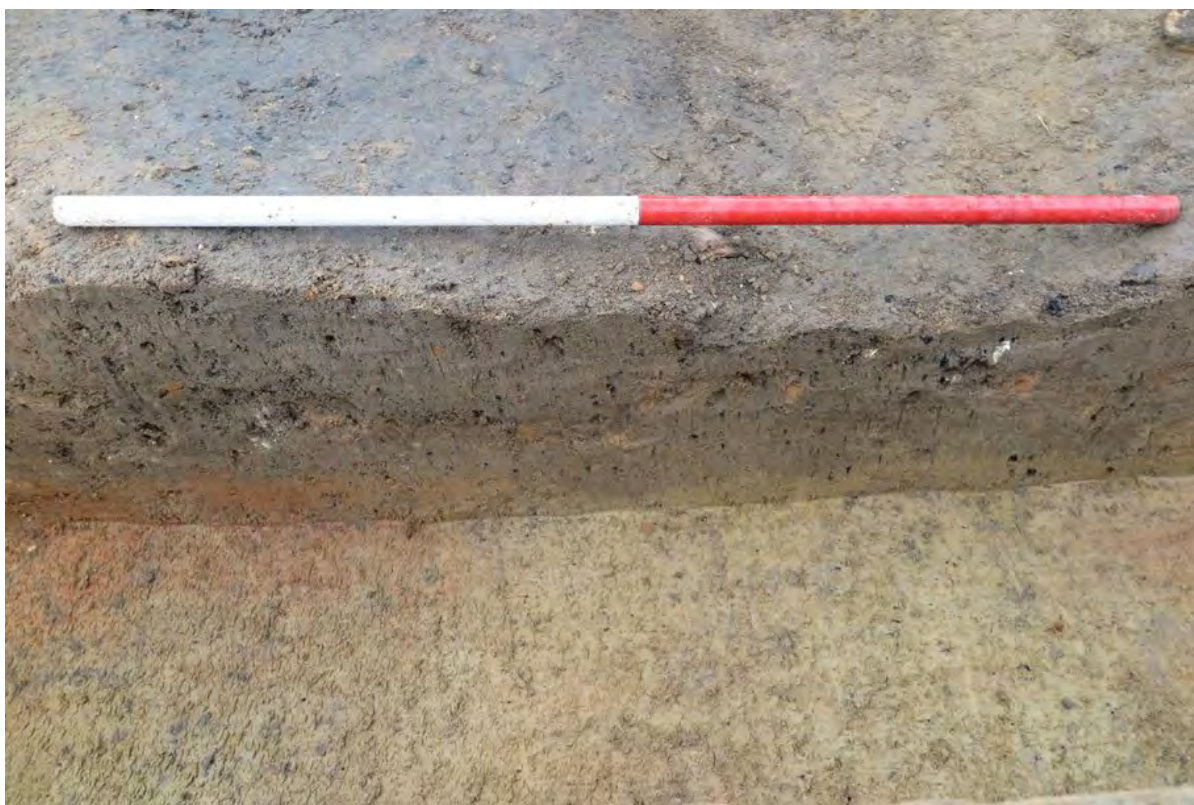
Figure 4.4: Area A South, the darker modified historic topsoil (16318) above the lighter subsoil (16257). The orange-red staining on the left side of the photo is burnt clay caused from removing a tree bole. View south. Scale 1m. IMG_4460.

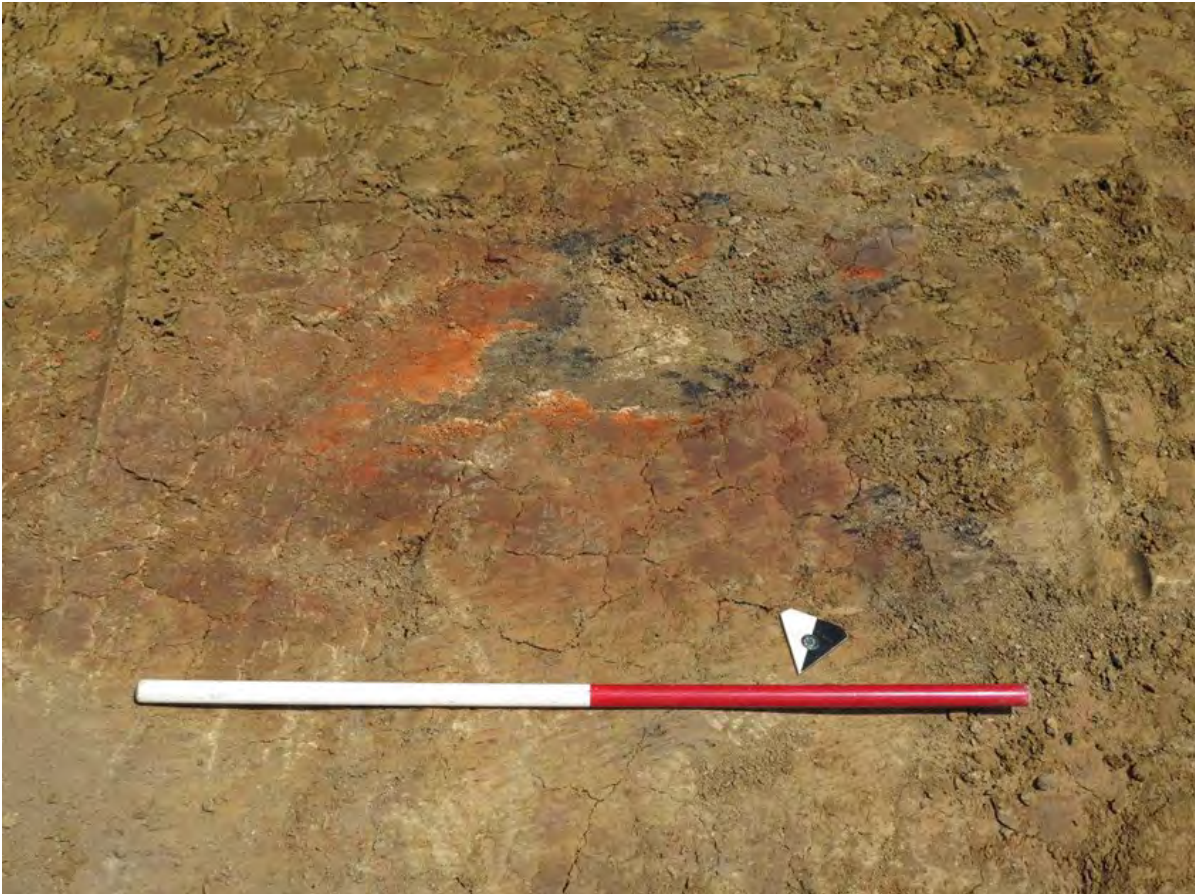
Figure 6.2: Unexcavated burnt tree bole (16327) visible in the subsoil in Area A South, close to the edge of the pond at RL 9.42m. View south. Scale 1m. IMG_3318.

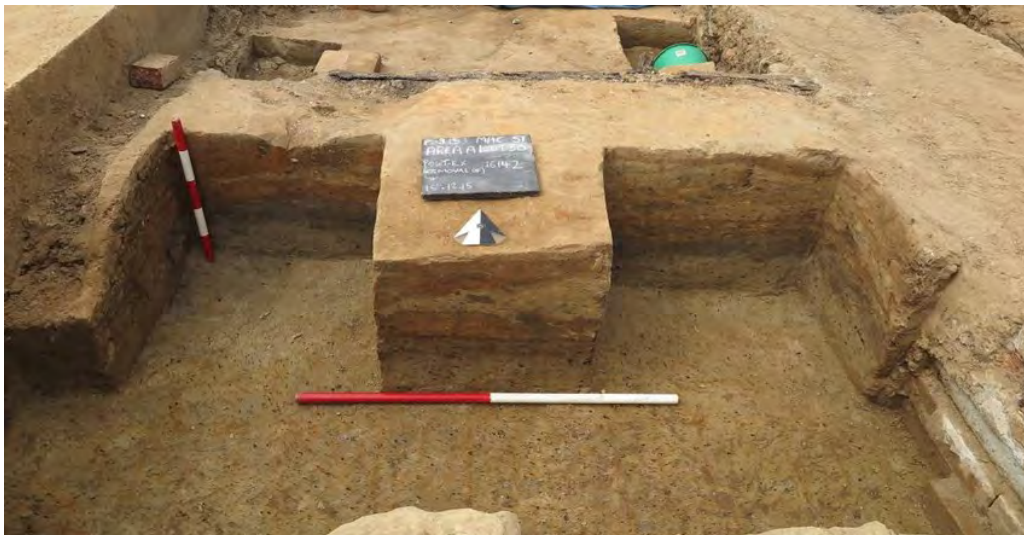
Figure 7.3: South-facing section showing the imported fills 16193 and 16214 above the natural deposits. These fills were deepest below the northern half of House 4 as the slope of the natural was steeper towards the north. In the background sitting on top of 16193 is the northern baseplate (17270) running east-west. View north. Scale 1m and 50cm. IMG_4421.

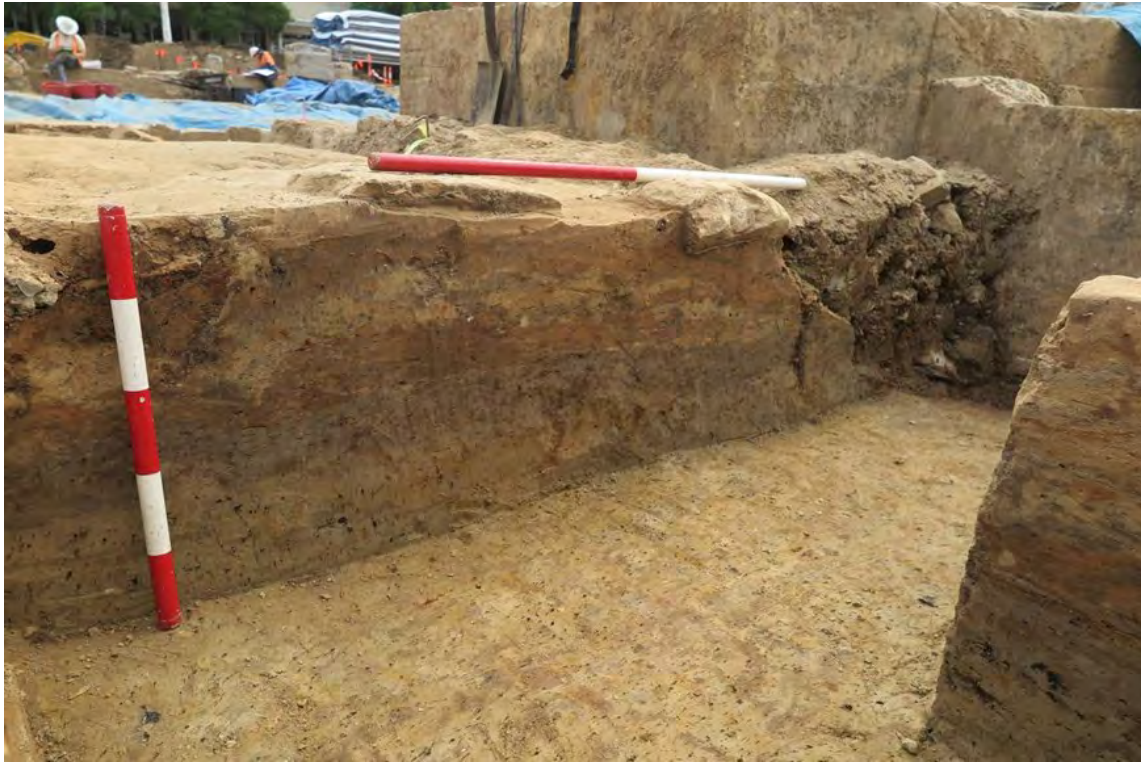
Figure 7.4: North facing section (section drawing #4) in area of Room 3, House 4 showing the imported fills (c.300mm deep) above the original topsoil and subsoil. At the right-hand side of the photo the wall trench for the post office footings cuts through these fills. View southwest. Scale 50cm and 1m. IMG_4426.

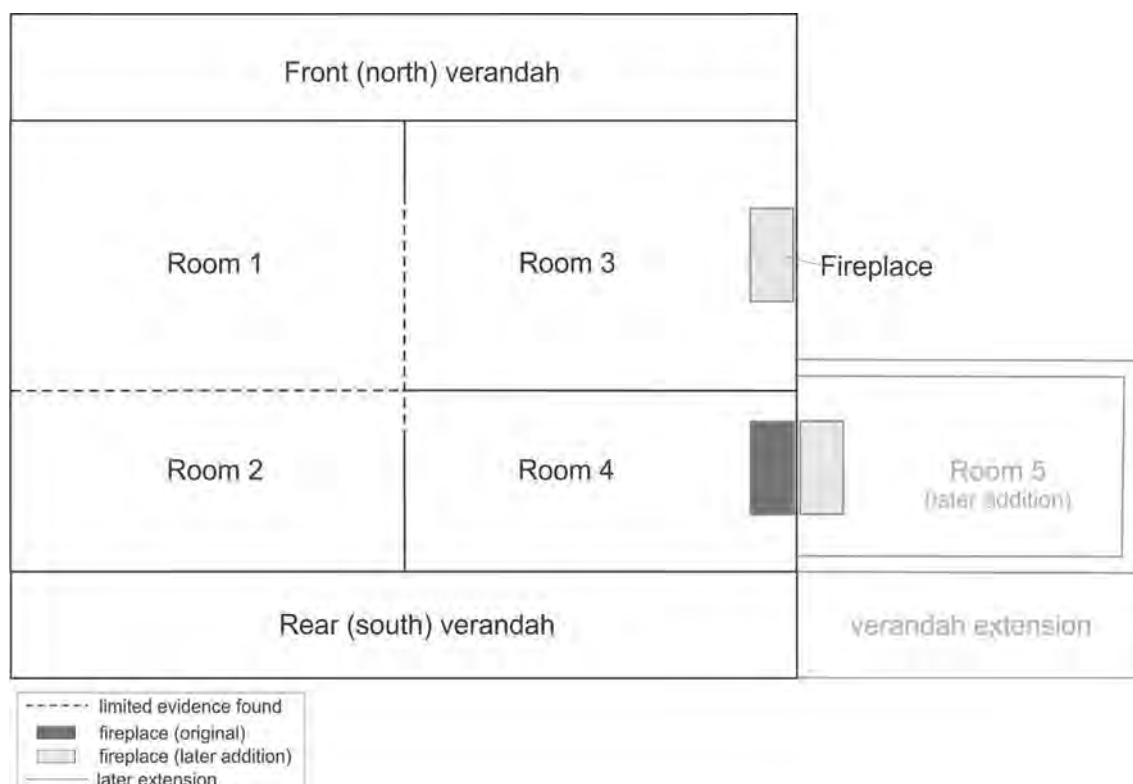
Figure 7.7: Drawing showing the layout of the early house and the numbering of the rooms. North is at the top of the image. Not to scale.

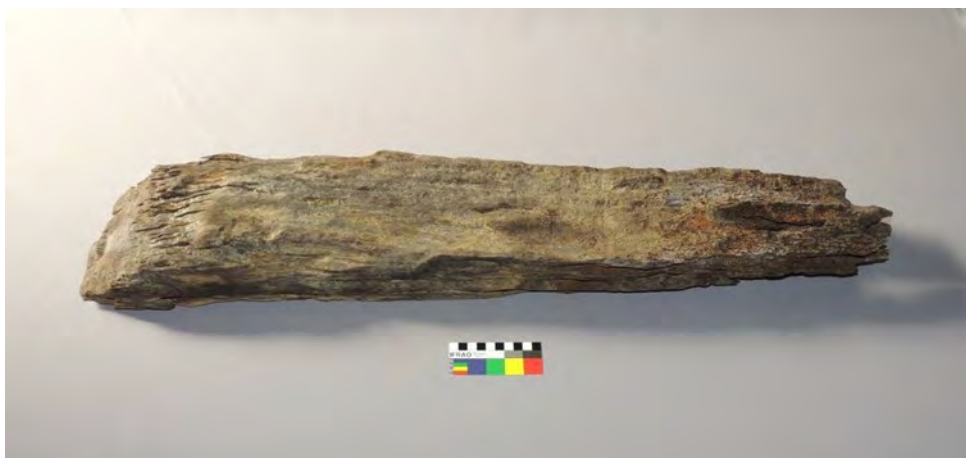
Figure 7.9: Timber post (16233) from north wall of House 4. The end of the post was a wedge shape. Scale 10cm.

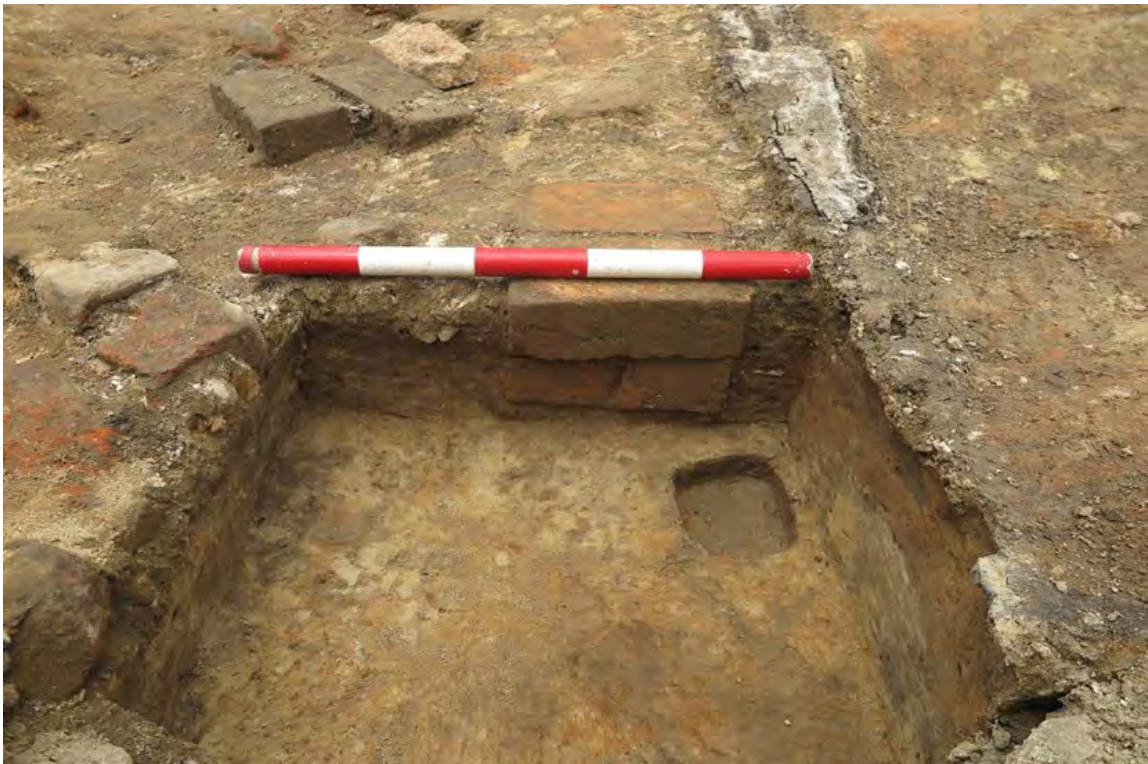
Figure 7.10: A smaller, shallower post-pipe (16216) near the centre of the north wall but on the same alignment as the larger postholes also had the brick piers to the east. In the section below the timber plate the imported fills (16193 and 16214) are clearly seen. View east. Scale 50cm. IMG_3901.

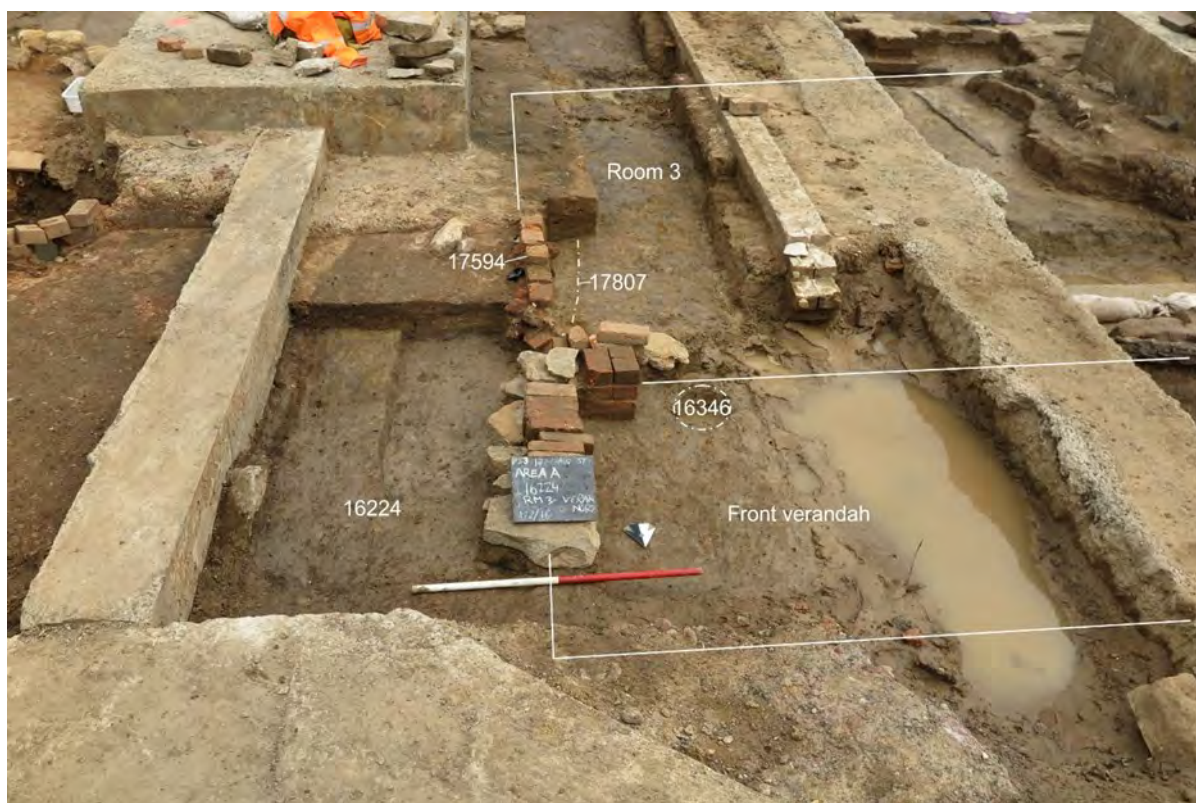
Figure 7.12: Northeast corner of House 4 showing the front verandah and the row of bricks (17594) running north-south along the eastern wall of the house. After these bricks were removed another posthole (17803) was found within a shallow construction trench (17807). View south. Scale 1m. IMG_5209.

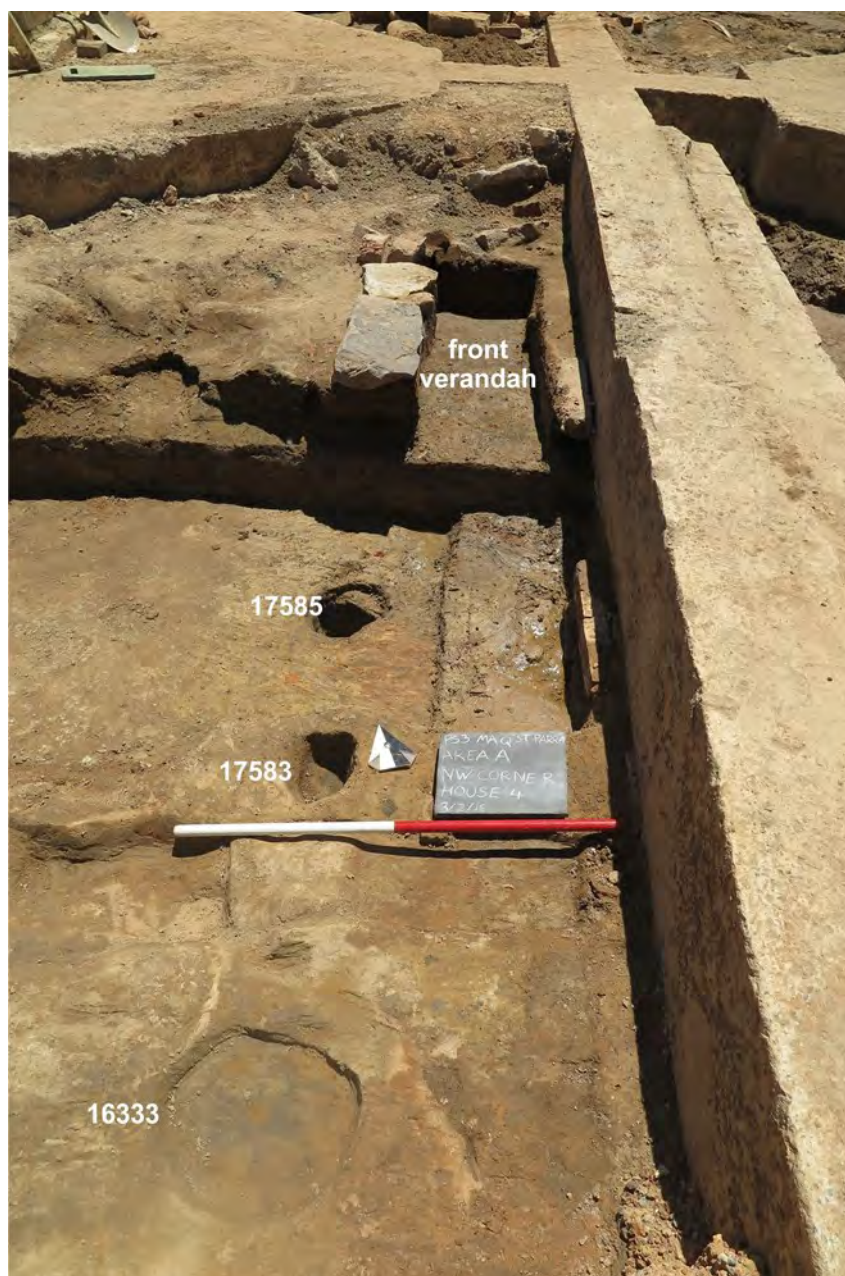
Figure 7.13: Three postholes (17585, 17583 and 16333) running north-south along the western wall of House 4. In the foreground context 16333 looks a lot larger than the other pipes, this posthole had to be re-excavated on a number of occasions after heavy rain. View north. Scale 1m. IMG_5315.

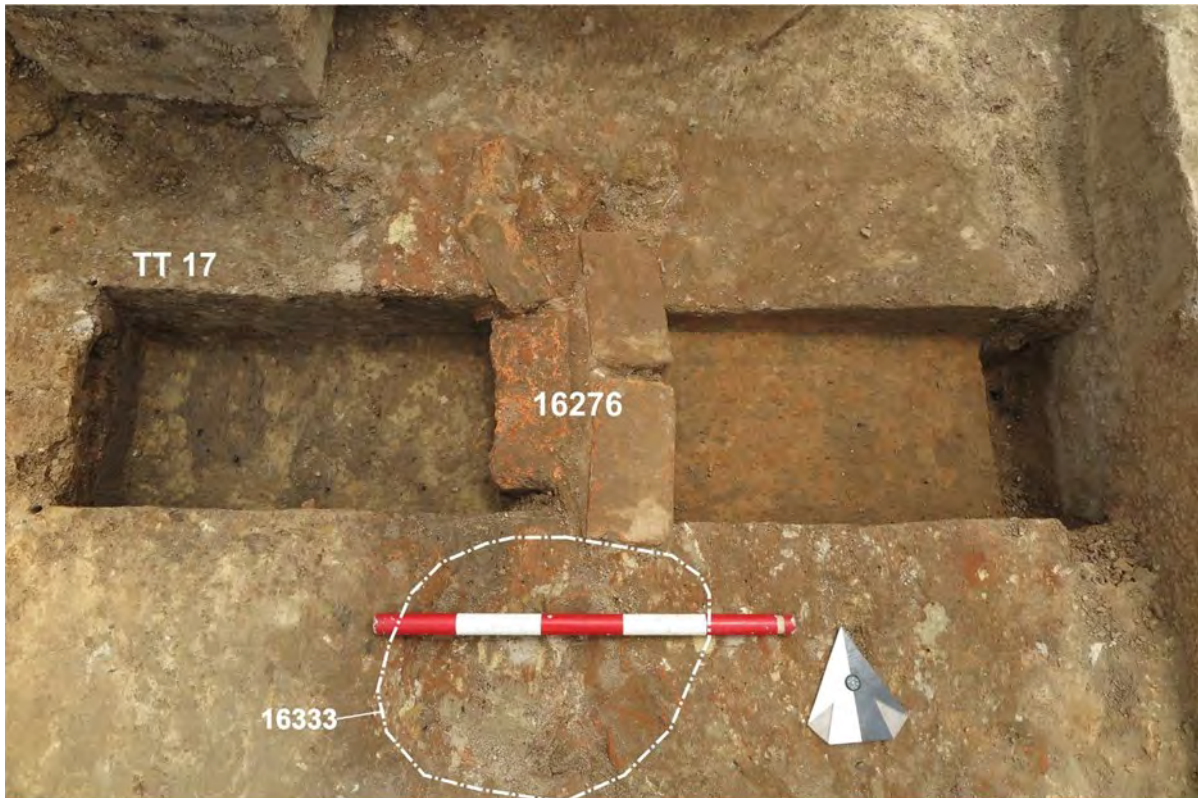
Figure 7.14: TT17 showing the sandstock bricks (16276) end to end along the western wall of House 4 abutting the unexcavated post-pipe (16333) which has been roughly outlined. There is also a clear distinction between the fills on the exterior and interior of the house. IMG_3888.

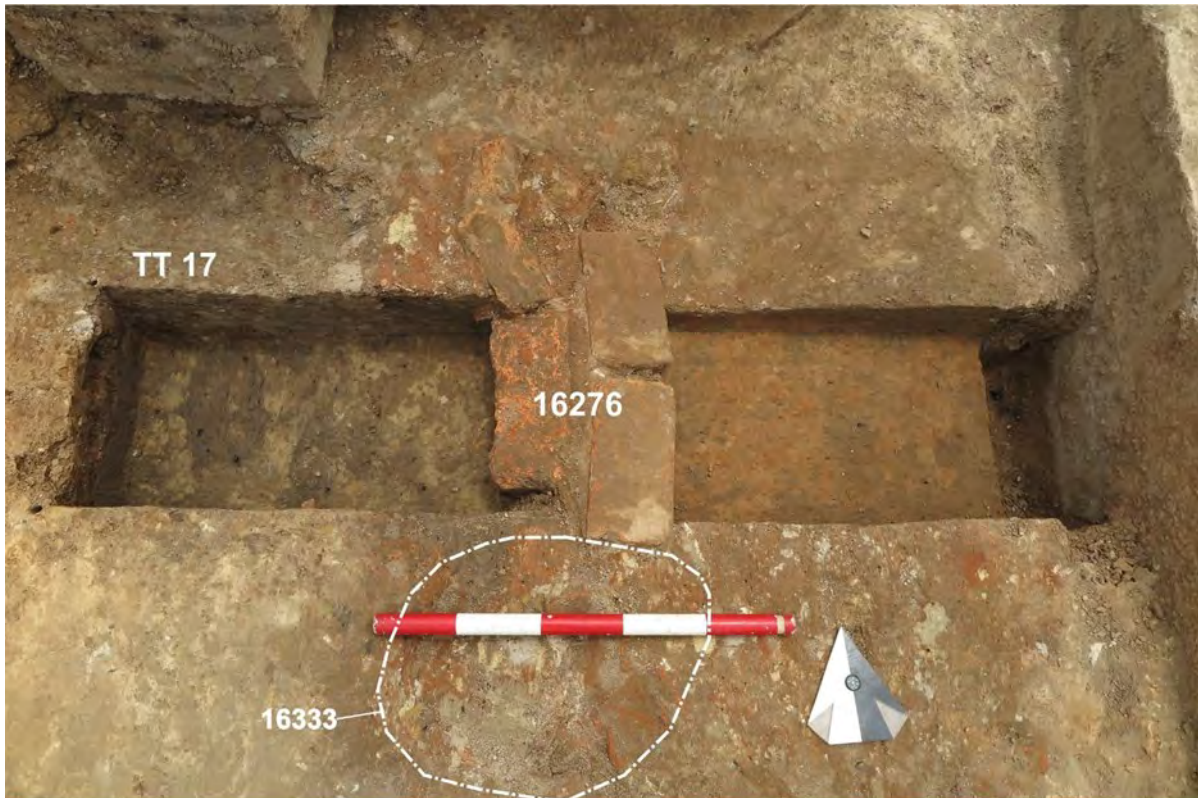
Figure 7.14: TT17 showing the sandstock bricks (16276) end to end along the western wall of House 4 abutting the unexcavated post-pipe (16333) which has been roughly outlined. There is also a clear distinction between the fills on the exterior and interior of the house. IMG_3888.

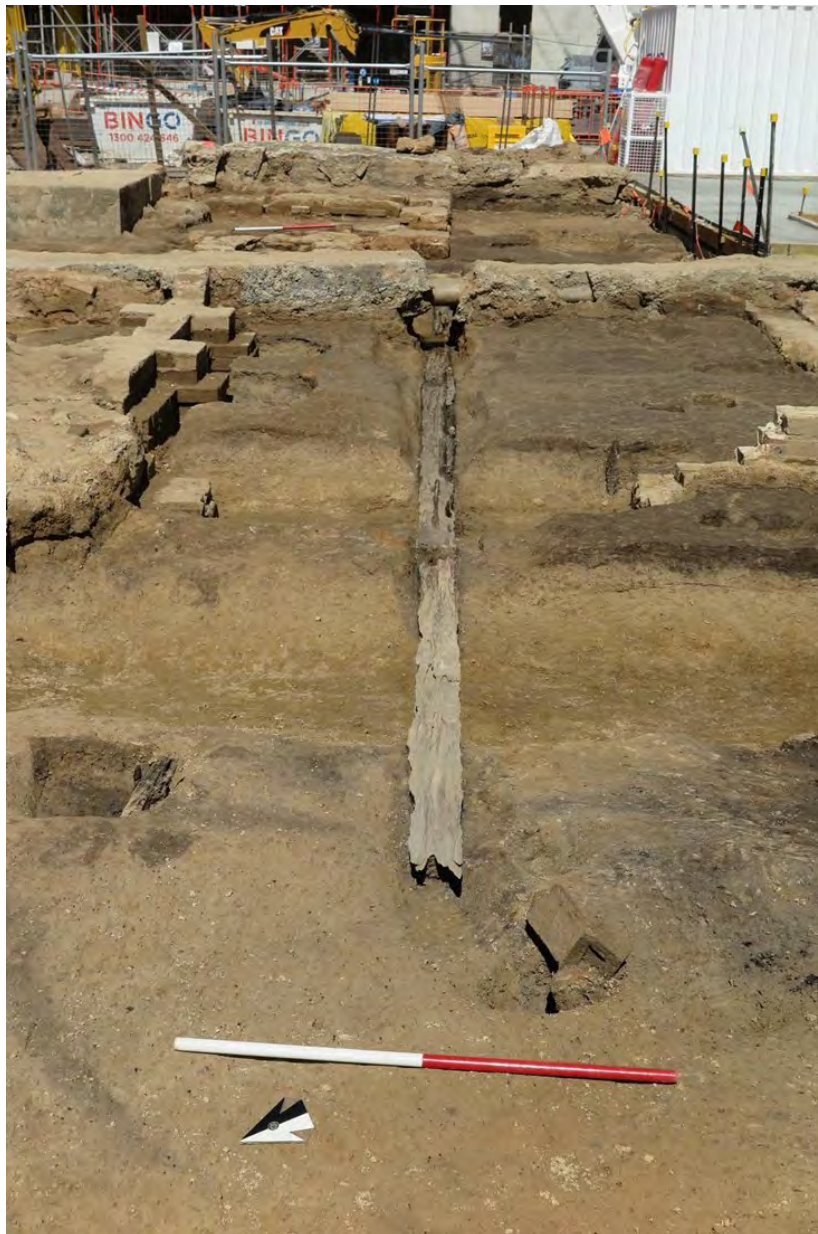
Figure 7.15: Timber baseplate (16362) running east-west which supported the southern wall of House 4. This photo shows the baseplate cutting the original topsoil (16224) and the subsoil (16190). The house associated deposits and fills were removed by this stage of the excavation. View east. Scale 1m. IMG_5239.

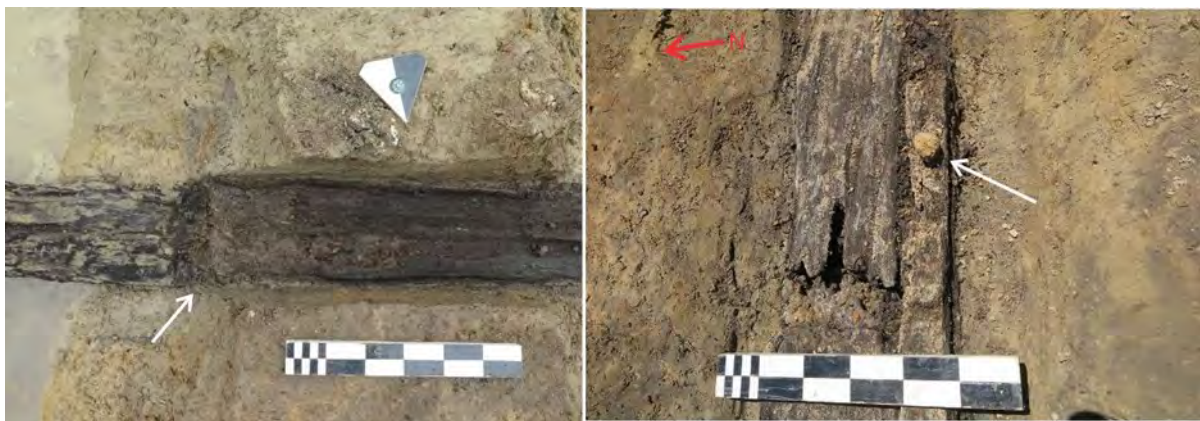
Figure 7.16: Detail of two of the long timber segments aligned to form the baseplate with a small gap between the two timbers (left), IMG_3368. The image on the right shows the second layer of smaller timbers with the bolt in situ which may have acted as a wedge to secure the upright timbers (IMG_5294). Scale 30cm.

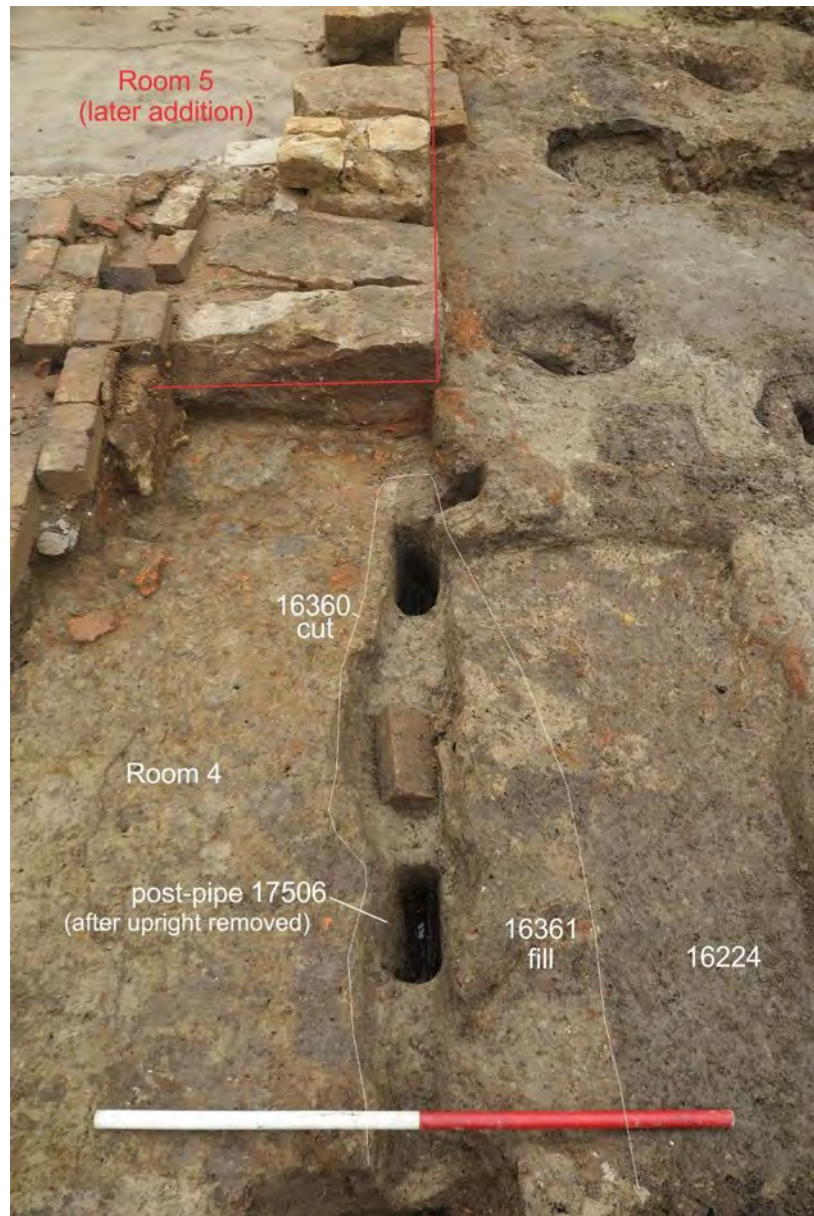
Figure 7.17: Southeast corner of House 4 showing the packing fill (16361) and the impression (post-pipes) of the wall slabs/posts forming the rear wall of the house. In the background (red) is the later addition to the house (Room 5) constructed of sandstone footings. View east. Scale 1m. IMG_5116.

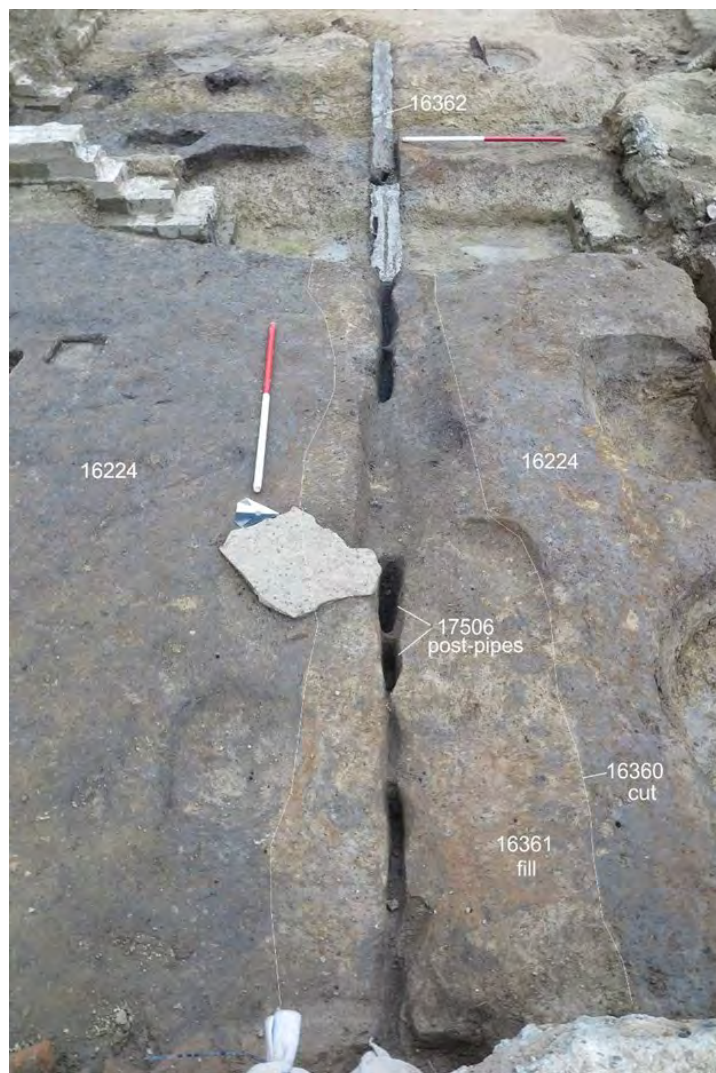
Figure 7.18: Southwest corner of House 4 showing the baseplate (16362) in the background and the excavated impressions of the wall slabs or upright posts within the packing fill (16361). The cut for the baseplate (16360) became a lot cleared in plan after the area was excavated to the level of the original topsoil (16224). View west. Scale 1m. IMG_5176.

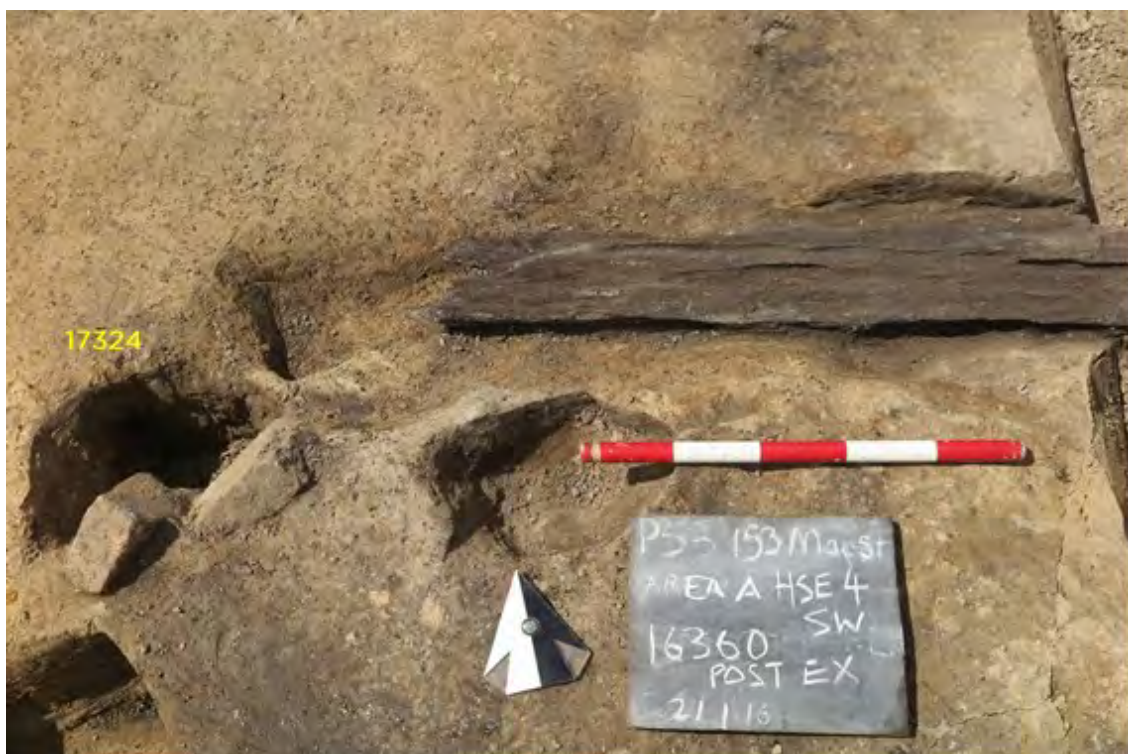
Figure 7.19: Western end of the baseplate and posthole (17324) with some bricks still in place in the fill was possibly the corner post for the house supporting the roof as the roof likely extended past the southern wall. View north. Scale 1m. IMG_5013.

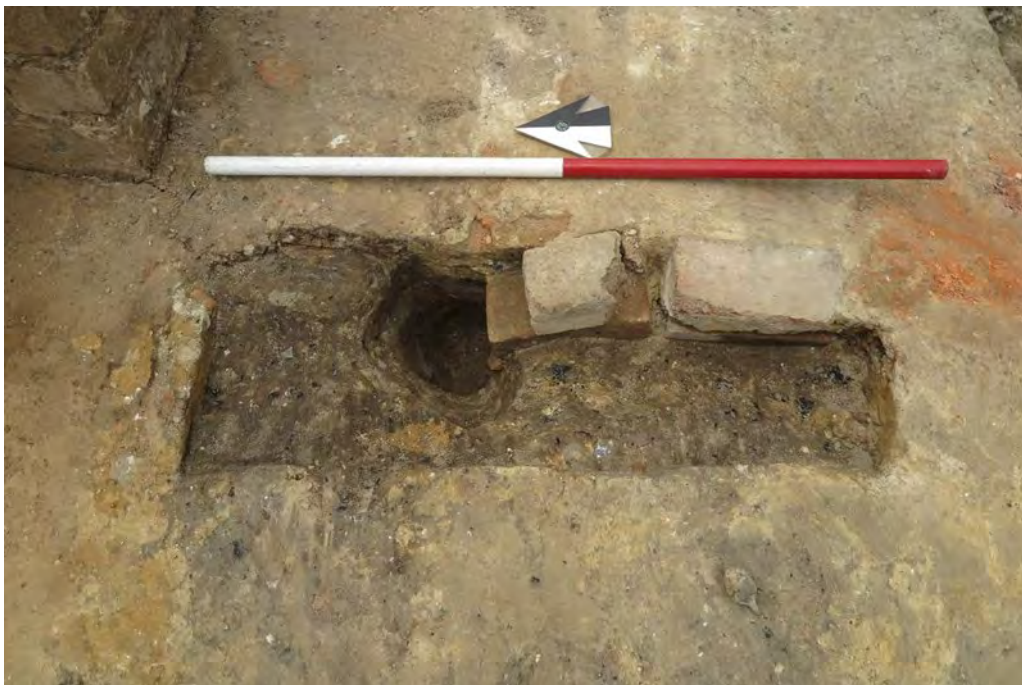
Figure 7.20: Posthole (16236) and brick row (16235) forming north-south partition within House 4. View east. Scale 1m. IMG_3945.

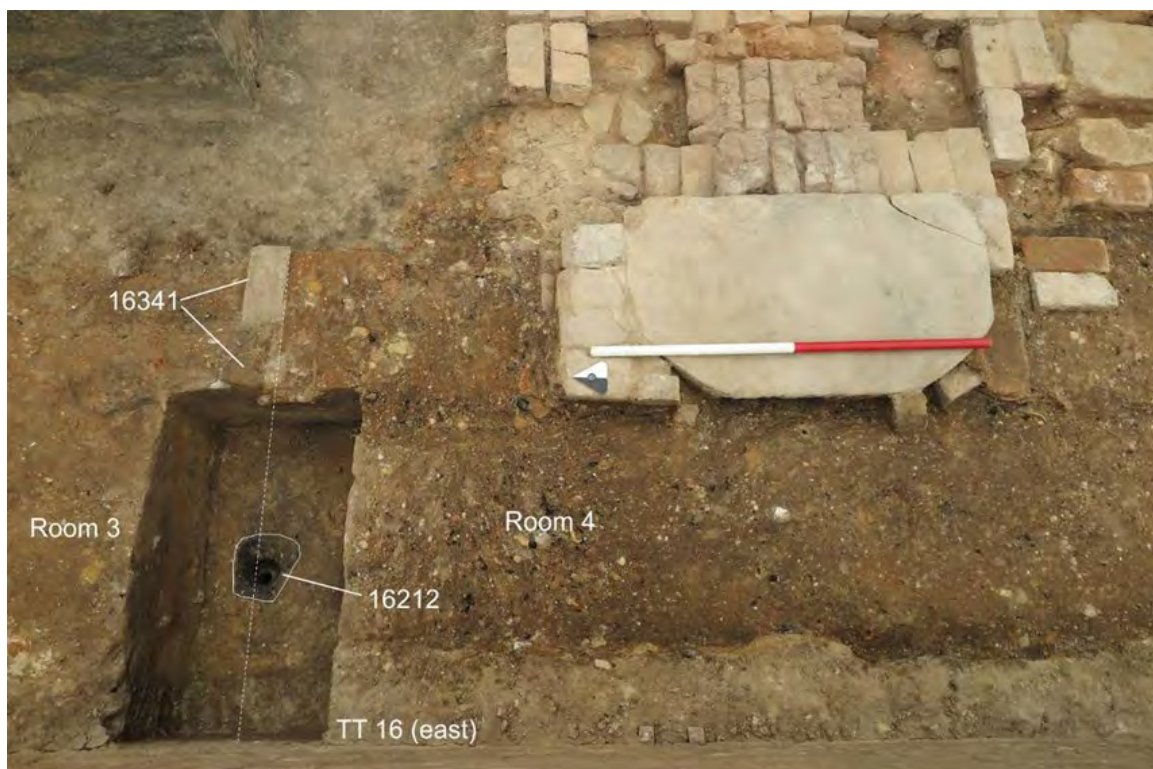
Figure 7.21: East-west partition between Room 3 and Room 4, House 4. A posthole was found in TT16 (east) along with a row of bricks head to head. View east. Scale 1m. IMG_4065.

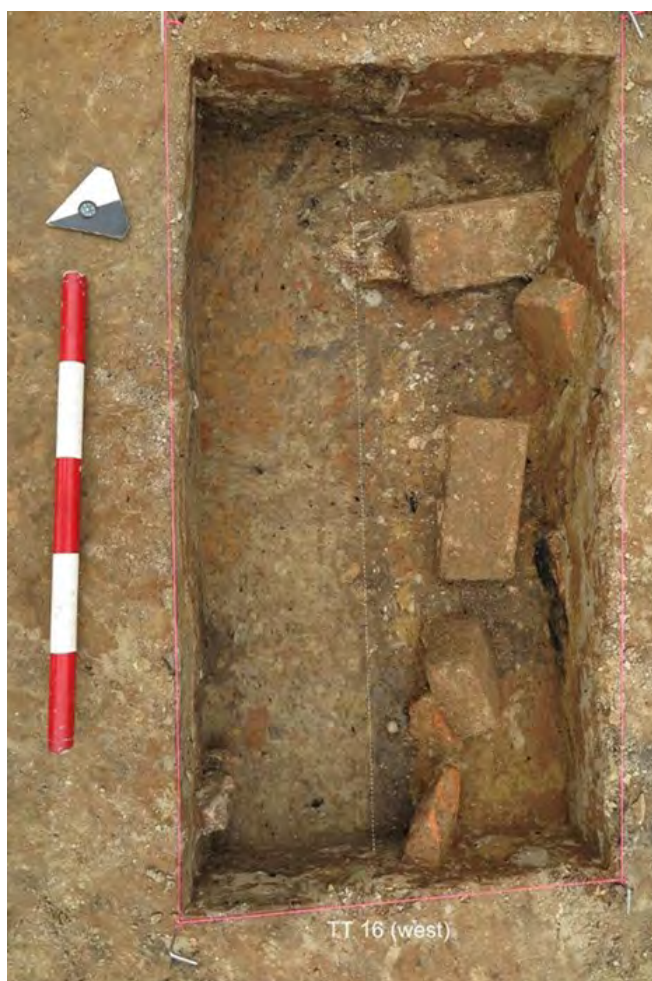
Figure 7.22: Extension westwards of Test trench 16 (TT16 west) showed the same difference in fills between the two rooms, a second posthole was found deeper down. Scale 50cm. IMG_4036.

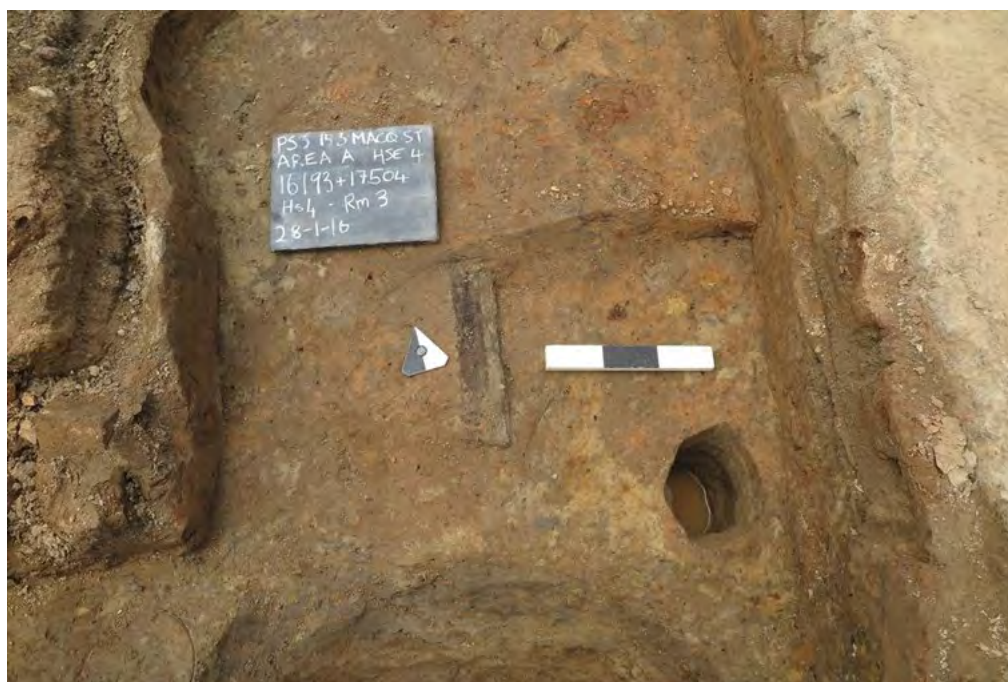
Figure 7.23: Post-pipe 17504 along the east-west partition, west of 16212. The pipe cut deep through the imported sandy fills and into the natural deposits. View north. Scale 30cm. IMG_5148.

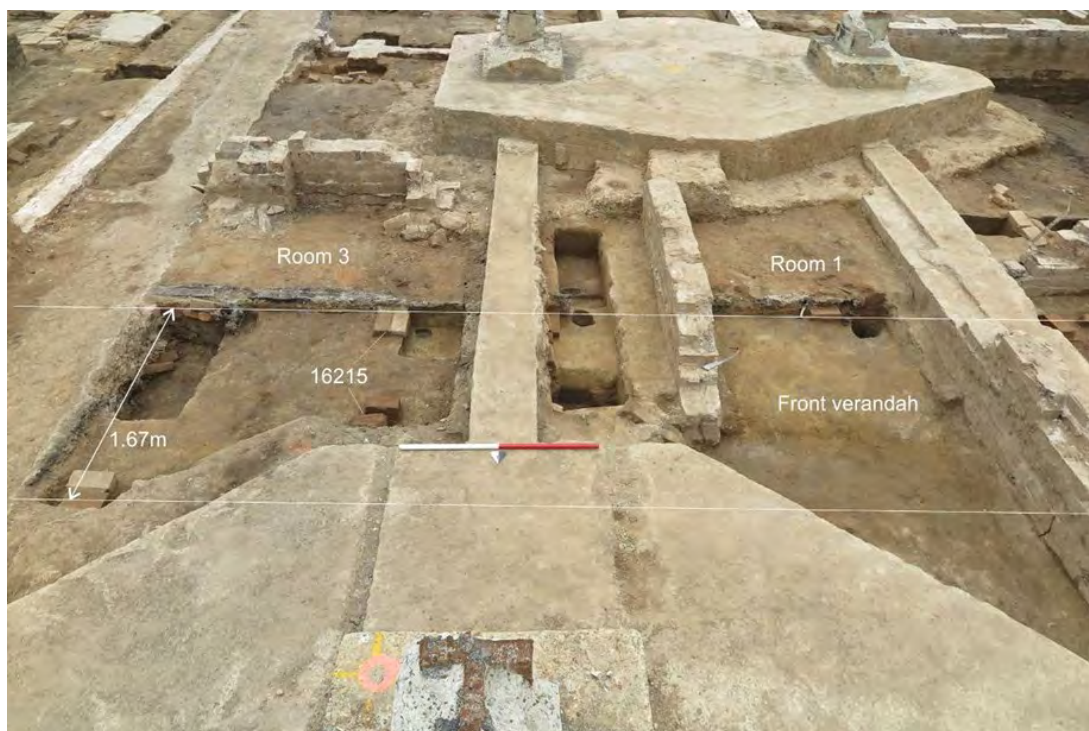
Figure 7.24: Middle section of the front verandah of House 4, greatly impacted by the Cranbrook and post office footings. The horizontal timber plate (17270) and postholes are at the rear of the verandah and the numerous brick pad/piers (all numbered 16215) east of the postholes and further to the north. View south. Scale 1m. IMG_4143.
