3PS – 153 MACQUARIE STREET, PARRAMATTA

TRENCH REPORT – AREA A & AREA A SOUTH

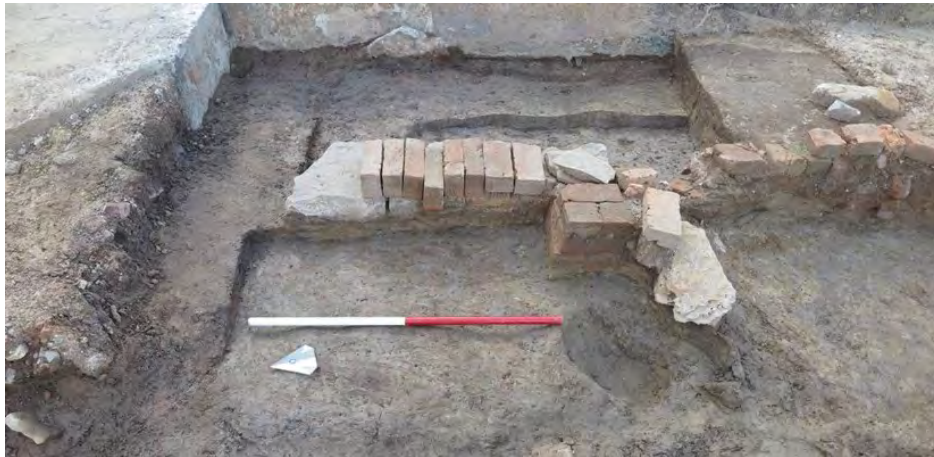
Figure 7.25: Eastern end of the front verandah constructed of brick and stone, possibly a threshold or step sitting above the imported sands. To the right of the scale are the remains of posthole 16346 from the north wall of the house, its shape was damaged by flooding. Beside the posthole is another set of brick piers 2 courses deep. View east. Scale 1m. IMG_5263.

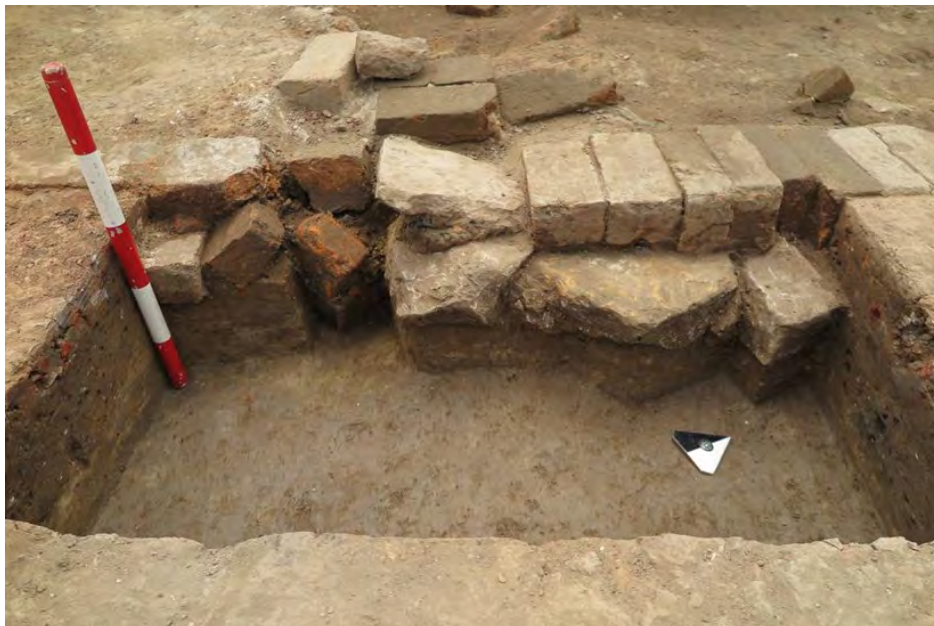
Figure 7.26: TT 19, excavated on the exterior side (east side) of the front verandah. The grey silty clay in the base of the test trench is the original topsoil (16224). View west. Scale 50cm. IMG_4014.

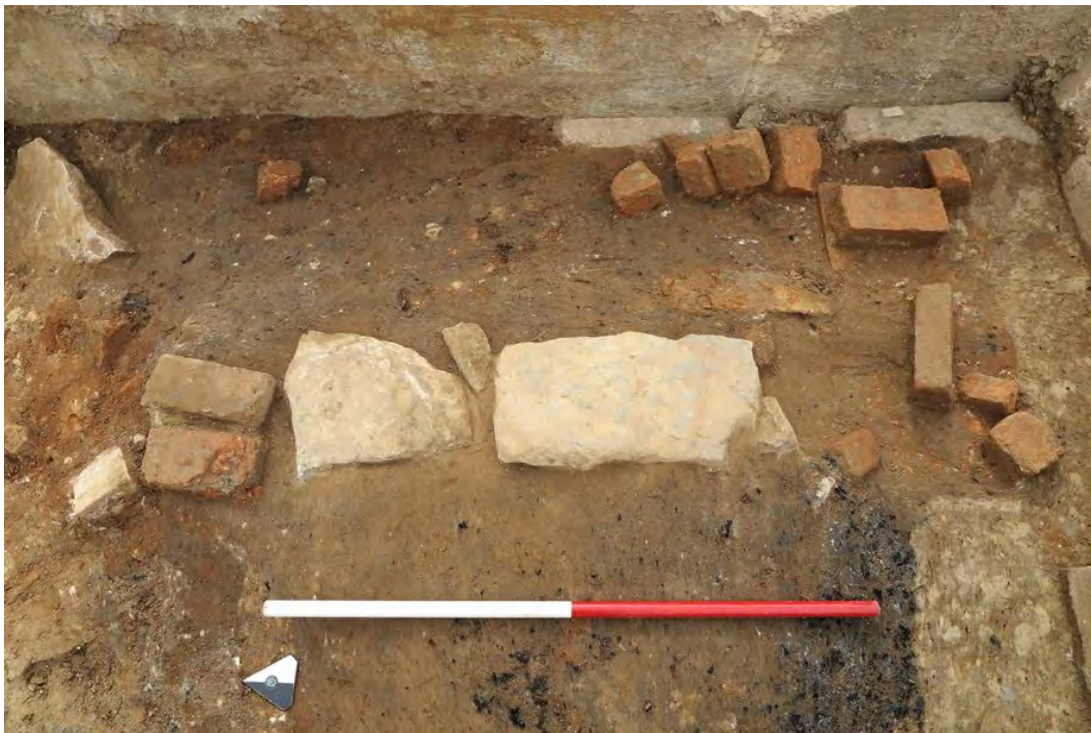
Figure 7.27: Western end of the front verandah with blocks of Parramatta shale and sandstock bricks similar to the eastern end. This area was greatly impacted by the modern concrete footings. View east. Scale 1m. IMG_4042.

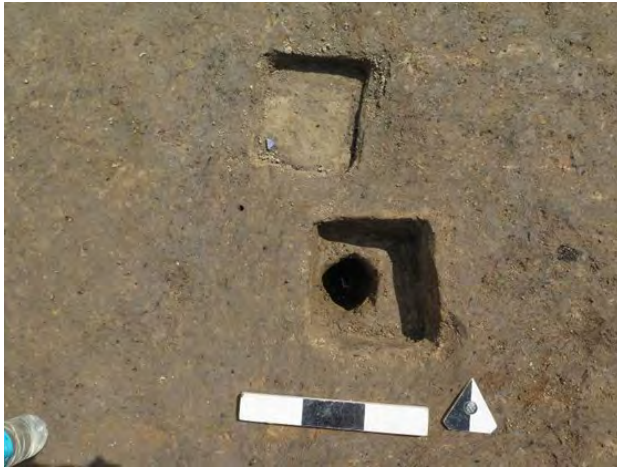
Figure 7.28: Detail of the square posthole (17524) with a circular pipe and just north of it the base of posthole 17248 a possible replacement post. Both features were on the east-west alignment of the earlier phased rear verandah. View north. Scale 30cm. IMG_3405.

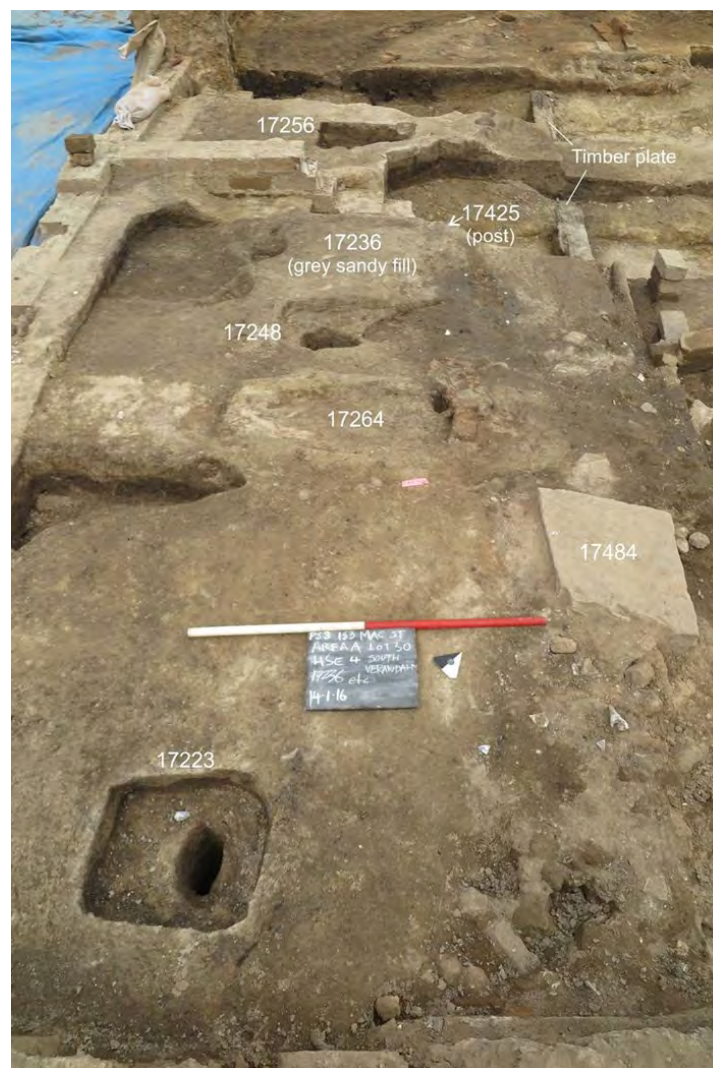
Figure 7.29: Rear verandah postholes running east-west cutting the grey sandy fill (17236) after the occupation related deposit (17229) was removed. The postholes had oval post-pipes. Only the top 100mm of the packing fill was removed. The timber baseplate can be seen in the background. The sandstone block (17484) was possibly the threshold for the back door. The rubbly fill (17380) surrounding the sandstone was part of the levelling before the brick paving (16181) was laid. View northwest. Scale 1m. IMG_4783.

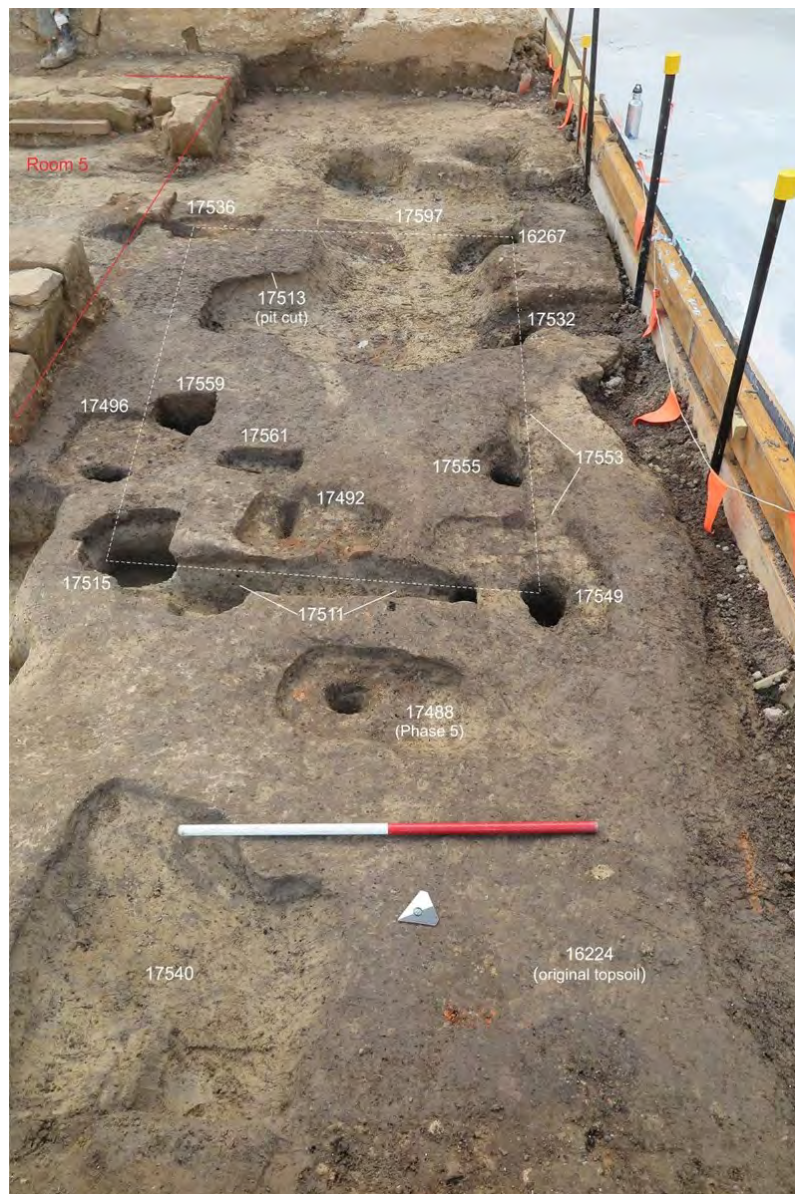
Figure 7.31: Possible small rectangular structure adjoining the eastern end of the south verandah. The numbered features (including their post-pipe fills) were all below the brick paving (16181) suggesting this structure was demolished when the new kitchen (Room 5) was built and the verandah area was extended and paved. This area was also truncated by later pits (Phase 5). View east. Scale 1m. IMG_5278.

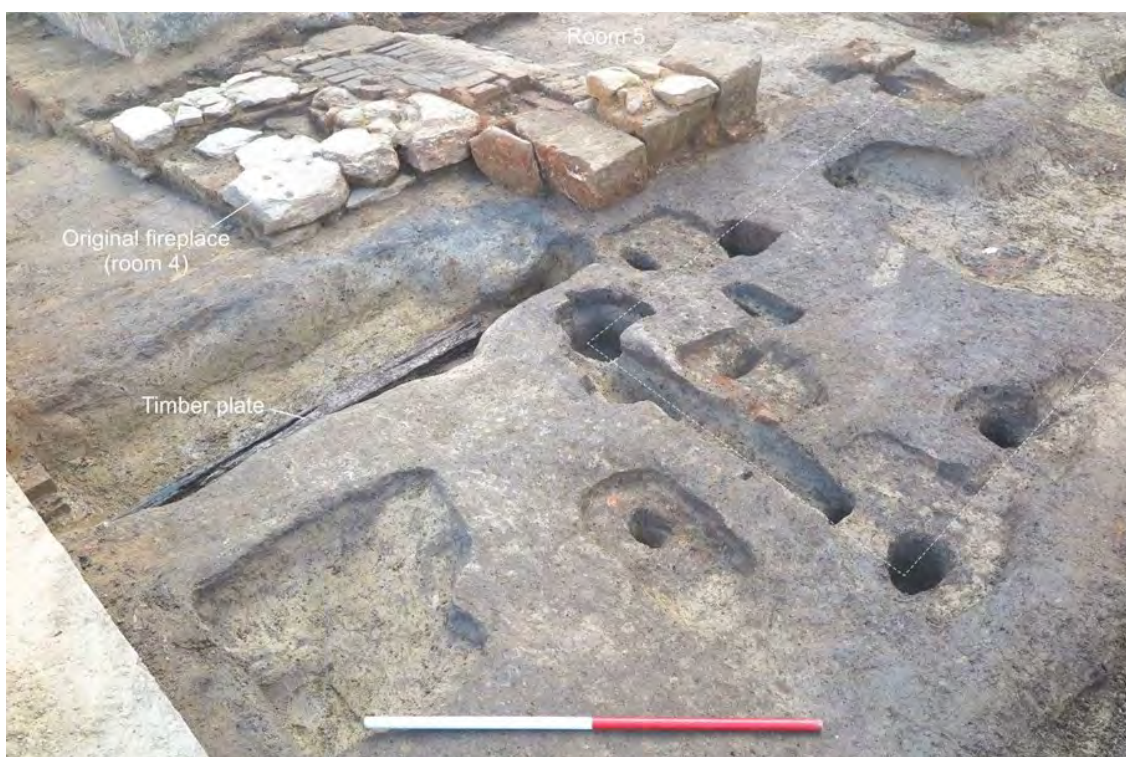
Figure 7.32: Small structure adjoining eastern end of House 4 rear verandah. The western end represented by trench 17511 was perpendicular to the baseplate (16362). All the postholes associated with the structure were below the brick paving (16181). View northeast. Scale 1m. IMG_5276.

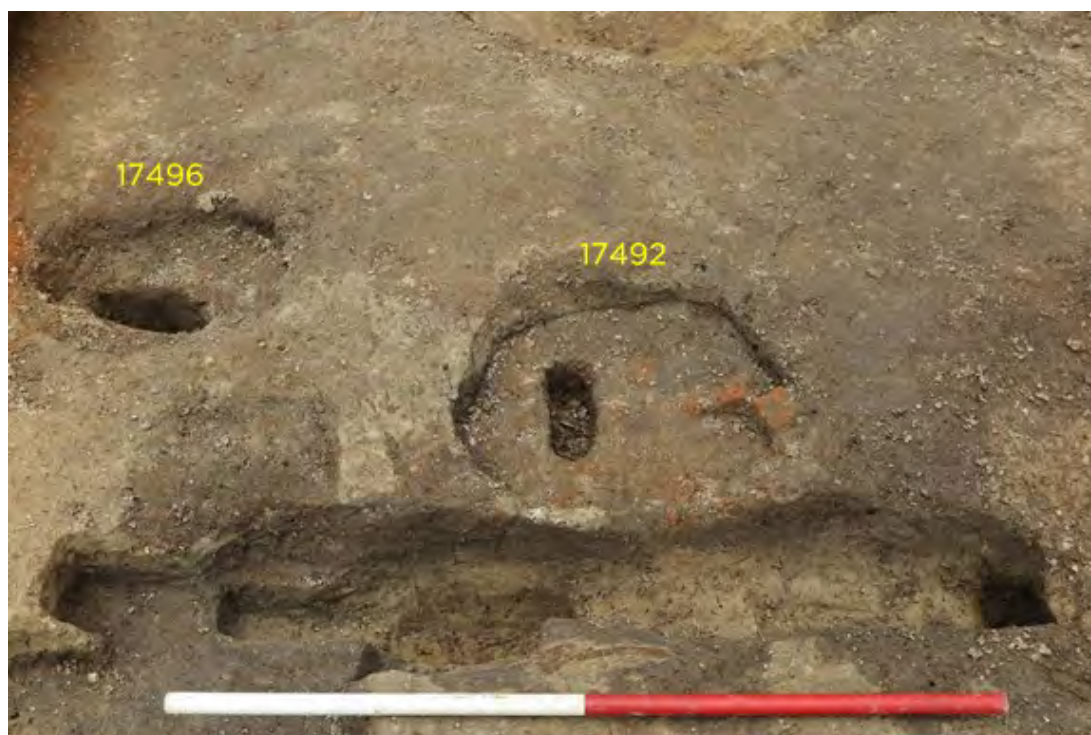
Figure 7.33: Detail of the linear feature (17511) in the foreground showing impressions in the base of the trench from upright posts, also visible are two similar postholes (17492 and 17496) with rectangular post-pipes. View east. Scale 1m. IMG_5140.

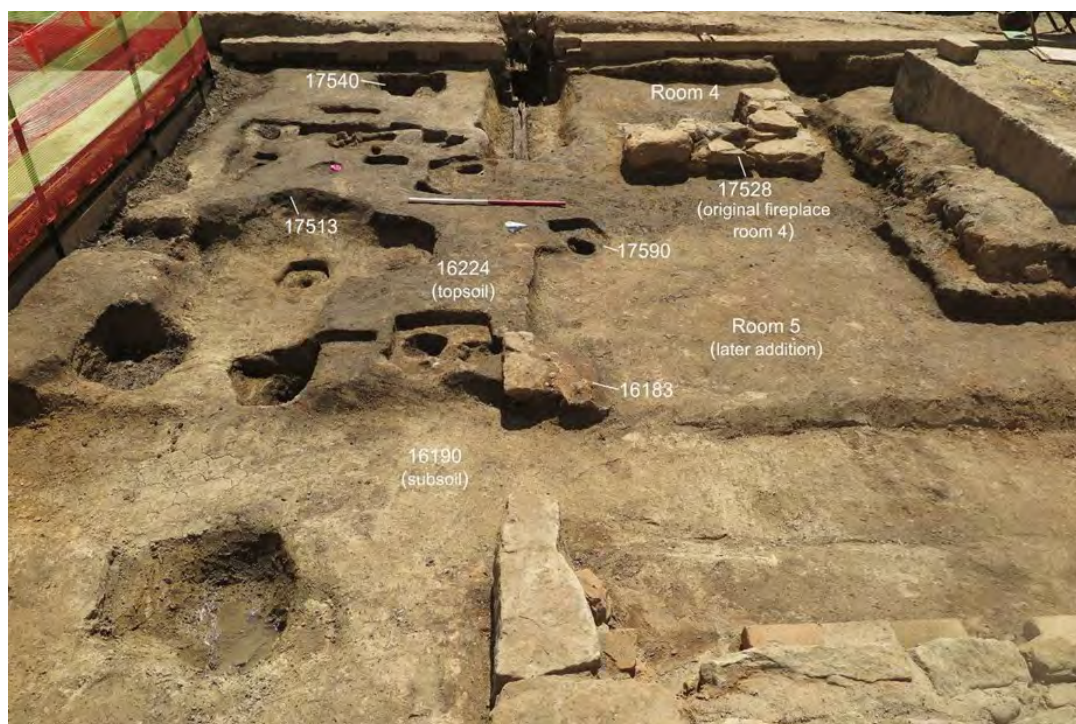
Figure 7.34: Postholes forming rectangular structure in southeast corner. Two pits 17540 and 17513 cutting the postholes. The posthole in the centre of pit 17513 is from a later phase (Phase 5.1). North of the structure below the footings of Room 5 was another posthole (17590) associated with the original house. View west. Scale 1m. IMG_5336.

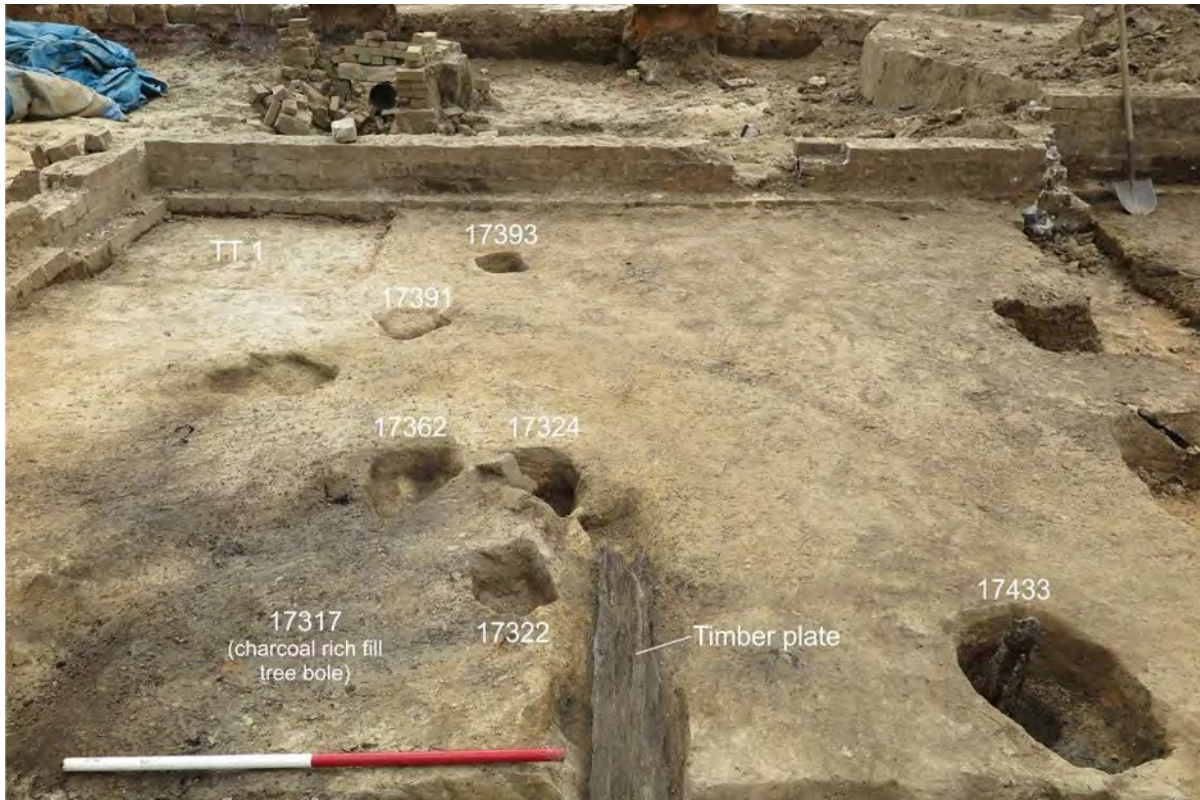
Figure 7.35: Features located close to the southwest corner of House 4, cutting the subsoil (16190). Most of these features only became clearly visible after the modified topsoil (16120) was removed. The darker fill (17317) was within an irregular cut (17316) caused by the removal of a tree bole which pre-dated the construction of the house. In the background is a brick sump/cesspit that flowed into the town drain (Phase 4.2). View west. Scale 1m. IMG_5022.

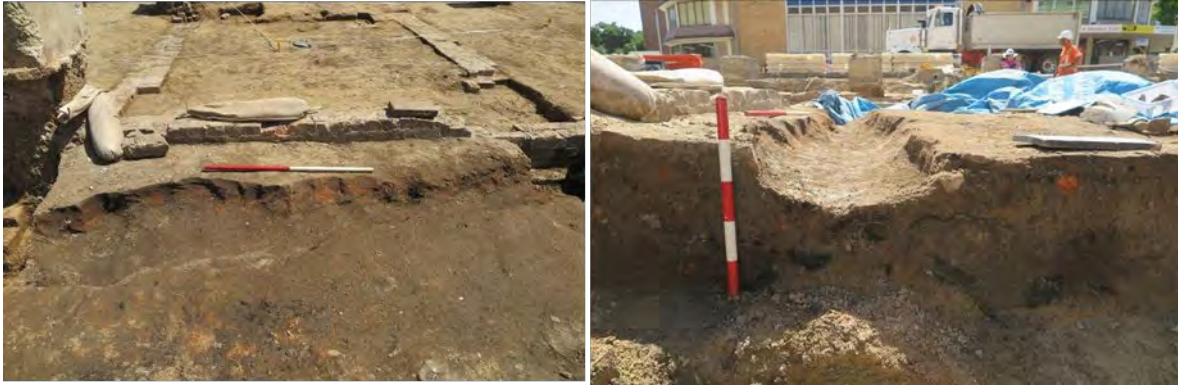
Figure 7.36: Shallow linear trench (17234), possibly a drainage channel running east-west towards the brick sump (16187) and creek line. View south, scale 1m. IMG_4727. Image on the right shows the feature in section. The irregular shape suggests it may be a robber cut. No structural remains were found. View east, scale 50cm (right). IMG_4730.

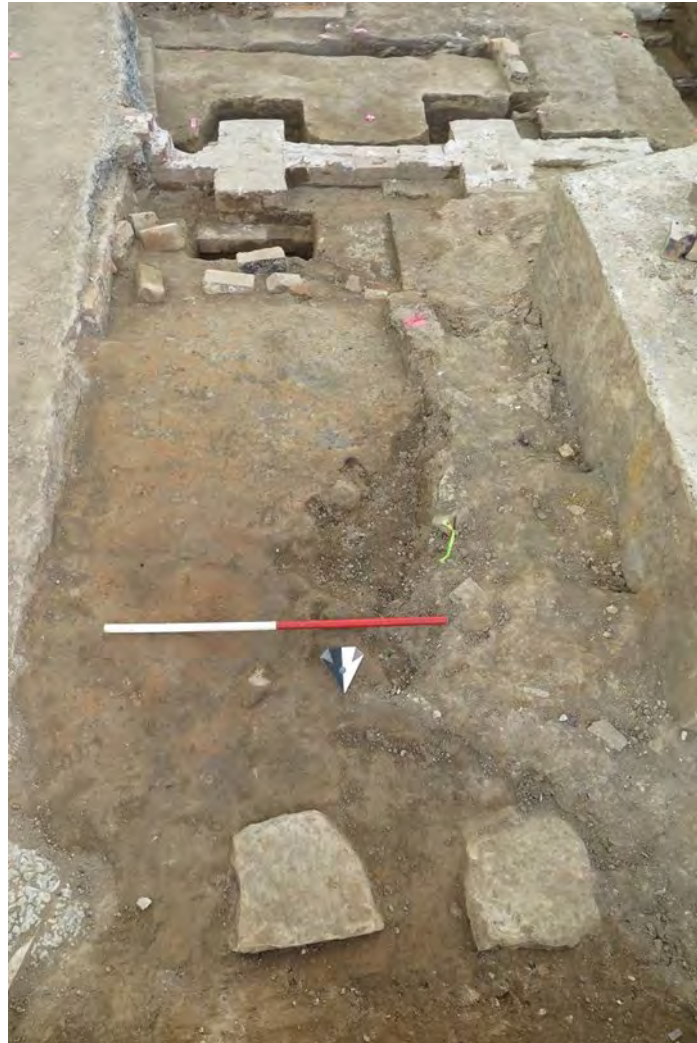
Figure 7.39: Two stone blocks sitting on the orange sand (16193) in the centre of Room 3 could have been pads/piers to support a timber floor. The sandstock bricks in the background are along the partition between Rooms 3 and 4. View south. Scale 1m. IMG_4282.

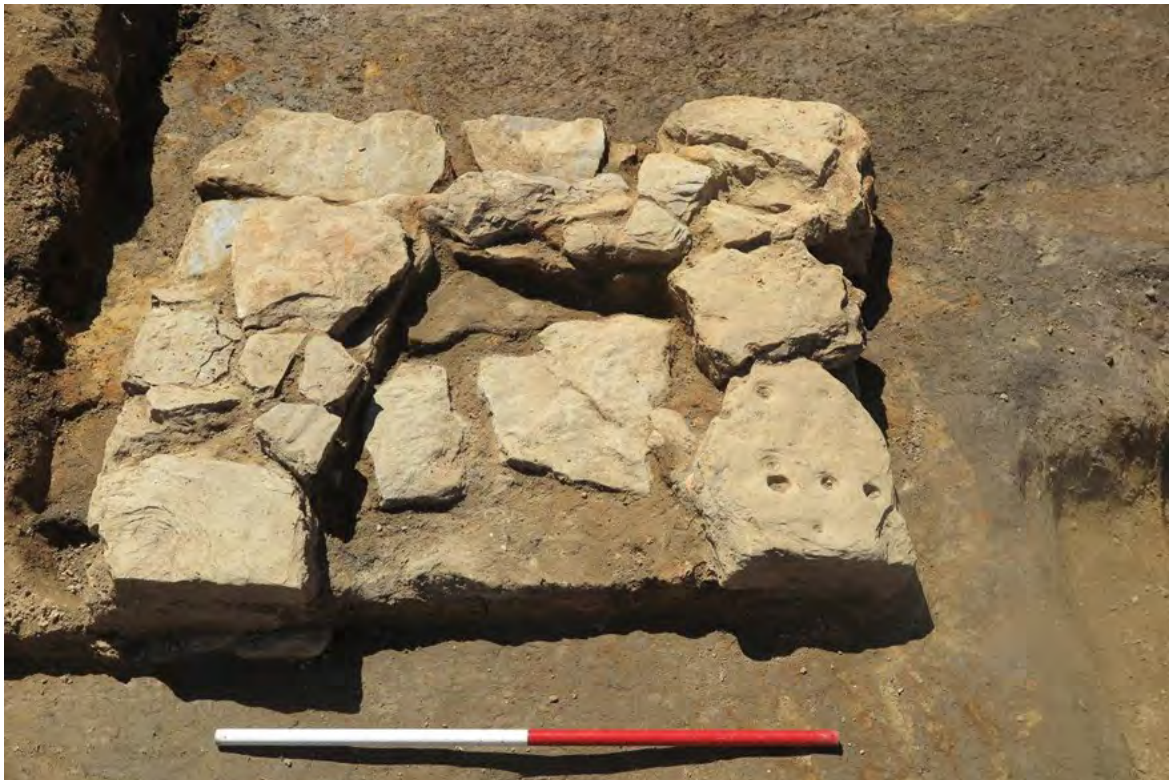
Figure 7.41: Detail of the original fireplace constructed of irregular shaped blocks of the local Parramatta shale. View east. Scale 1m. IMG_5283.

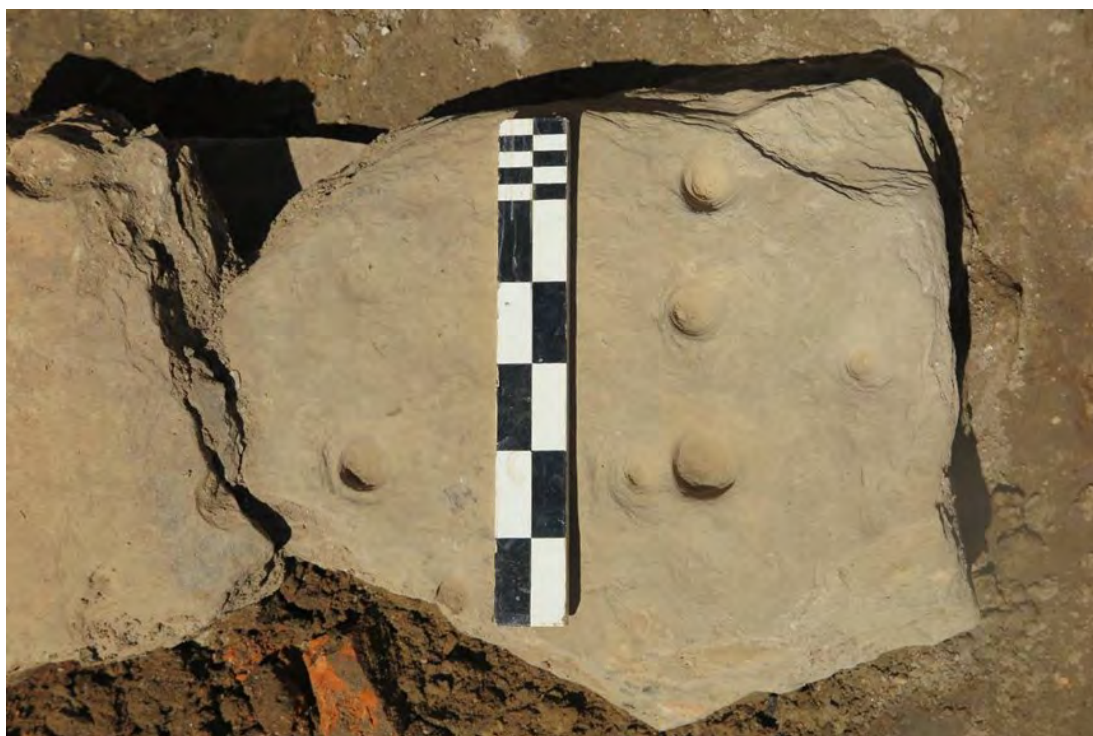
Figure 7.42: Detail of the corner stone of the original fireplace (17528) in Room 4. The conical shaped holes may have supported metal rods/poles to hold pots over the fire. Scale 30cm. IMG_5305.

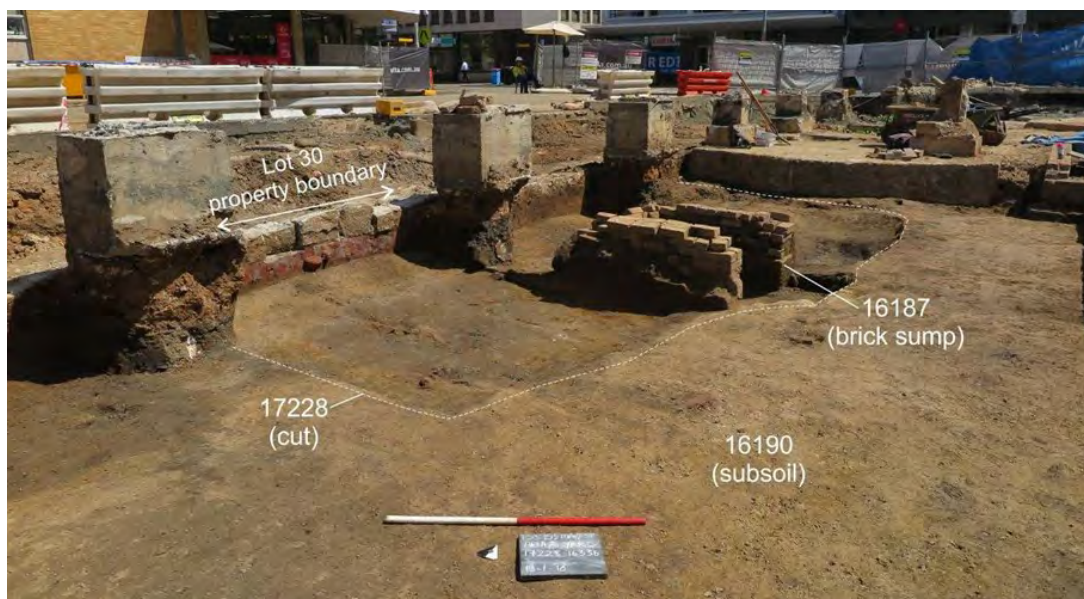
Figure 7.43: Large rectangular cut (17228) cutting the subsoil close to the property boundary of Lot 30 which is represented by the sandstone wall. This large feature was used as a sump or catchment for drains leading from House 4 and was later replaced by a more formalised brick sump (16187) which flowed into the town drain via a timber lined drain (1788 in Area D). View northwest. Scale 1m. IMG_4715.

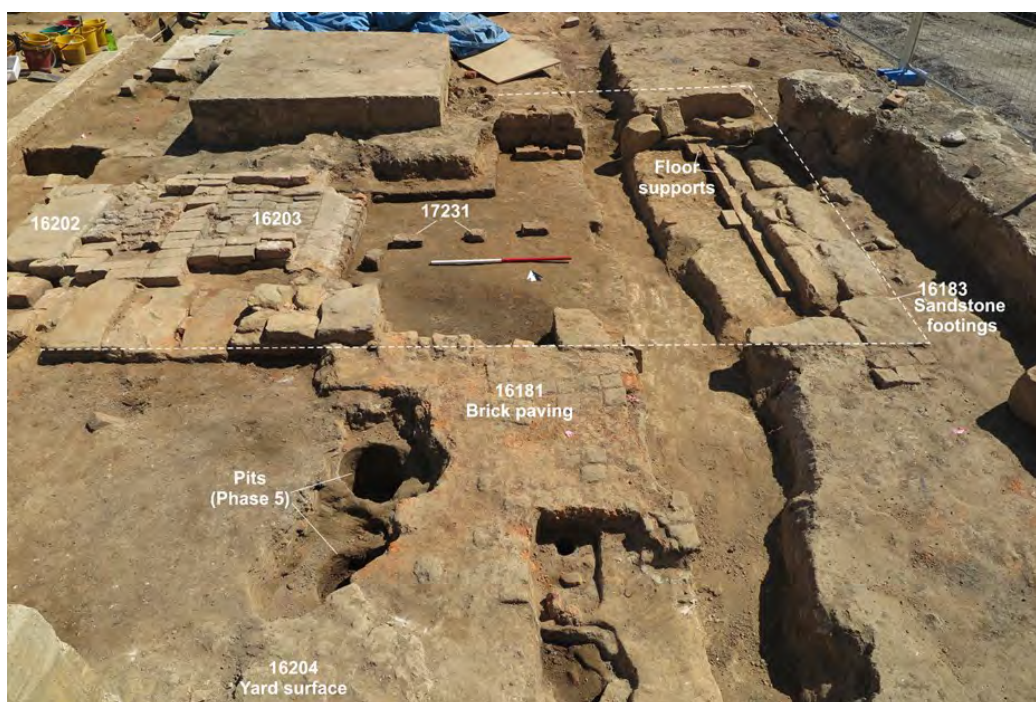
Figure 7.45: Room 5 outlined by the dashed line. The footings were truncated by a service trench (north-south) and the post office footings in the northwest corner. The fireplaces (16202 and 16203) in Rooms 4 and 5 were back to back. The brick paving (16181) abutted the south wall and the interior space of the room contained brick piers (17231) to support the timber floor. View north. Scale 1m. IMG_4554.

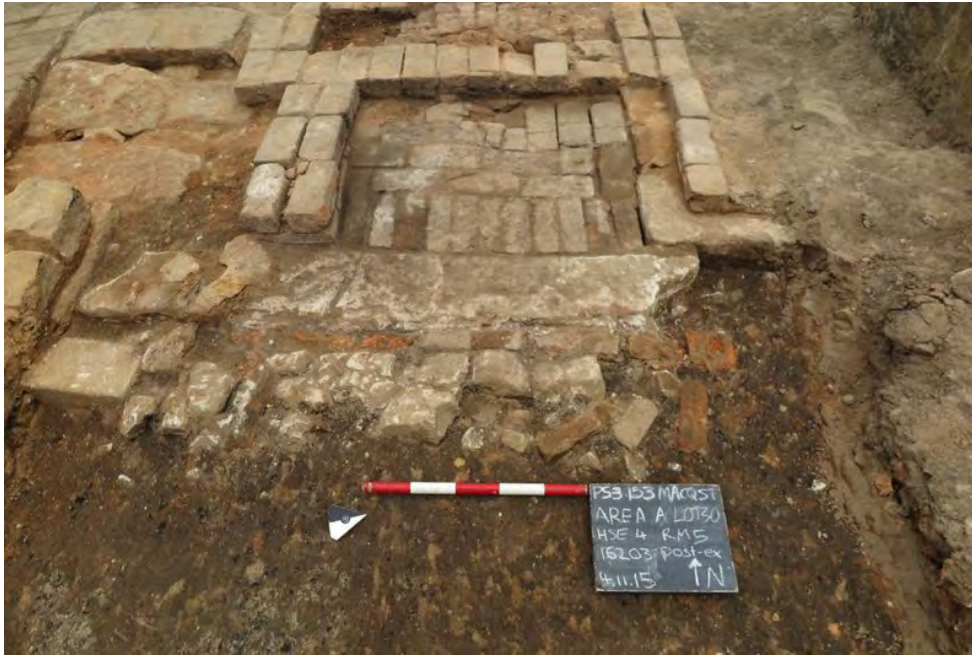
Figure 7.46: Room 5 fireplace (16203) abutting the later phased fireplace (16202) in Room 4 (background). The fireplace was brick lined with a long narrow hearthstone. The broken stones and brick in front of the hearthstone were demolition debris. View west. Scale 30cm. IMG_3987.

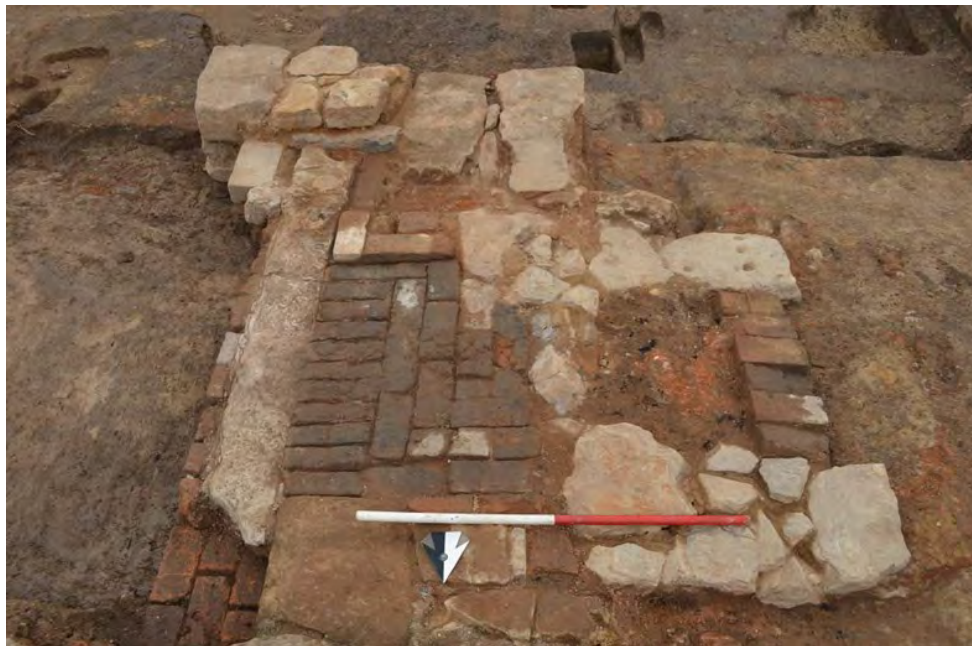
Figure 7.47: Long narrow hearthstone (left) sitting on a single course of bricks and extending beyond the width of the fireplace in Room 5. View south. Scale 1m. IMG_5167.

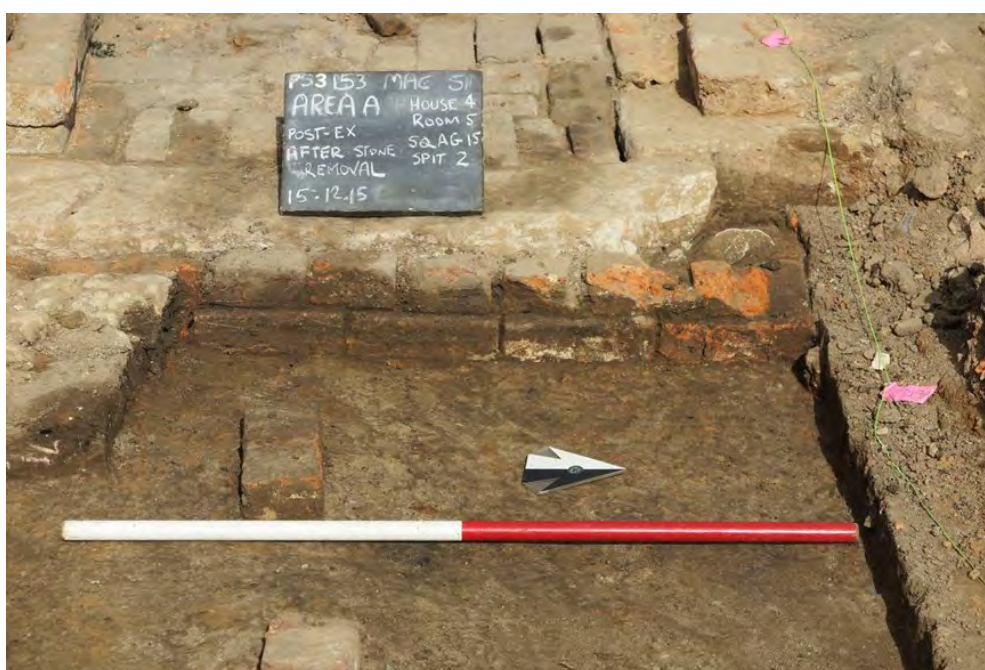
Figure 7.48: Detail of the brick edging around the hearthstone during the excavation of the occupation deposit (16248). Some of the bricks were broken and others had whitewash/paint on their sides. The single bricks in the foreground (near the scale) were brick piers to support a timber floor (17231). View west. Scale 1m. IMG_4377.

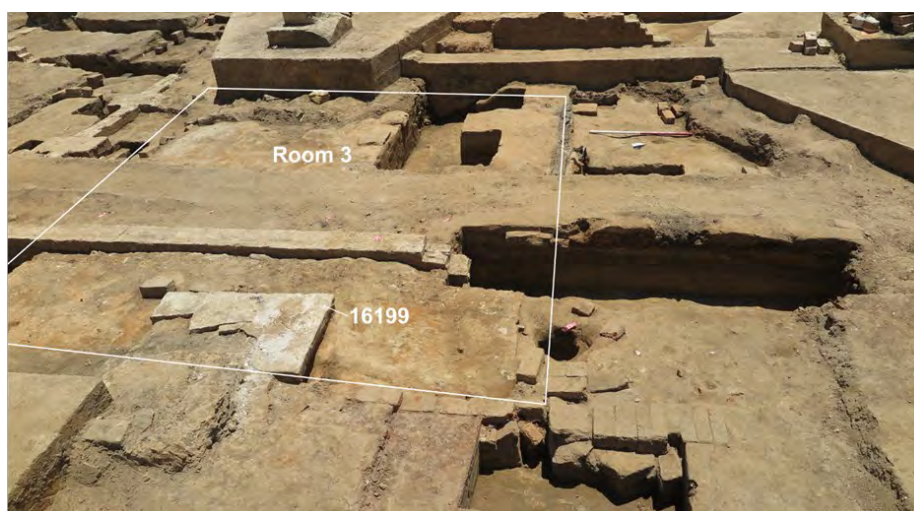
Figure 7.51: The white outline showing the location of Room3, House 4 after the occupation deposit (16282) was removed. The fireplace was located along the eastern wall, what remained of the hearthstone was truncated by the post office foundation trench. A north-south service trench and Cranbrook brick footings split the room in two. View west. Scale 1m. IMG_4589.

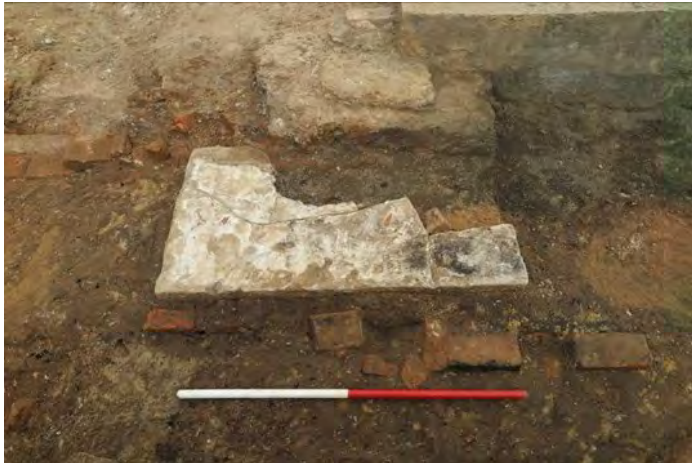
Figure 7.52: White chalky paint/wash covered the surface of the hearthstone. It was likely painted if it was not in regular use. The black staining is from the demolition debris. View east. Scale 1m. IMG_3526.

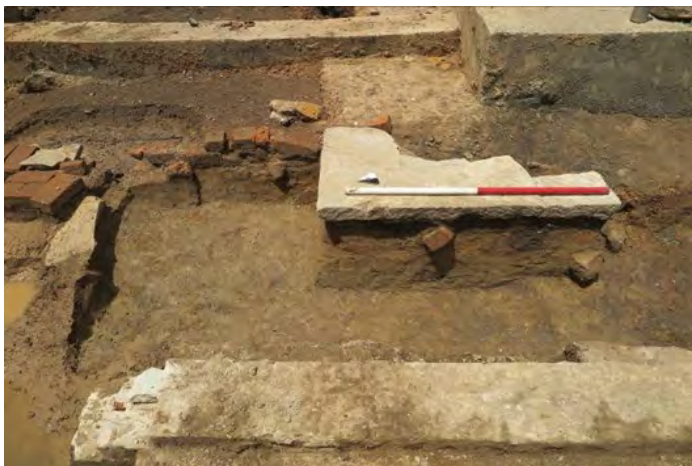
Figure 7.53: The hearthstone in Room 3 sitting above the imported fills 16193 and 16214. View east. Scale 1m. IMG_5190.

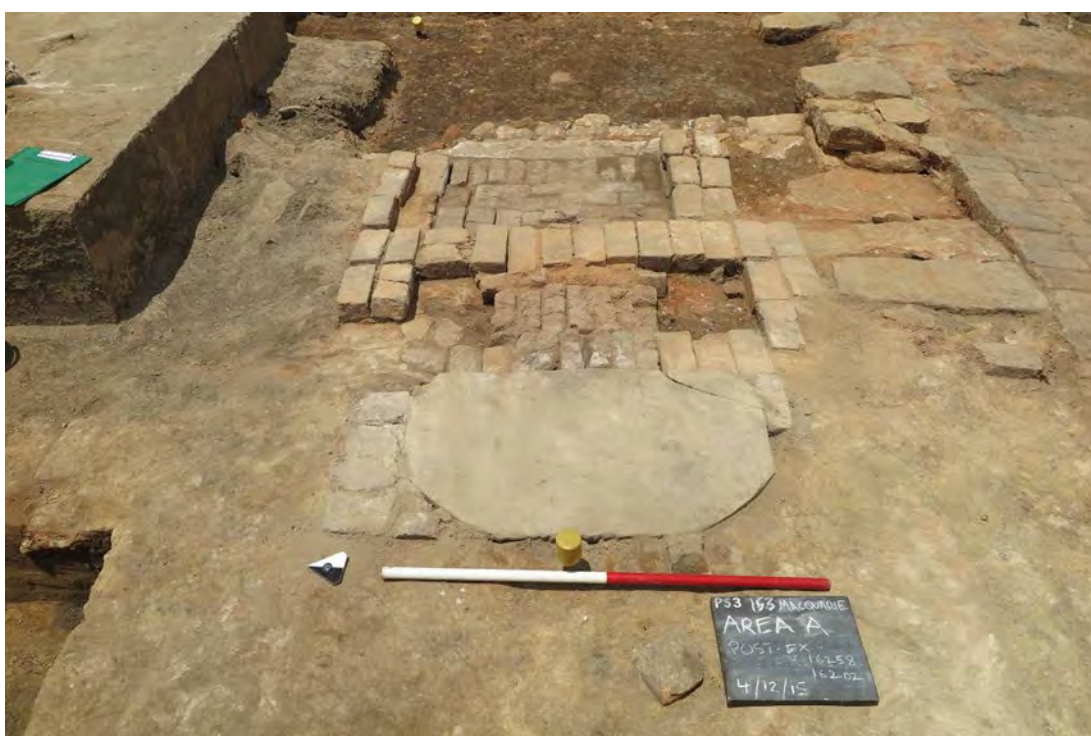
Figure 7.54: The later phased fireplace and hearthstone (16202) in Room 4 is in the foreground abutting the brick fireplace (16203) in Room 5 in the background. View east. Scale 1m. IMG_4005.

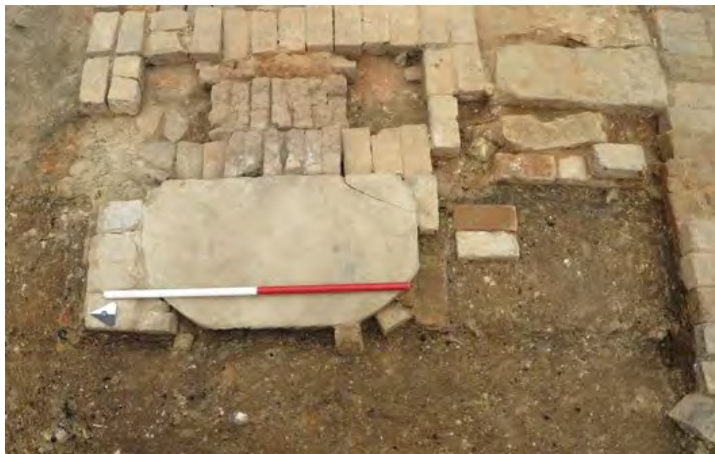
Figure 7.55: Detail of the later phased fireplace in Room 4 with a neatly dressed hearthstone and brick edging. IMG_4064.

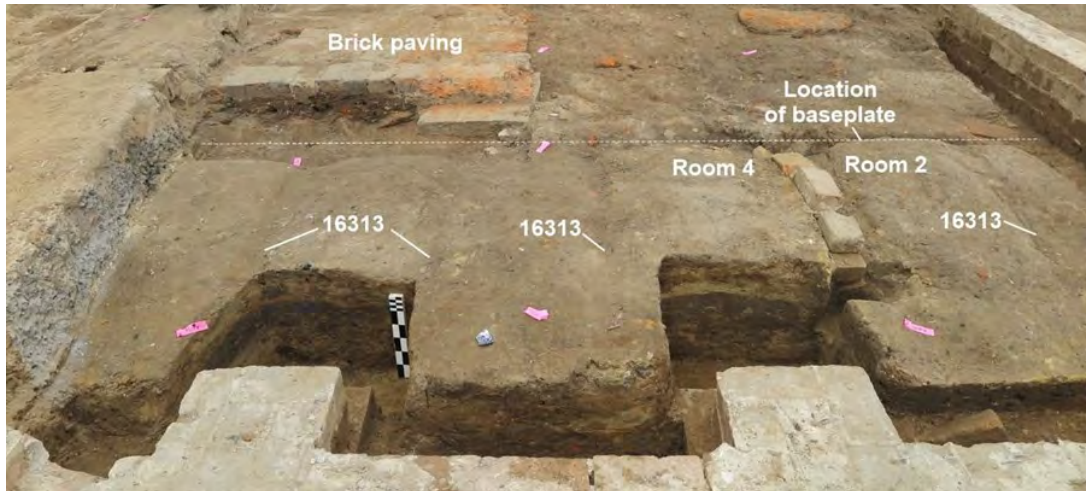
Figure 7.60: Shallow linear impressions (16313) left behind from the removal of timber joists running north-south. These impressions were also found in Room 2 and Room 3. View south. Scale 30cm. IMG_4159.

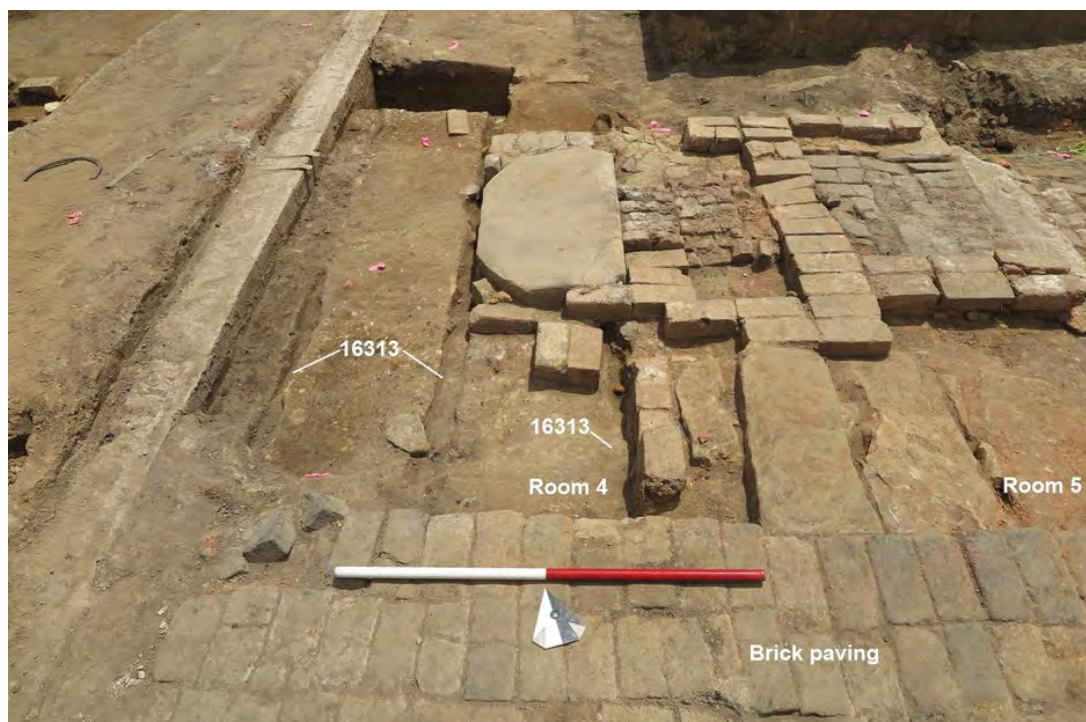
Figure 7.61: Room 4, east of the service trench (16166) showing liner impressions from the removal of timbers running the full length of the room. View north. Scale 1m. IMG_4288.

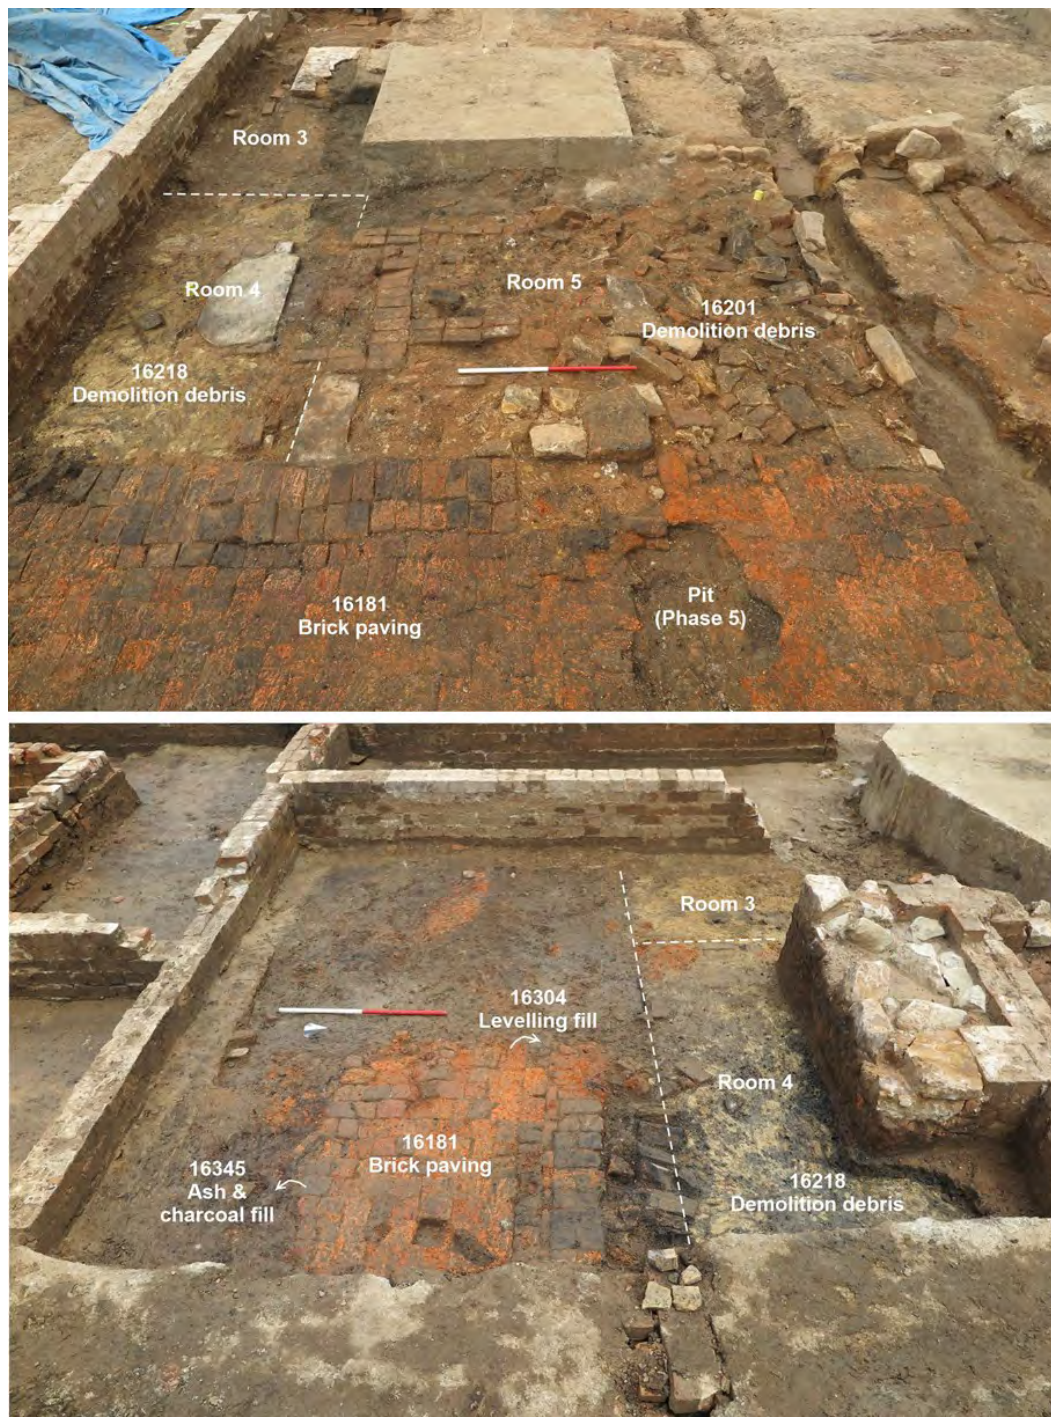
Figure 7.62: Brick paving (16181) rear of House 4 abutting Rooms 4 and 5 (top) with limited evidence of it extending behind Room 3 (bottom). The paving was sitting on levelling fill (16304) and was later truncated by pits and footings associated with Cranbrook and modern service trenches. Top image view north, bottom image view west. Scale 1m. IMG_3505, IMG_3373.

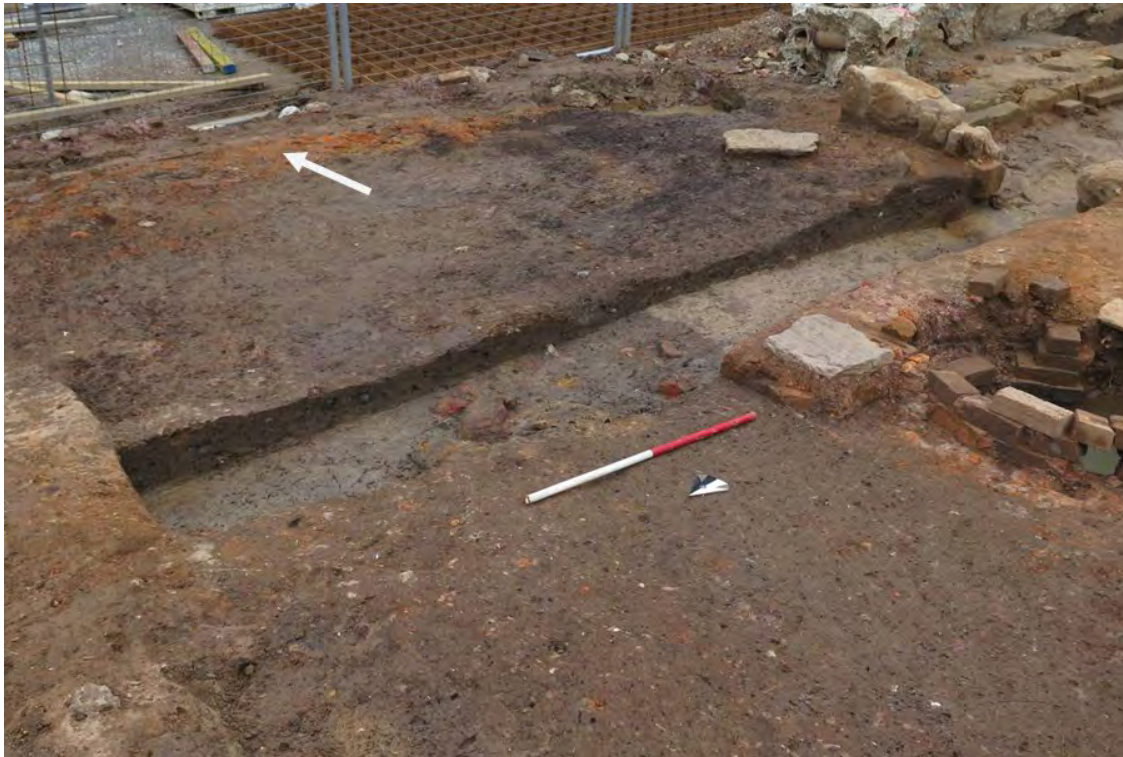
Figure 7.64: Small segment of brick paving (17542) along eastern boundary of House 4 (white arrow) which likely ran from Macquarie Street southwards and joined the paving (16181) at the rear of the house. West of the paving was a black yard surface (17547). The cut for the well (on the right side of the photo) became visible after 17545 was removed. Room 5 footings in the top right corner. View southeast. Scale 1m. IMG_3449(2).

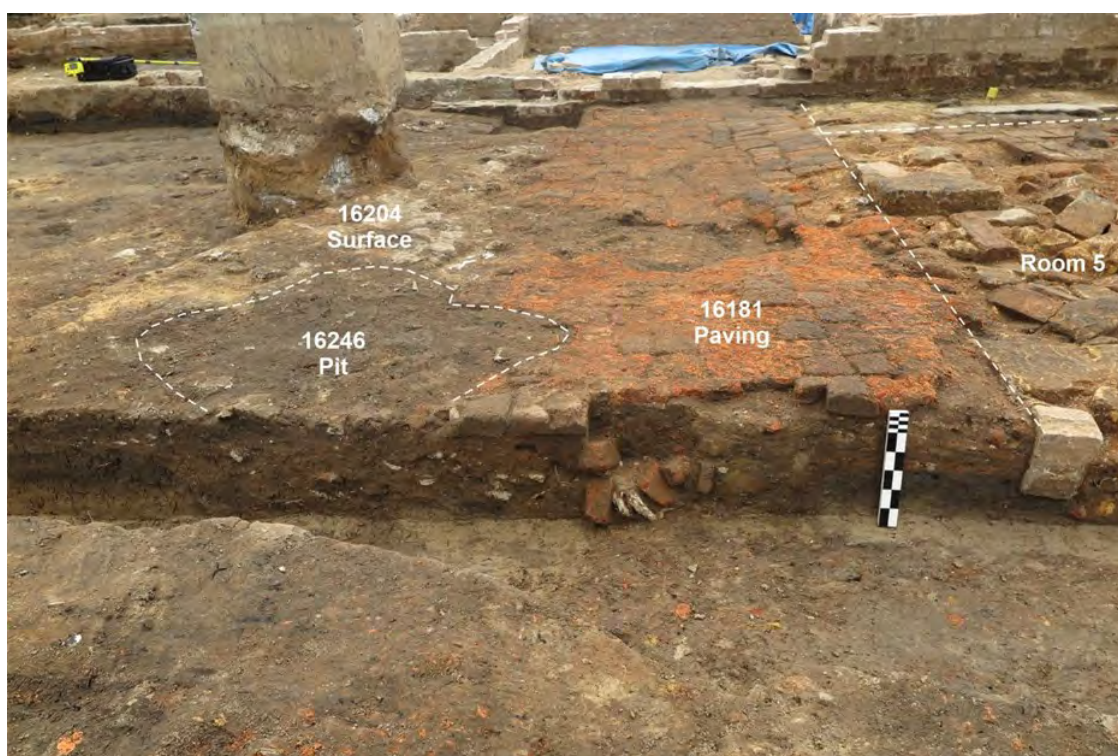
Figure 7.65: Compacted stone surface (16204) abutting the paving and later cut by a large pit (16246). In the foreground is an excavated modern service trench (17813) running north-south. View west. Scale 1m. IMG_3516.
