3PS – 153 MACQUARIE STREET, PARRAMATTA

TRENCH REPORT – AREA A & AREA A SOUTH

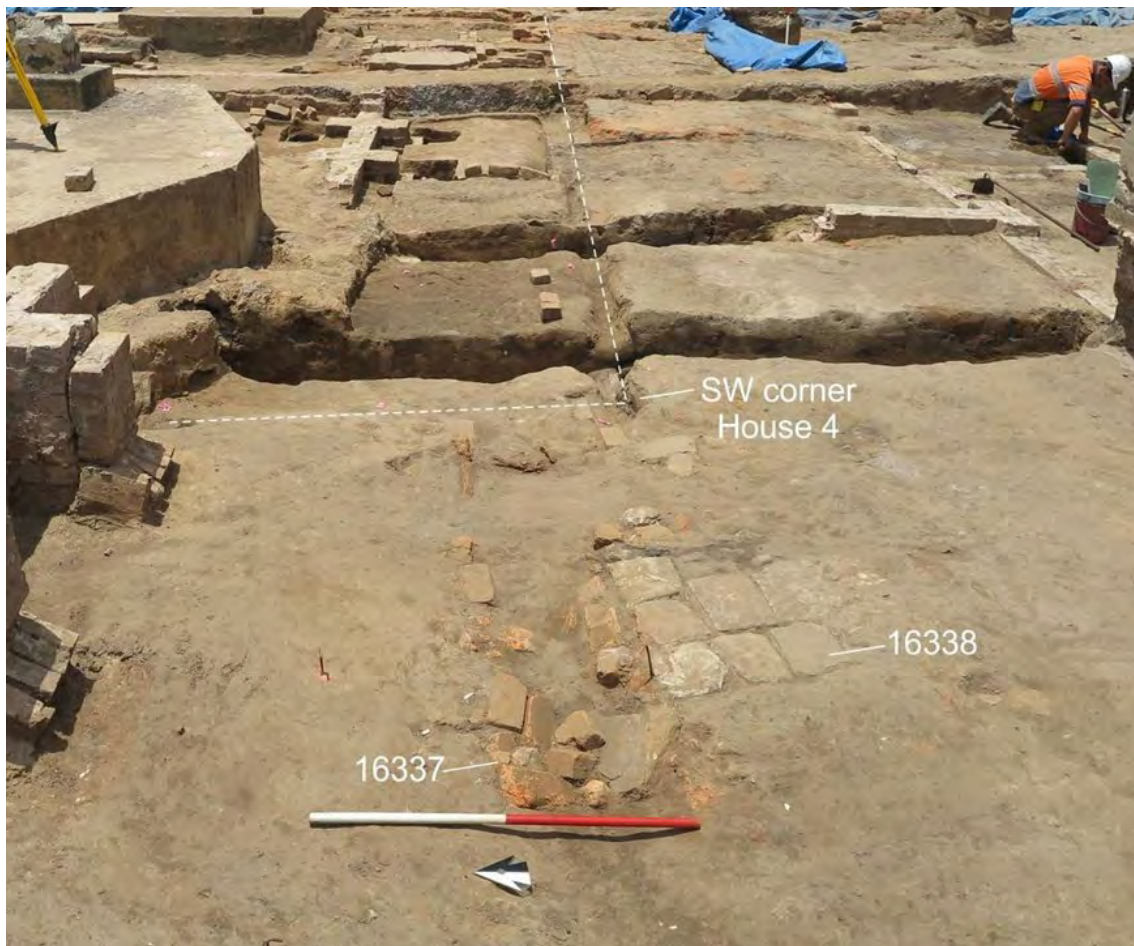
Figure 7.66: Stone paving (16338) and a brick drain (16337) outside the south west corner of House 4 (dashed line). The drain stops at the western wall of Room 2 and probably carried water away from the house towards the town drain or brick sump. The stones abutted the drain. View east. Scale 1m. IMG_4292.

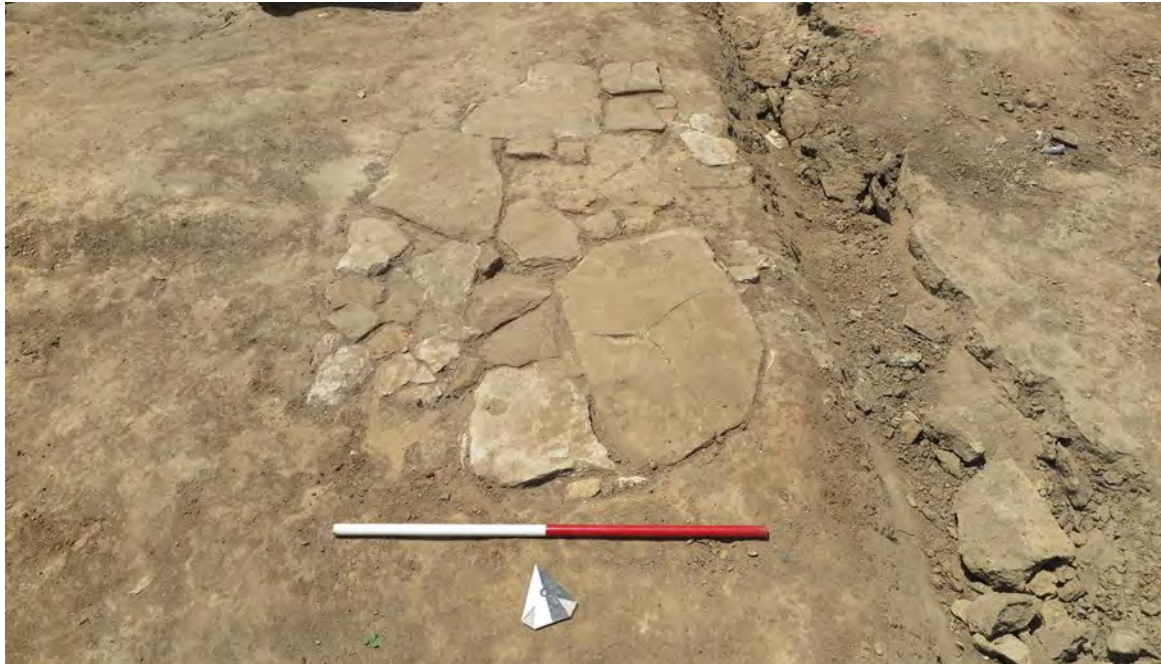
Figure 7.67: Small area of sandstone paving (16297) in the rear yard south of Room 5. The depression on the eastern side of the photo was caused by a service trench (17813) running north-south. View north. Scale 1m. IMG_4235.

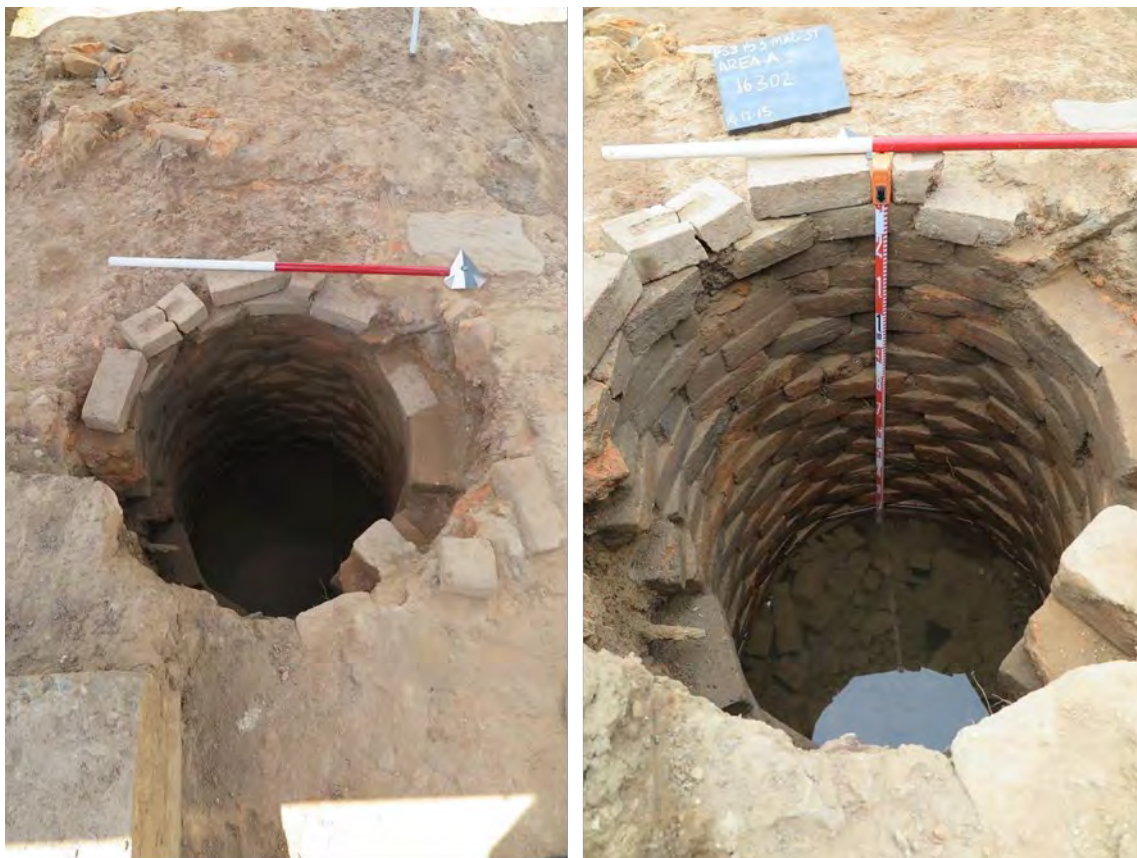
Figure 7.68: Sandstock brick well (16302) in the front yard of House 4, north of Room 5. The well was truncated in the southwest corner by the post office foundation trench (left). The bricks were mostly whole frogged bricks laid in a stretcher bond (right). View north. Scale 1m. IMG_4102 and IMG_4147.

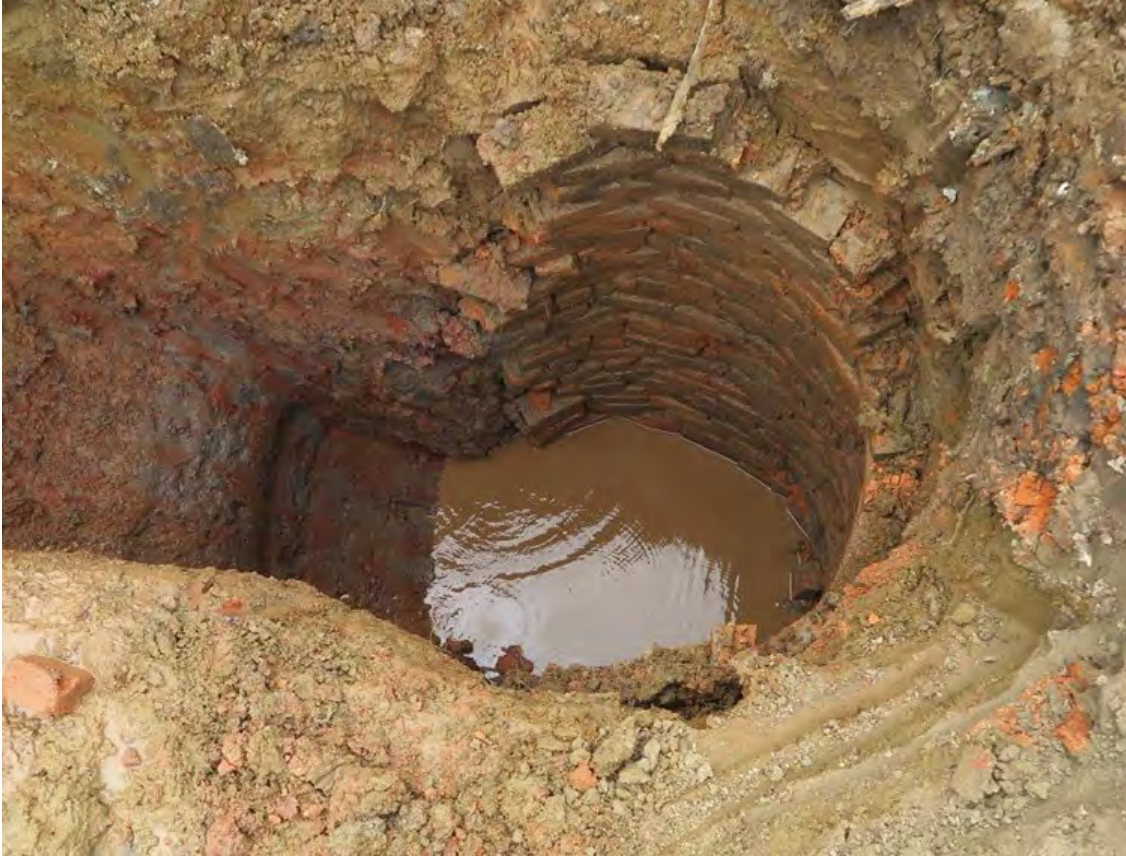
Figure 7.69: View into the lower half of the well which was removed by machine and kept refilling with water. The structure cut deep through the mottled red and grey natural base clays. View south. IMG_5363.

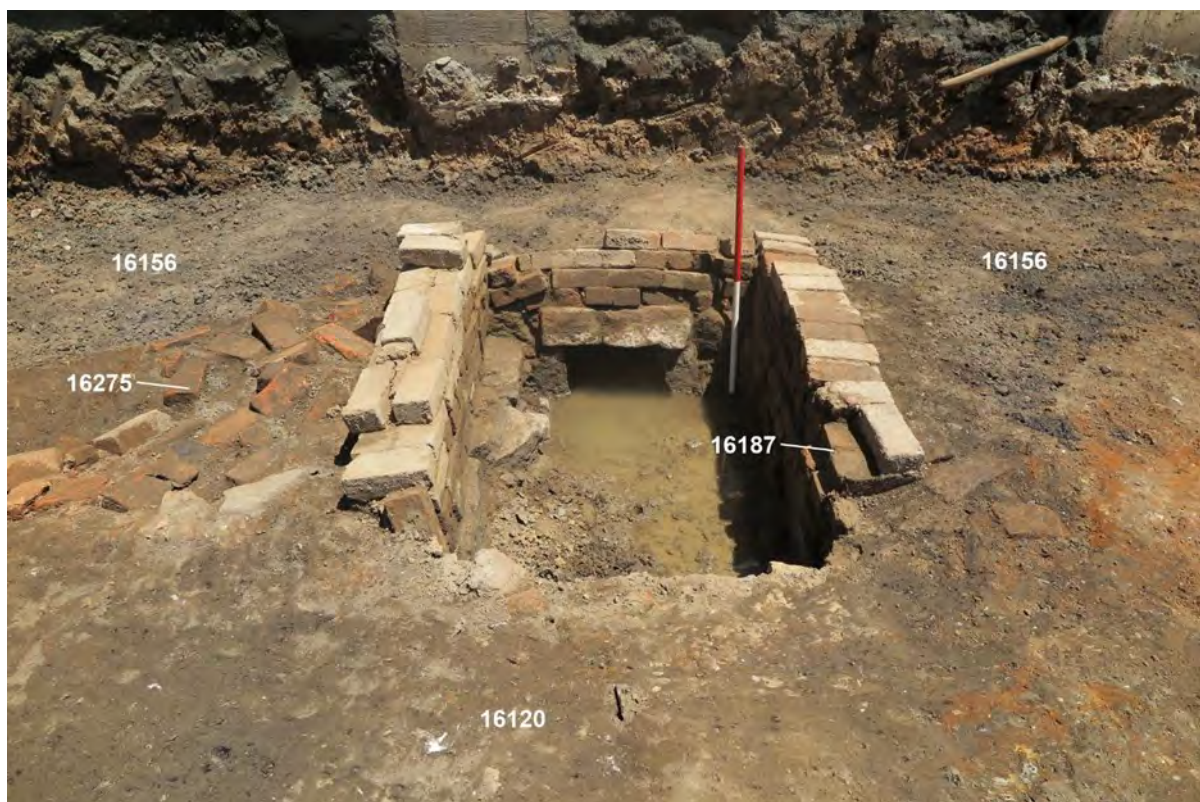
Figure 7.70: Mid-excavation of brick sump (16187) with brick rubble (16275) abutting the southern end, historic topsoil (16120) in the foreground and remains of the pre-Cranbrook cindery fill (16156) in the background. View west. Scale 1m. IMG_3470.

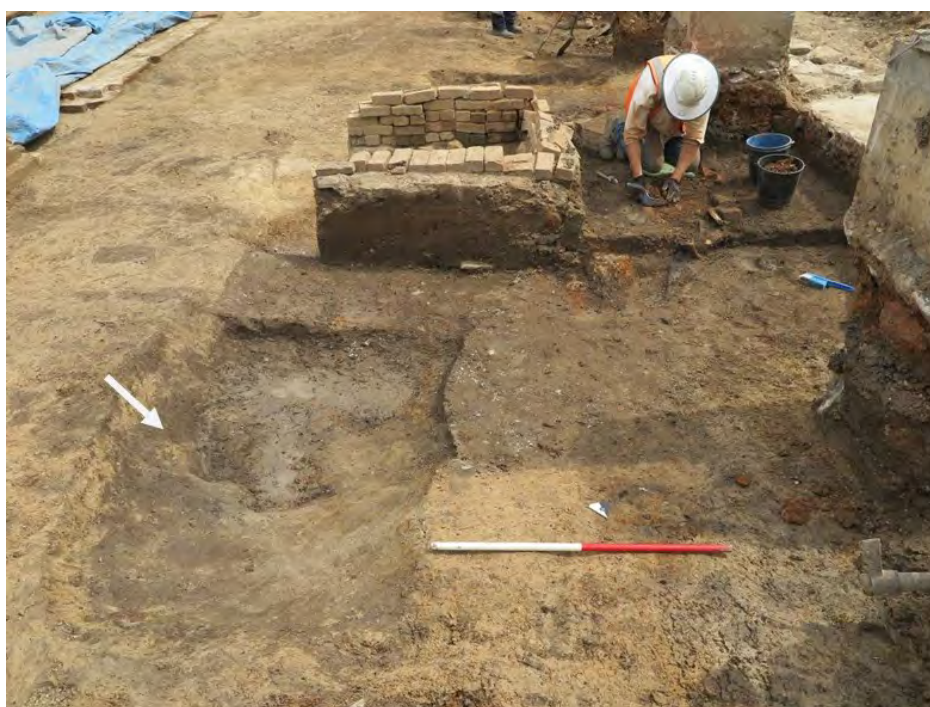
Figure 7.73: Large rectangular feature (white arrow) context 17220 cutting earlier sump (17228). View south. Scale 1m. IMG_4696.

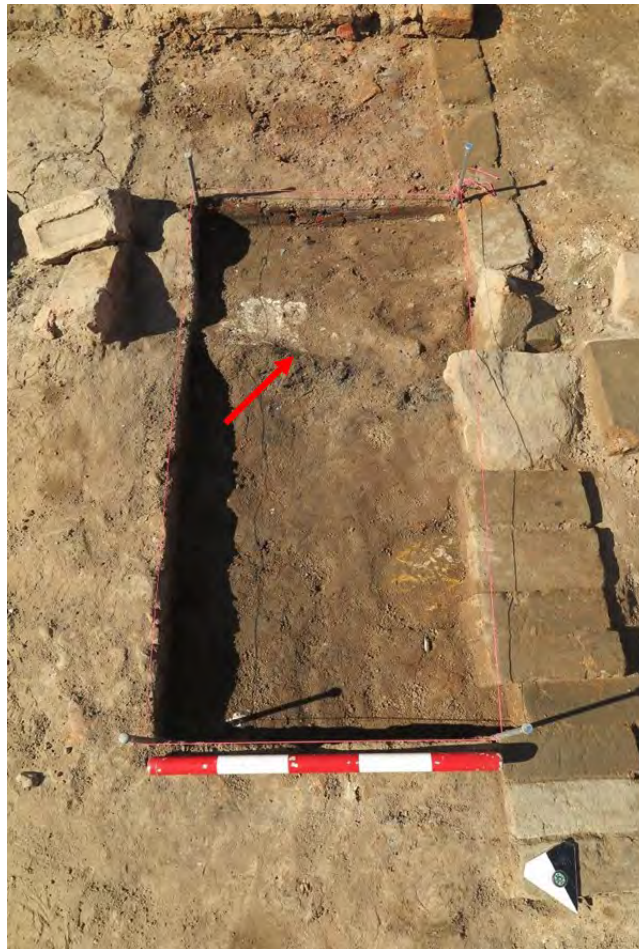
Figure 7.76: Test Trench 19 abutting the eastern wall of House 4 and the front verandah. At the northeast corner of the house was a shallow channel (red arrow) running in a southeast direction away from the building. This channel may have been a drain or part of a down pipe taking water away from the house. View south. Scale 50cm. IMG_3955.

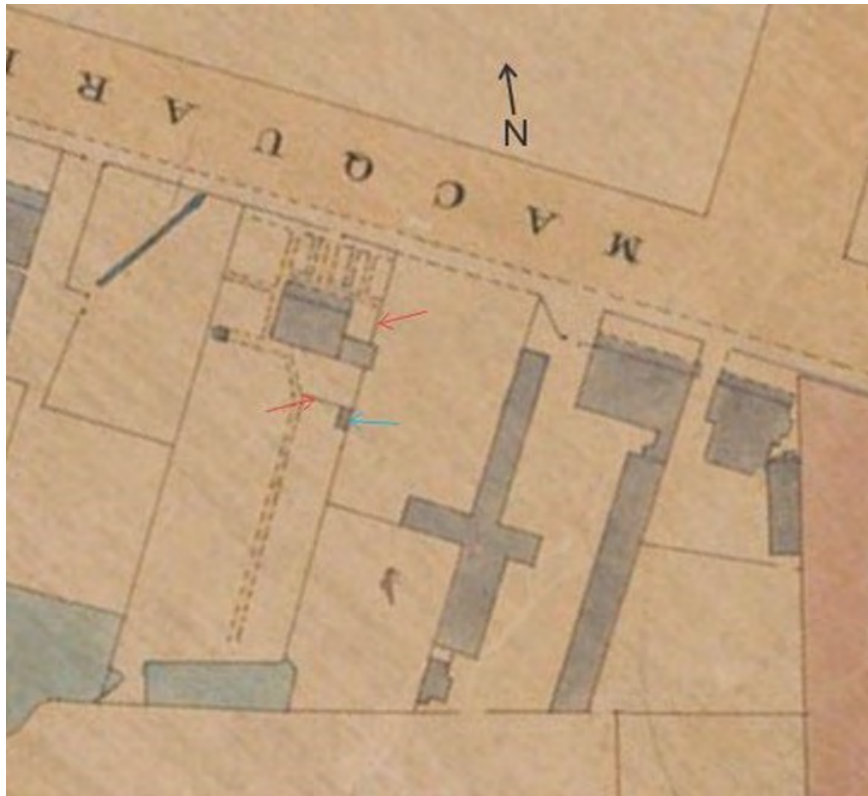
Figure 7.77: The 1858 plan with red arrows show the location of the north-south fence line extending around Room 5, House 4 and the shorter east-west fence line. Where the fence lines meet was a small structure (blue arrow). Some of the postholes may belong to this structure. View north. SRNSW NRS 15244, item [1].

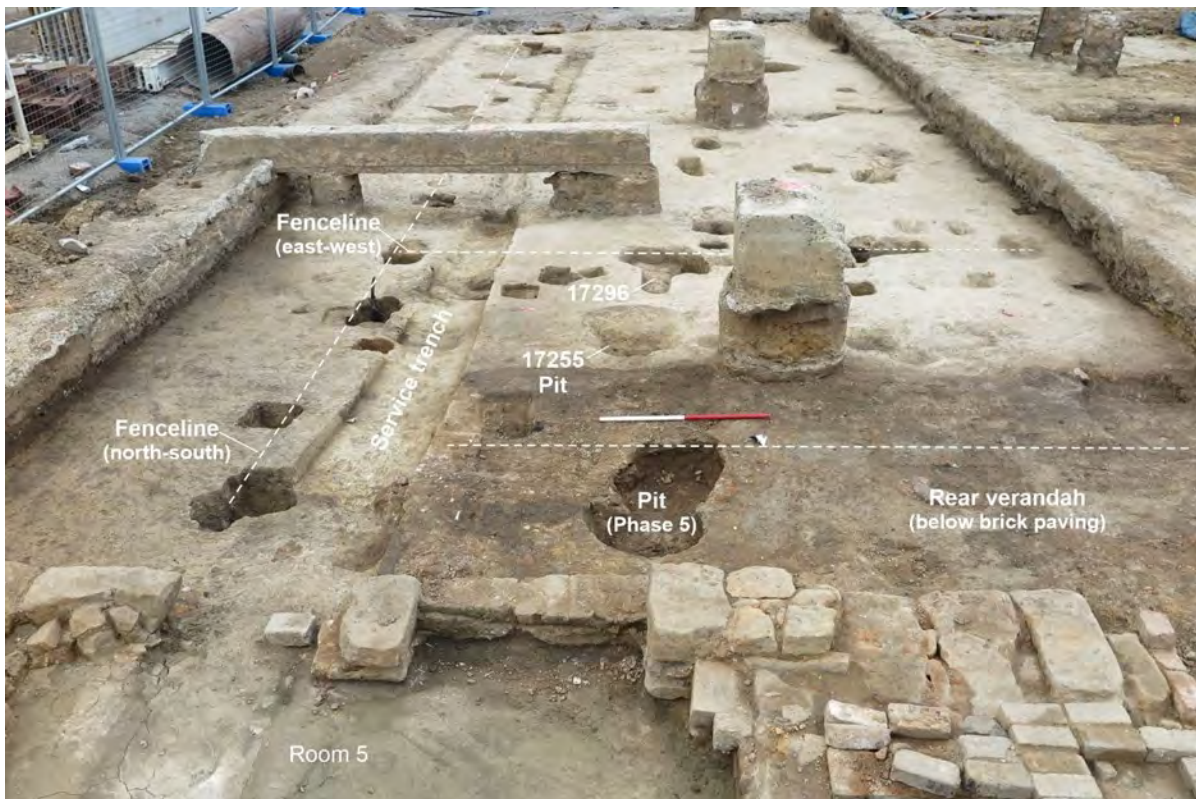
Figure 7.78: North-south fence line postholes east of the excavated modern service trench and the east-west return. Many of the Cranbrook phased postholes were evident in the base of the modern service trench. In the background are the excavated yard features (pits and postholes) cutting the subsoil. View south. Scale 1m. IMG_4949.

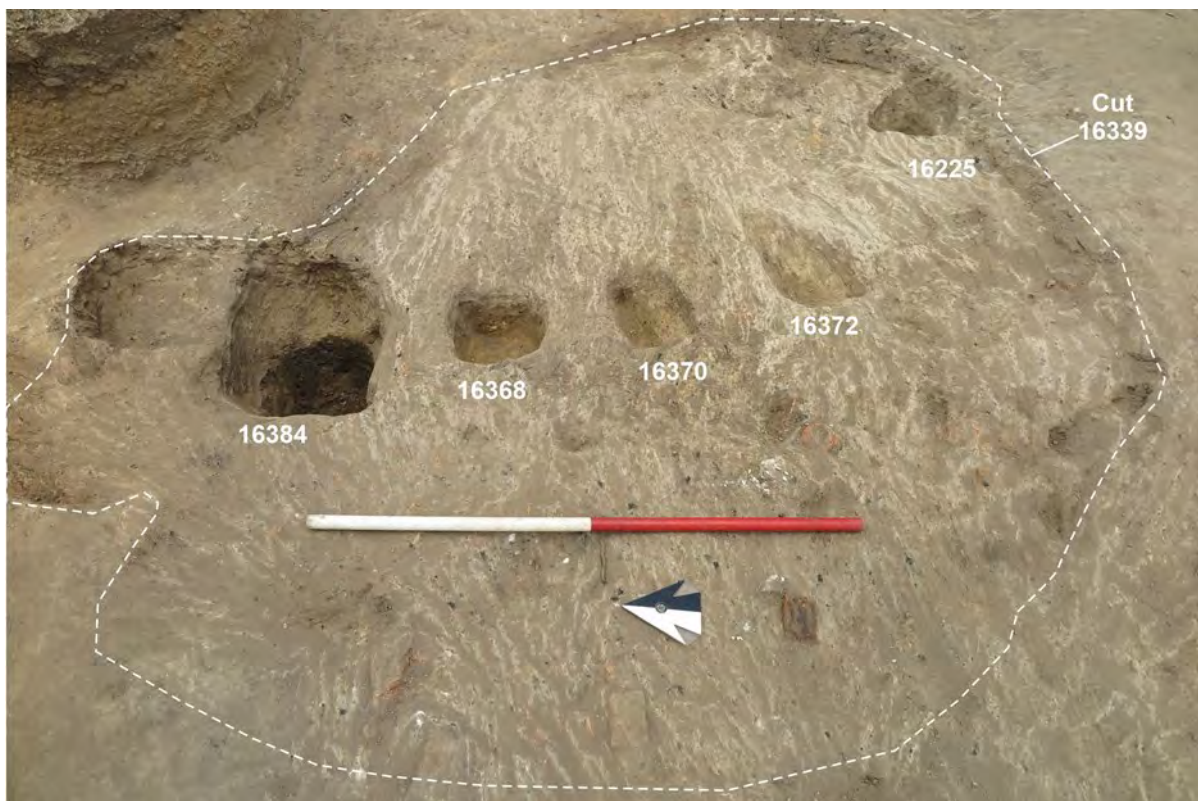
Figure 7.83: Post-excitation of large cut/depression (16339) with smaller features cutting through it into the subsoil. View east. Scale 1m. IMG_4521.

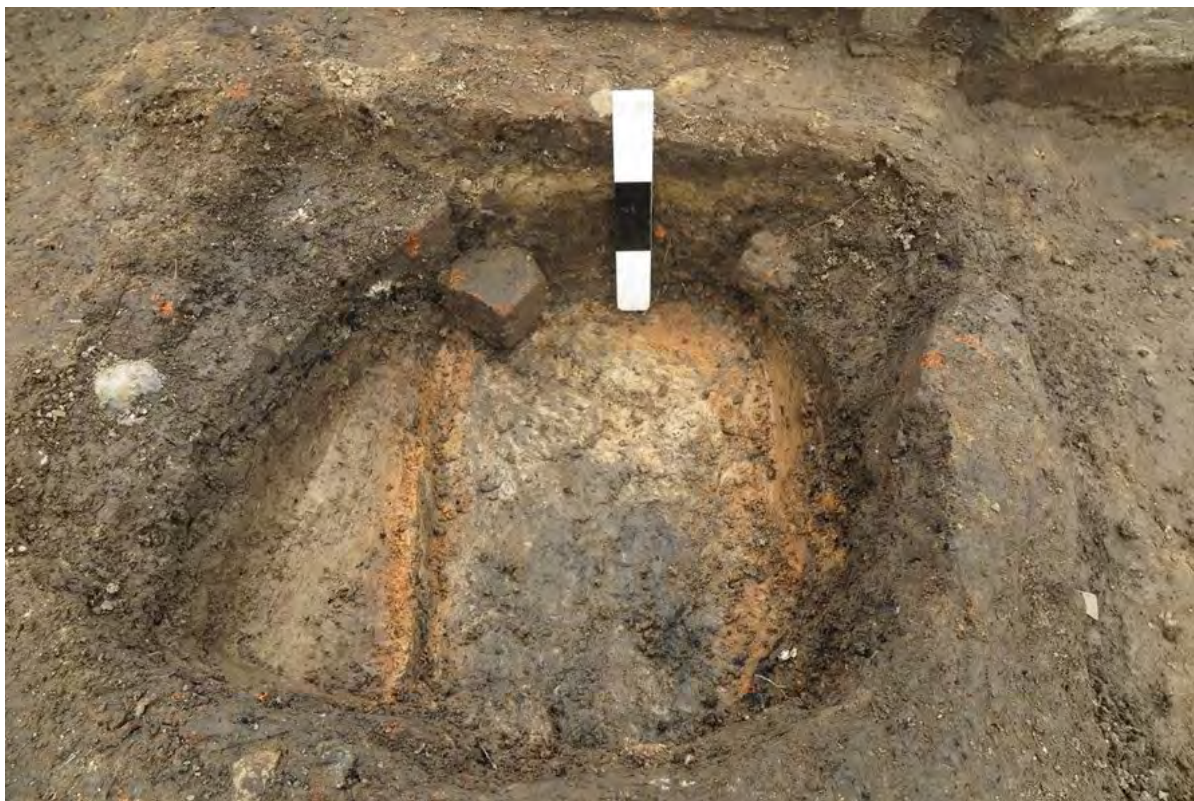
Figure 7.84: Post-excitation of rubbish pit (16209). The base of the pit came down onto black and orange burnt clay suggesting the base of a tree bole below the pit. View west. Scale 30cm. IMG_3580.

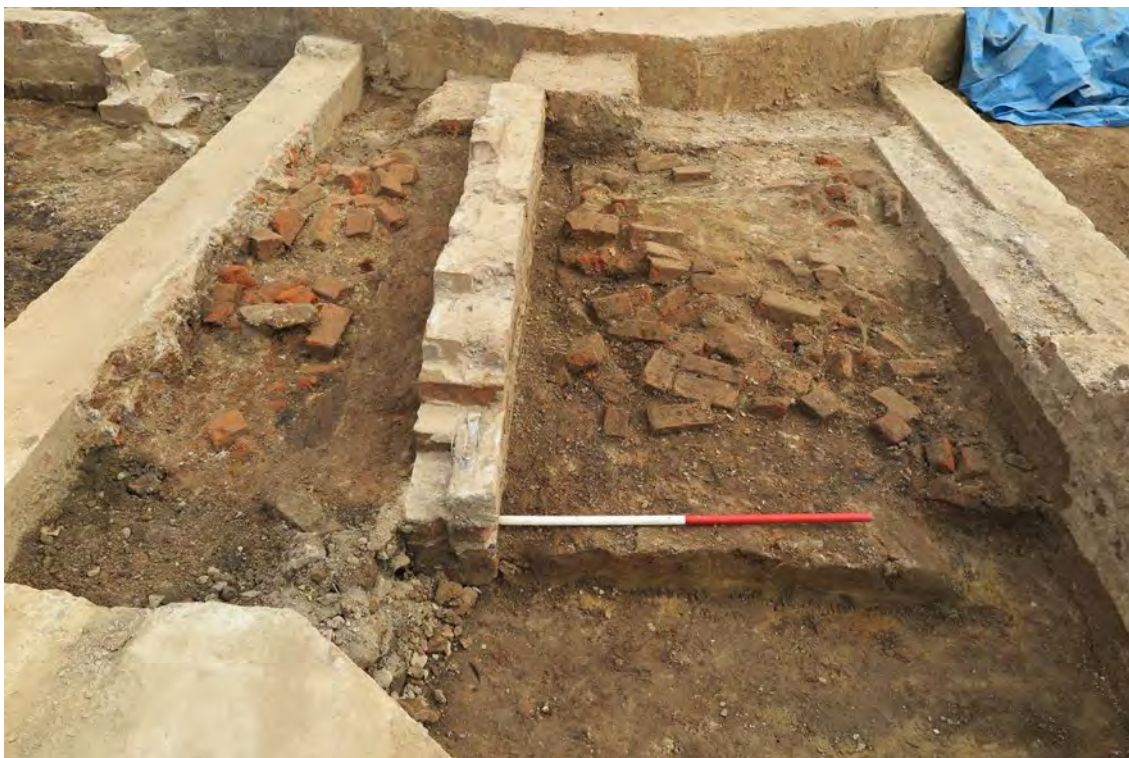
Figure 7.85: Brick rubble and demolition debris (16159) associated with the early house (House 4) truncated by the Cranbrook footings. View south. Scale 1m.

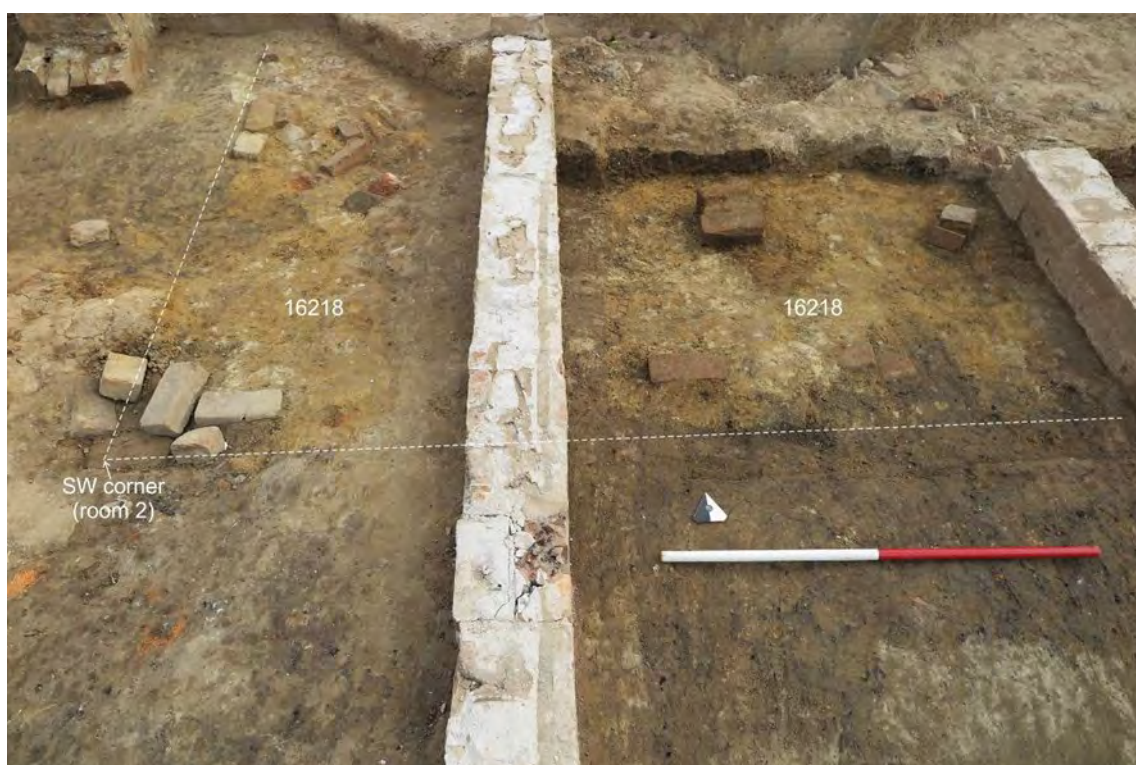
Figure 7.86: Yellow sandy demolition debris (16218) in Room 2. This thin deposit was only found in the back rooms of the house above the occupation deposits. It was also found within the linear impressions (16313) left behind by the removal of the floor timbers. View north. Scale 1m.

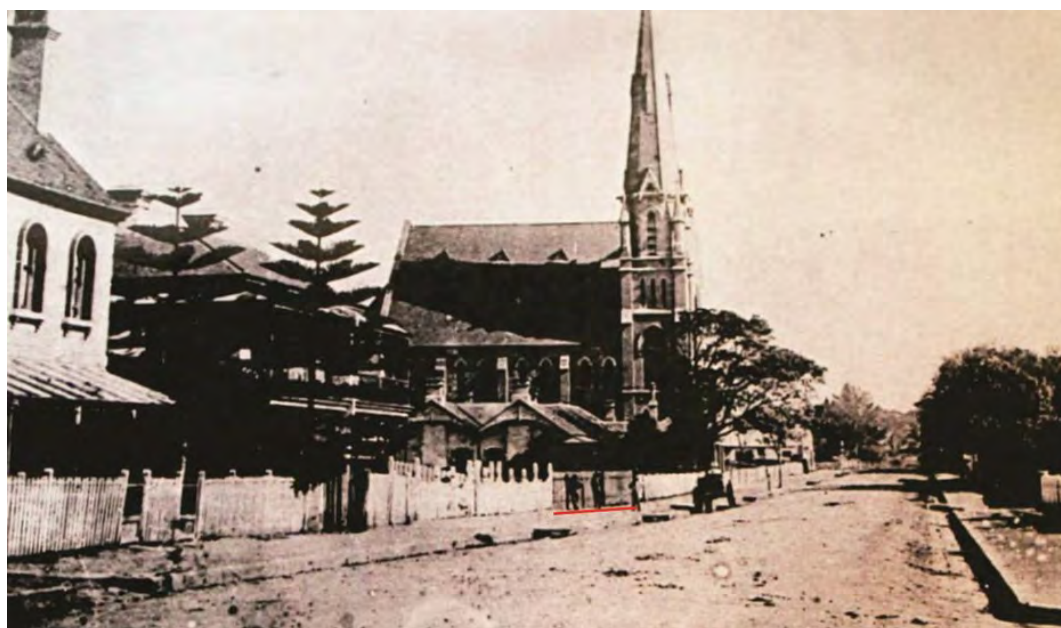
Figure 8.1: Photograph looking west along Macquarie Street dating to between 1884 and 1888. This photograph shows the site of the now demolished 1820s cottage prior to the construction of the new house, Cranbrook. The fence of the early cottage has been underlined in red. The single-storey structure to the west is Wyverne and the two-storey semi-detached houses partially obscured by tall trees, to the east are Northiam and Harleyville. Source: Parramatta Mission Archives.

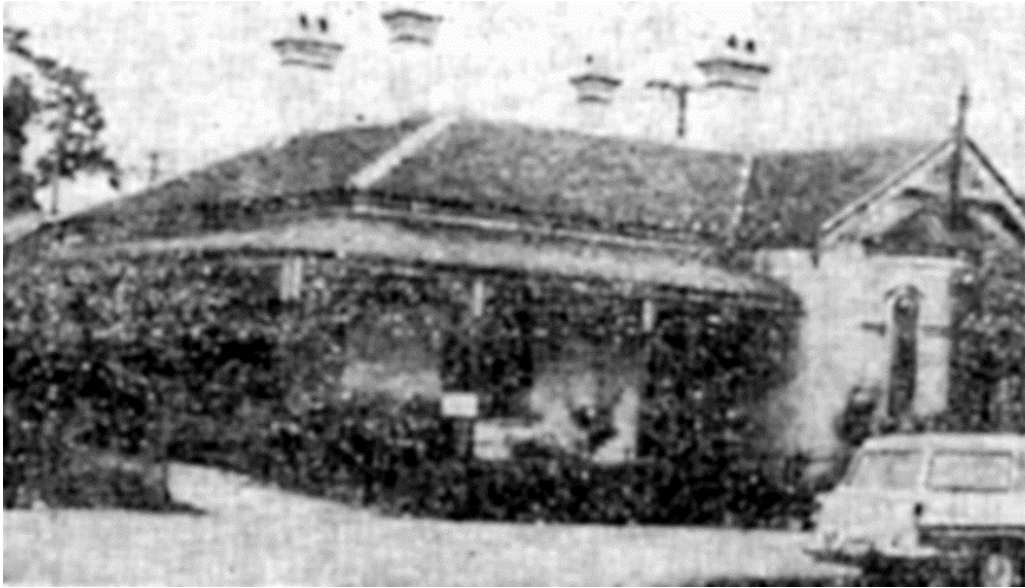
Figure 8.3: Photograph showing Cranbrook in c.1962, before its demolition. The front fence appears to have been replaced by a hedge by this time. Source: <http://arc.parracity.nsw.gov.au/blog/2016/05/03/dr-woolnoughs-residence-111-macquarie-street/>

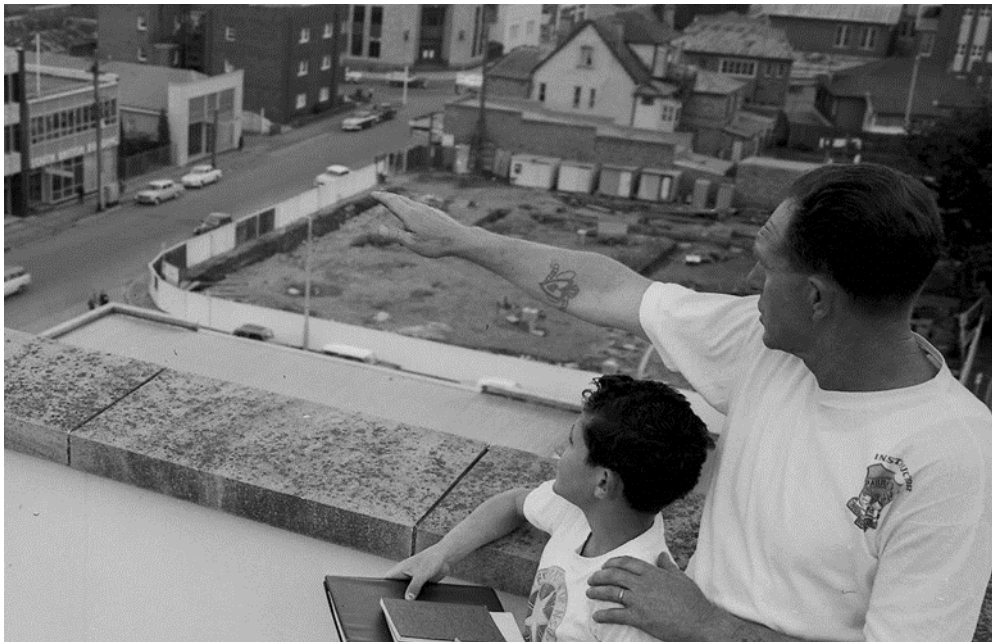
Figure 8.4: Detail of photograph looking to the northeast from the top of Parramatta Council Chambers Building after the demolition of Cranbrook, Northiam and Harleyville, c.1965. Parramatta Heritage Centre ACC002.

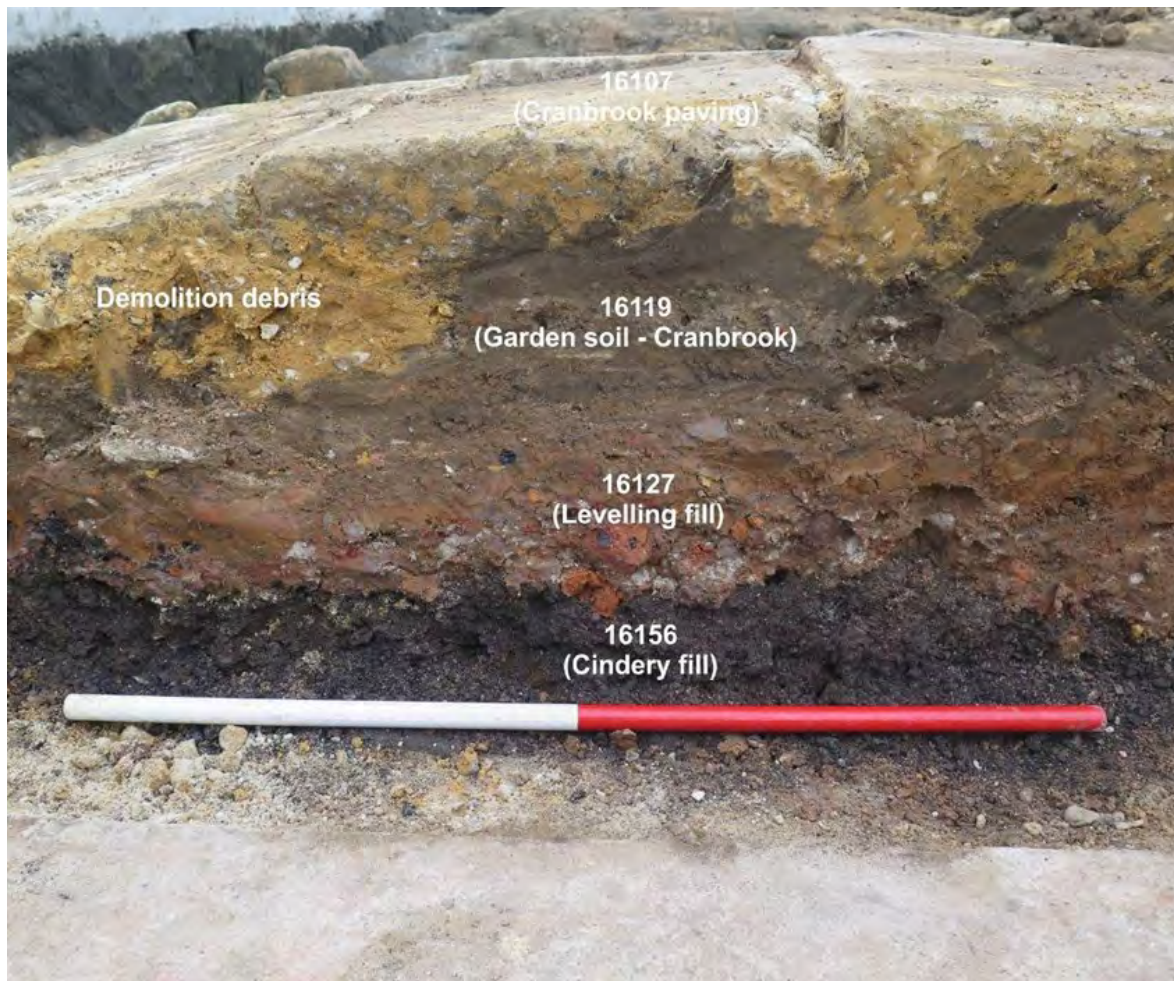
Figure 8.5: Levelling fills (16127 and 16156) below the garden bedding and brick paving at the front of Cranbrook house and north of the earlier house (House 4). Here the bulk clay fill (16127) was not as deep as it was further west. View east. Scale 1m. IMG_2827.

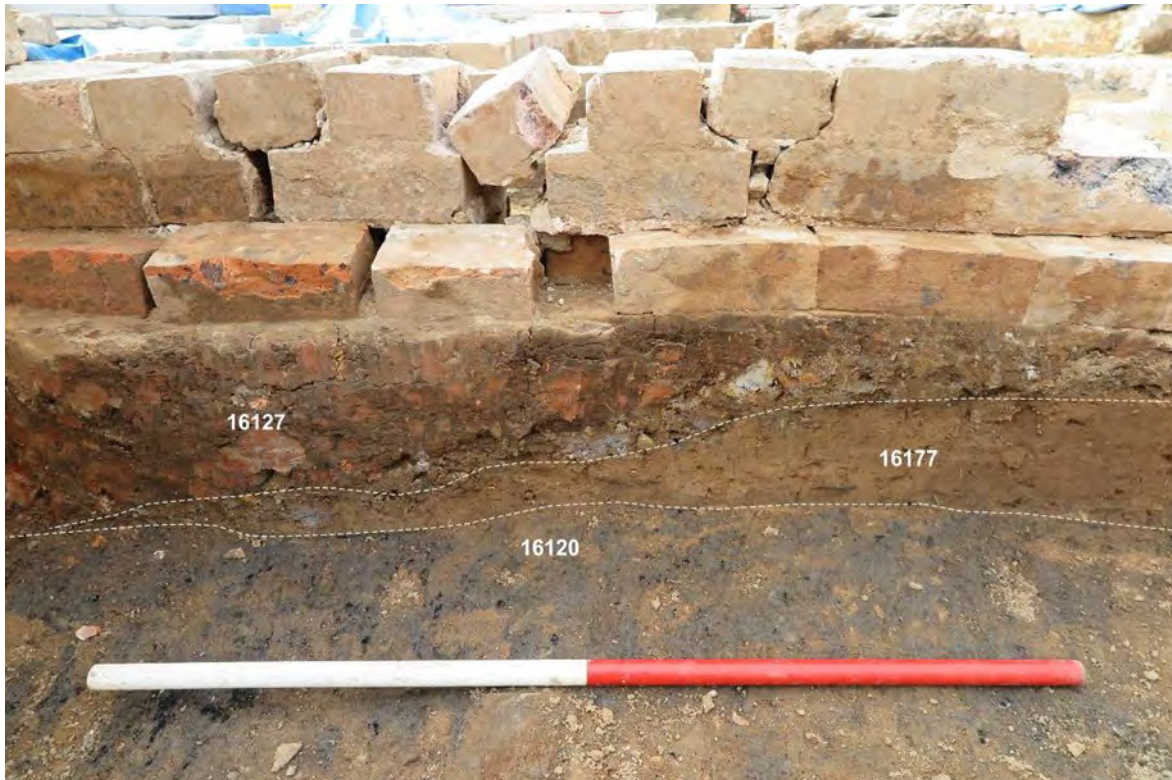
Figure 8.6: Orange-sandy fill (16177) above the historic topsoil (16120) and below the mottled clay fill (16127). The brick wall (16168) for the south verandah of Cranbrook (Room 12) sat on top of these fills as this verandah wall did not have deep foundations like the rest of the house footings. The levelling fills in the rear yard were not as deep as the fills further west. View north. Scale 1m. IMG_3191.

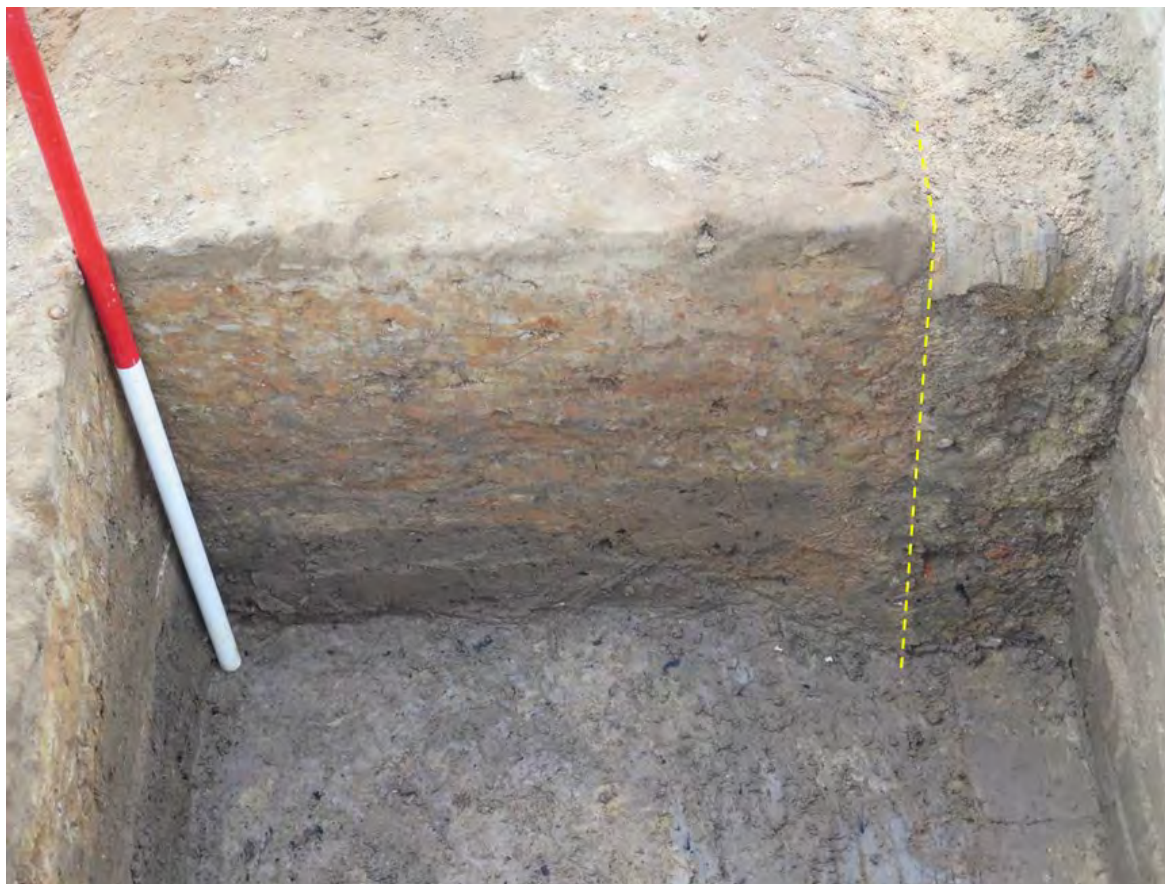
Figure 8.7: West-facing section in Test trench 1, Room 3 of Cranbrook showing the mottled orange and yellow bulk levelling fill (16127) above the historic topsoil and on the right side the foundation trench for the Cranbrook footings cutting the levelling fill. View east. Scale 1m. IMG_3058.

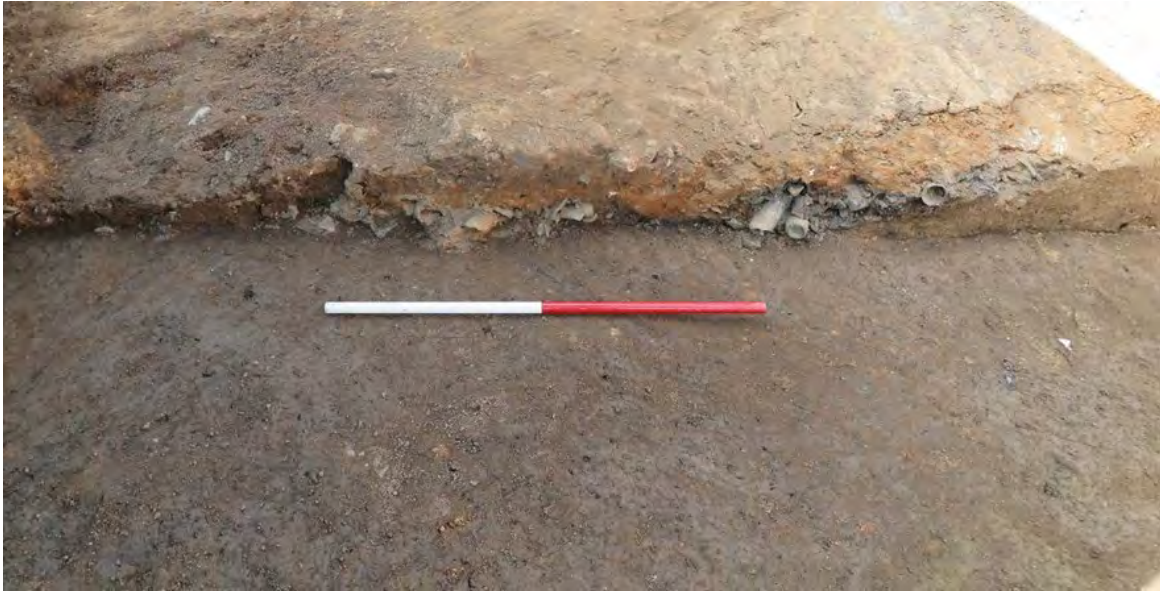
Figure 8.8: North-facing section through the bottle dump (16186) that pre-dated Cranbrook. The bottles (visible in section) were contemporary with the imported levelling fills to raise the ground level. View south. Scale 1m. IMG_3449.

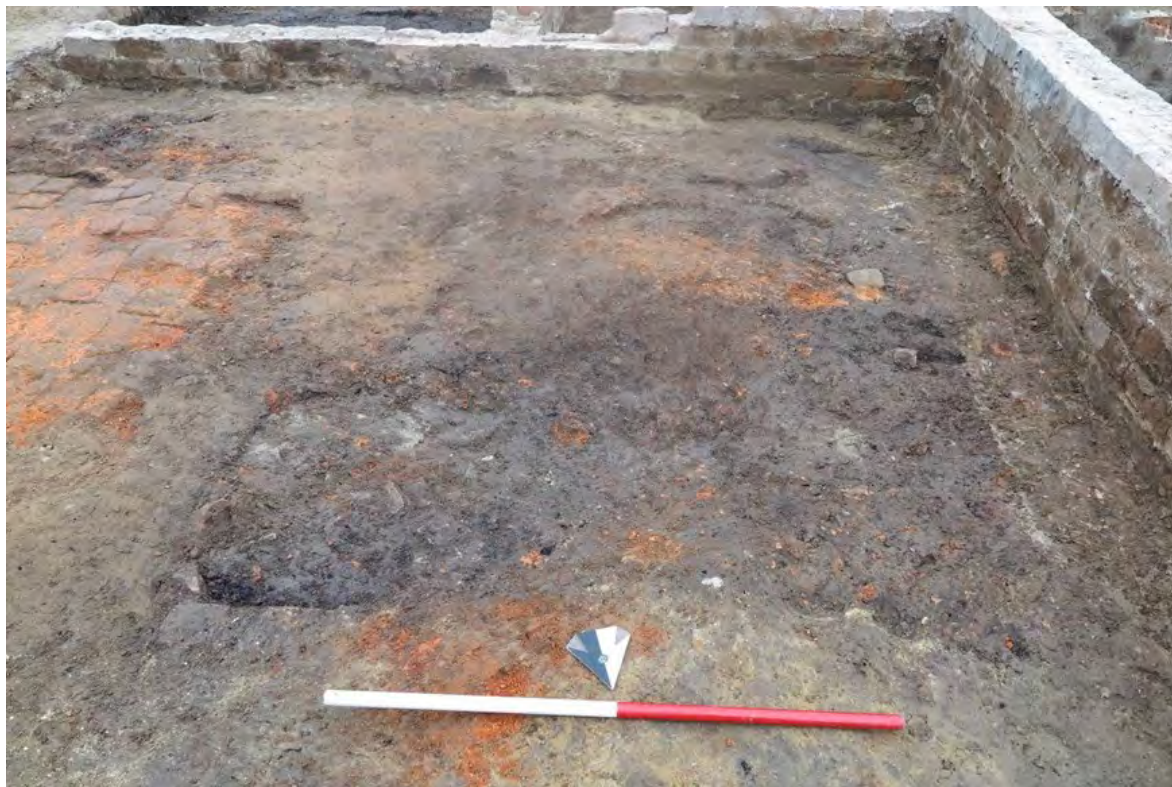
Figure 8.10: Post-excavation photo after the removal of 16182 which filled a depression in the topsoil and was above the House 4 demolition debris. View south. Scale 1m. IMG_3241.

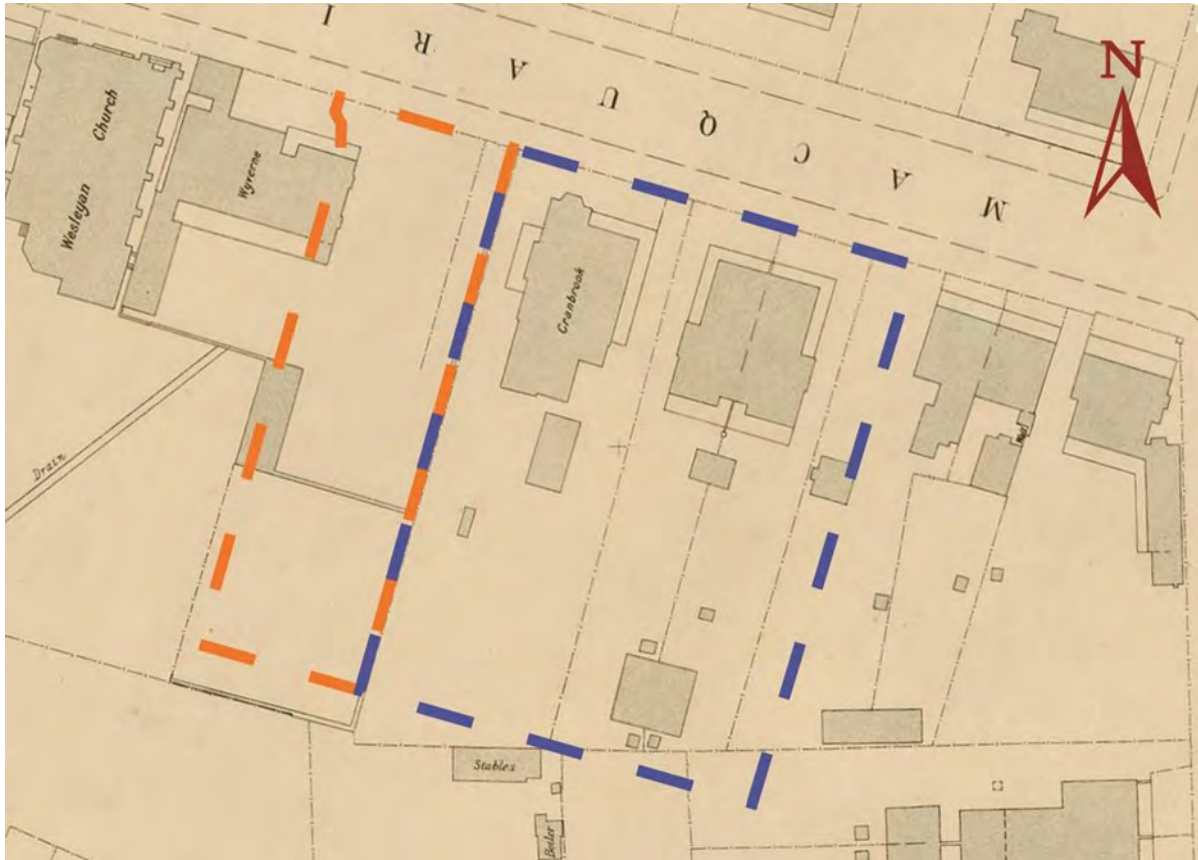
Figure 8.11:1895 plan showing the new phase of building within the site. Cranbrook and its outbuildings are to the west of Harleyville and Northiam. 153 Macquarie Street is outlined in blue and Civic Place in orange. Parramatta Detail Survey, Sheet 18, 1895. SLNSW Z/M Ser 4 811.1301/1, digital order no. a1364020.

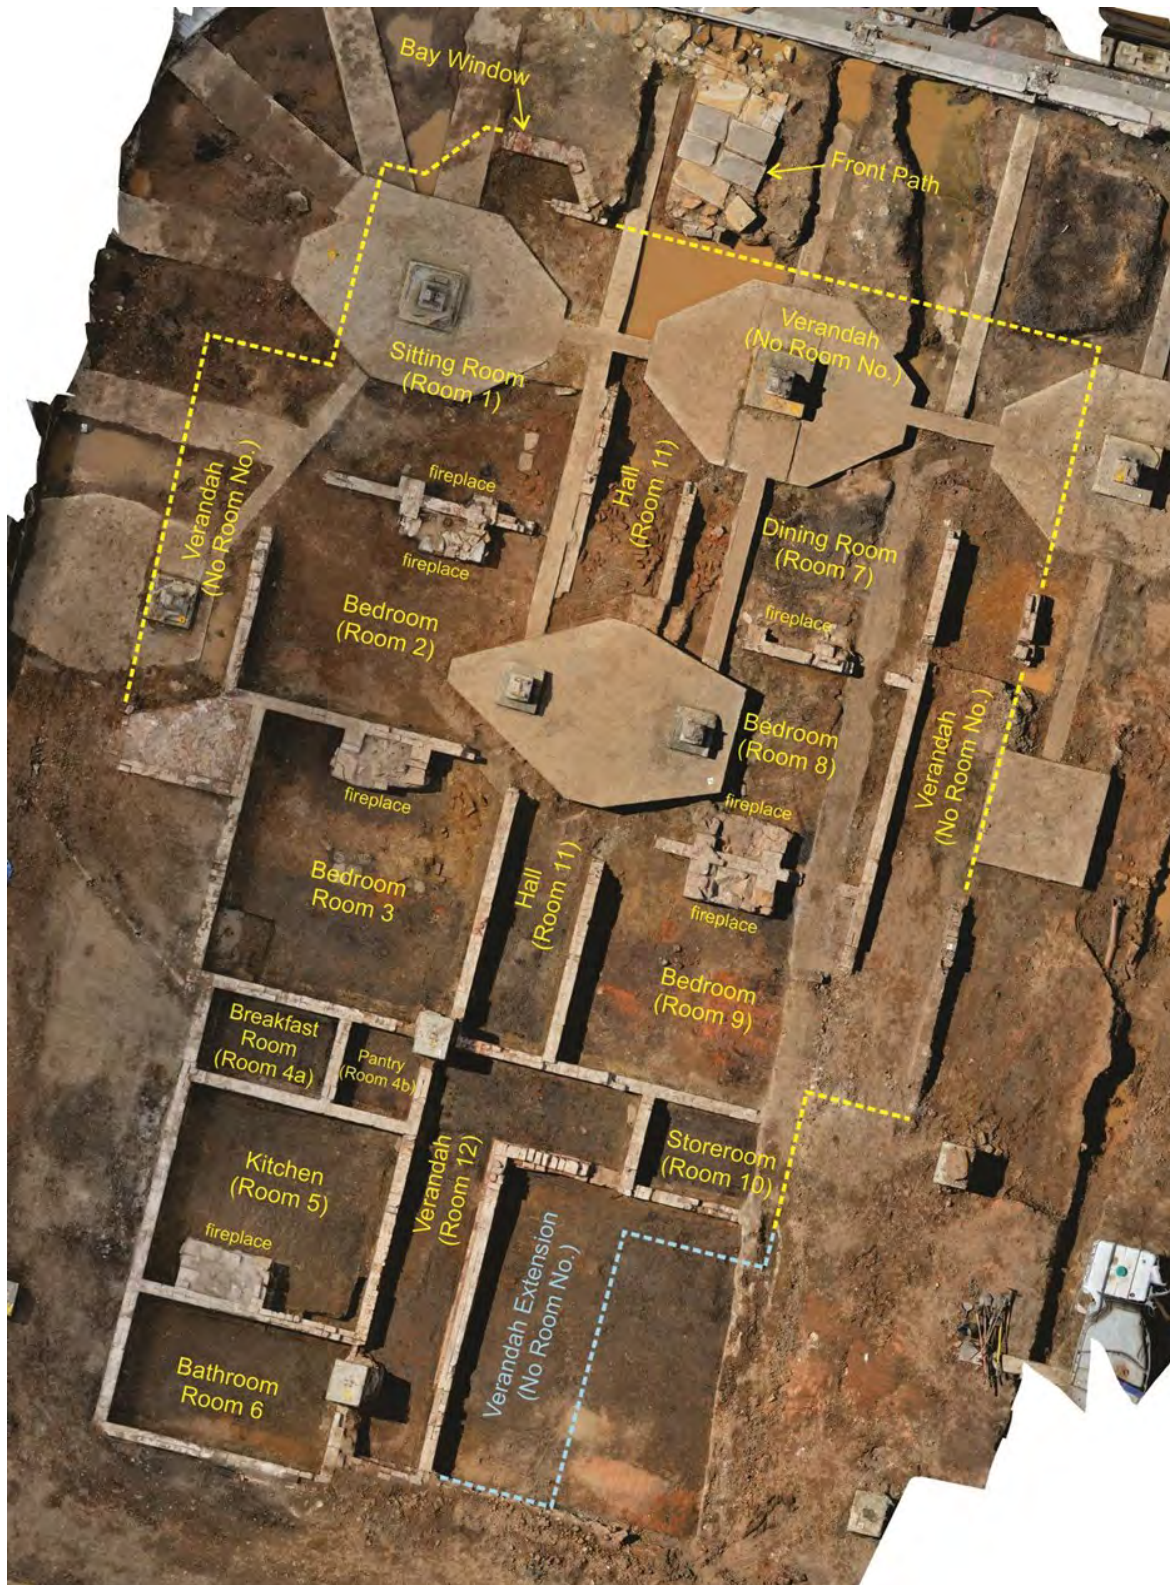
Figure 8.12: Orthophoto of Cranbrook showing wall footings and probable layout of rooms. The large outbuilding to the south containing the laundry is not shown. The yellow dotted lines indicate the outline of the building where it has been removed by the 1960s Post Office and 20th-century services and the blue dotted line corresponds with an external wall illustrated on the 1895 Parramatta Detail Series but not found during excavation. The large octagonal concrete pads are part of the Post Office foundations. North is at the top of the image. Hazell 2016 with annotations by Casey & Lowe.
