3PS – 153 MACQUARIE STREET, PARRAMATTA

TRENCH REPORT – AREA A & AREA A SOUTH

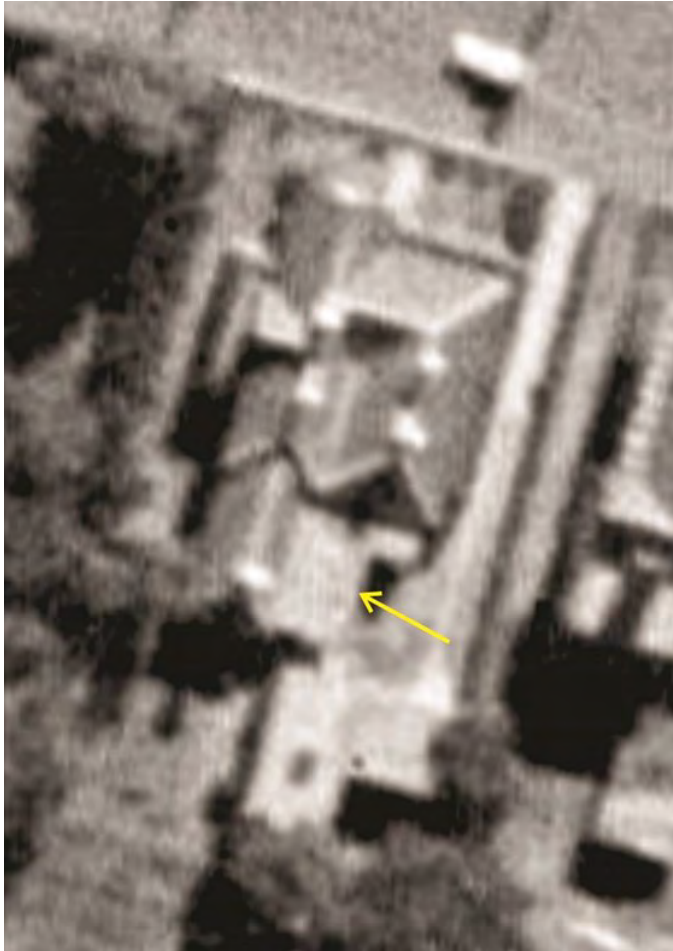
Figure 8.13: Aerial photograph dating to 1943, showing Cranbrook. The southeast verandah roof is indicated by the yellow arrow. North is at the top of the image. SIX Maps, NSW LPI.

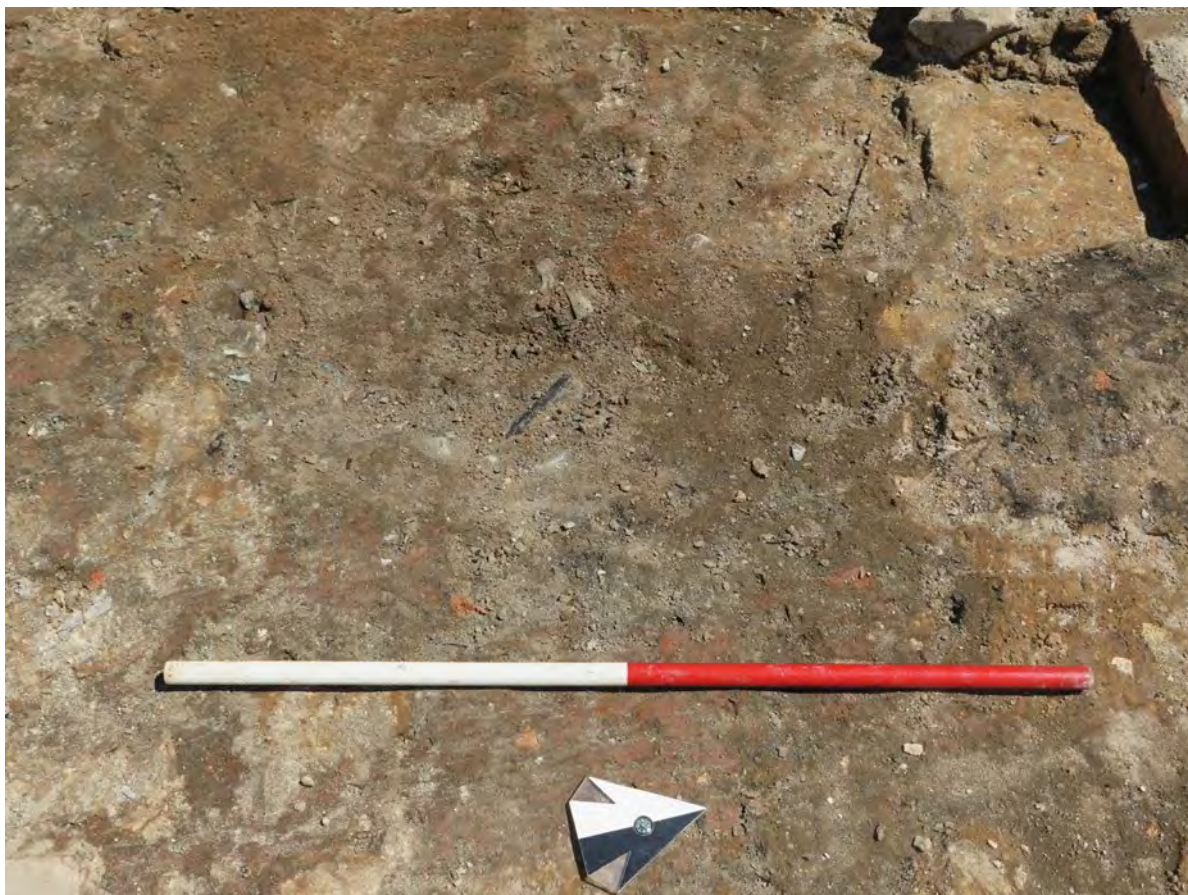
Figure 8.14: Detail of levelling fill 16132, prior to excavation. View to the west. Scale 1m. IMG_2882.

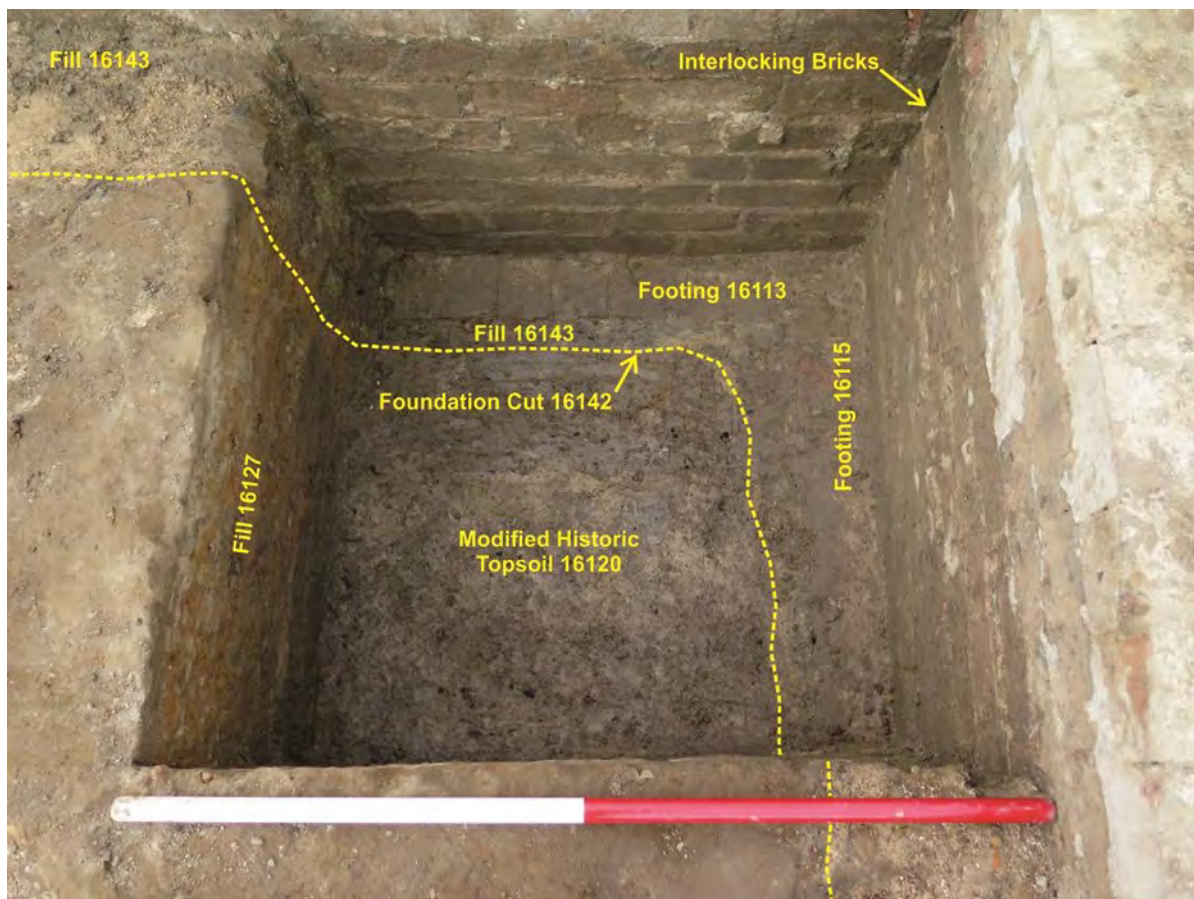
Figure 8.15: Foundation cut (16142/16126) exposed within TT1. The foundation trench cuts bulk clay fill 16127 and modified historic topsoil 16120. Brick sub-floor walls 16113 and 16115 are interlocking. View to the south. Scale 1m. IMG_3060.

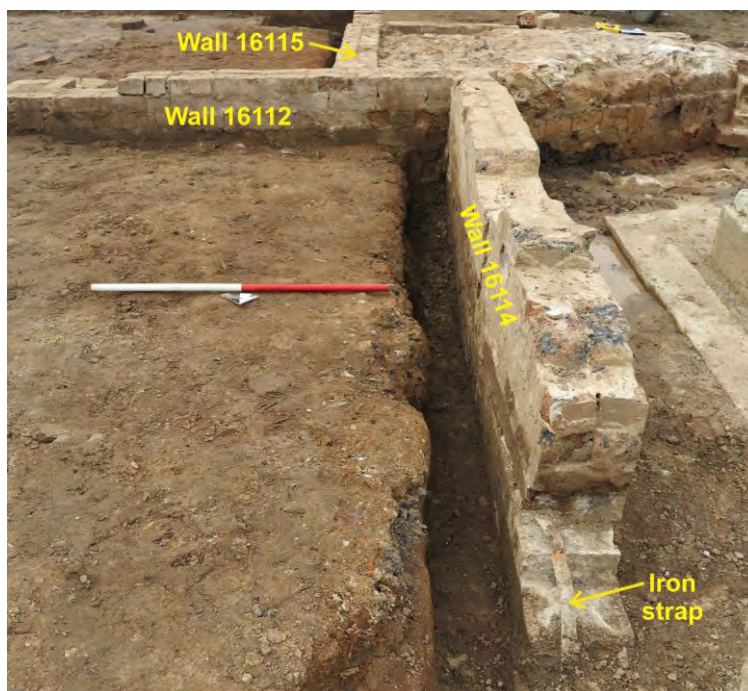
Figure 8.17: Typical sub-floor walls. The foundation trench cut (16142) has been partially excavated to the left of wall 16114 and an iron strap protrudes from where the wall has been cut by the Post Office footings. View to the south. Scale 1m. IMG_3124.

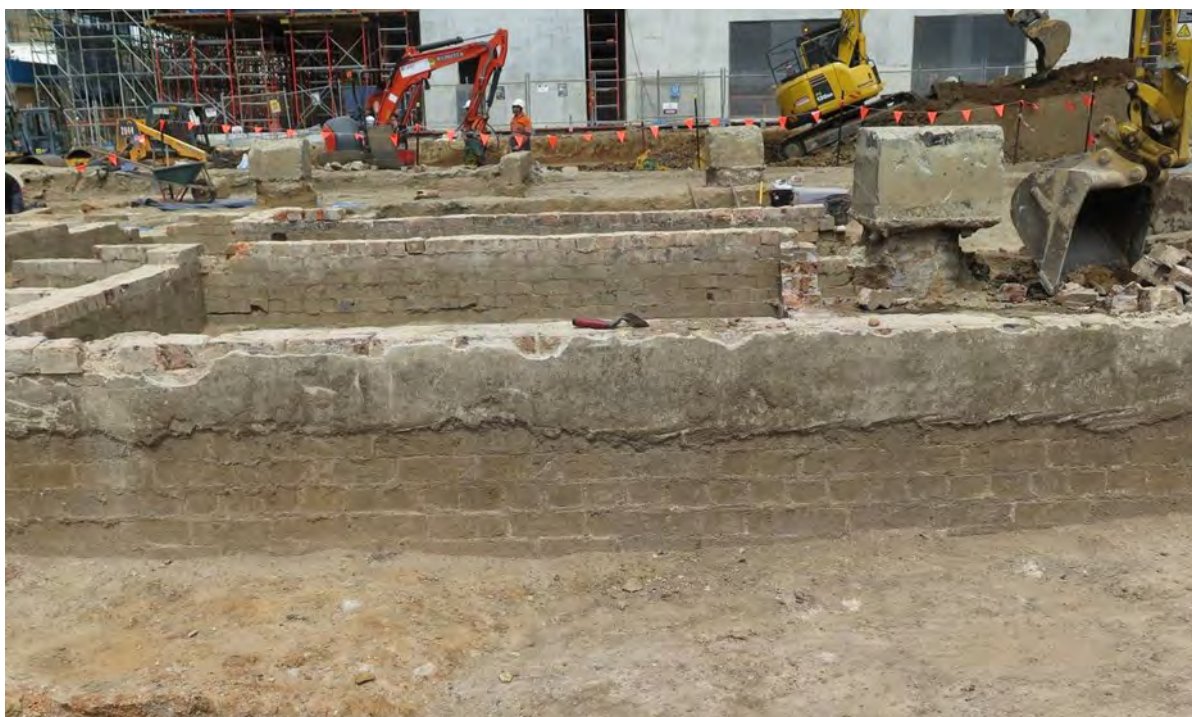
Figure 8.18: Render covering the upper three to four courses of outside wall 14146. View to the east, trowel for scale, approximately 200mm long. IMG_3239(2).

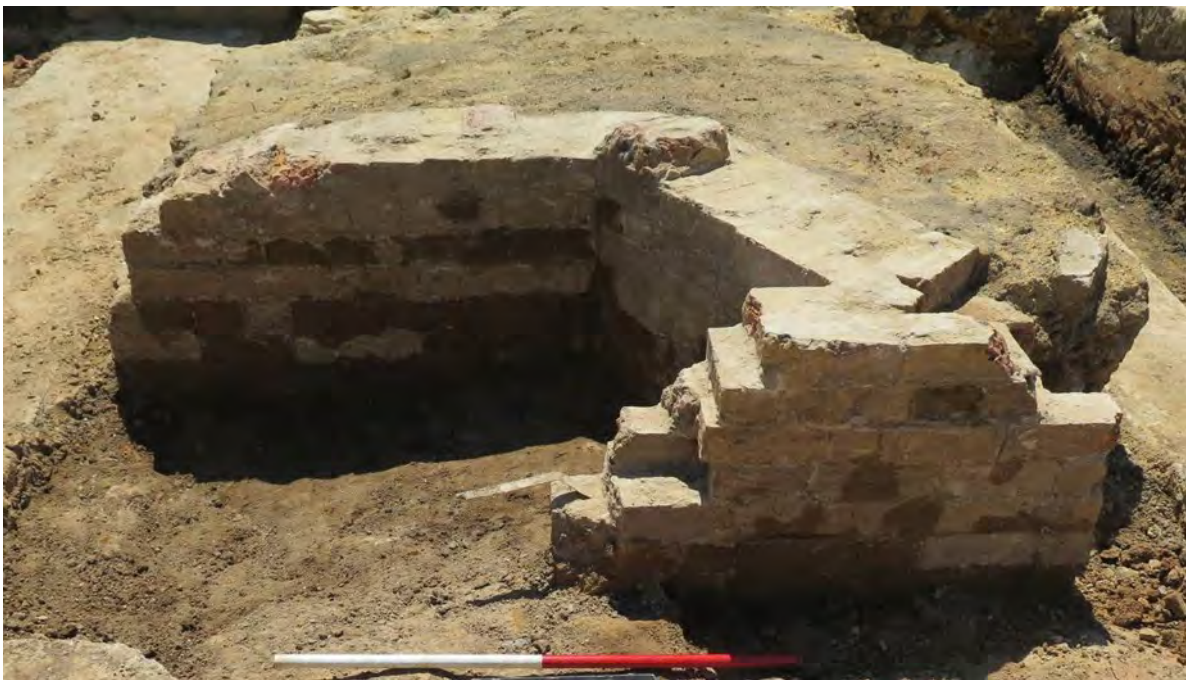
Figure 8.20: Remains of bay window (16110) in sitting room (Room 1) of Cranbrook. The western side of the bay window has been removed by 1960s footings. View to the north. Scale 1m. IMG_2883.

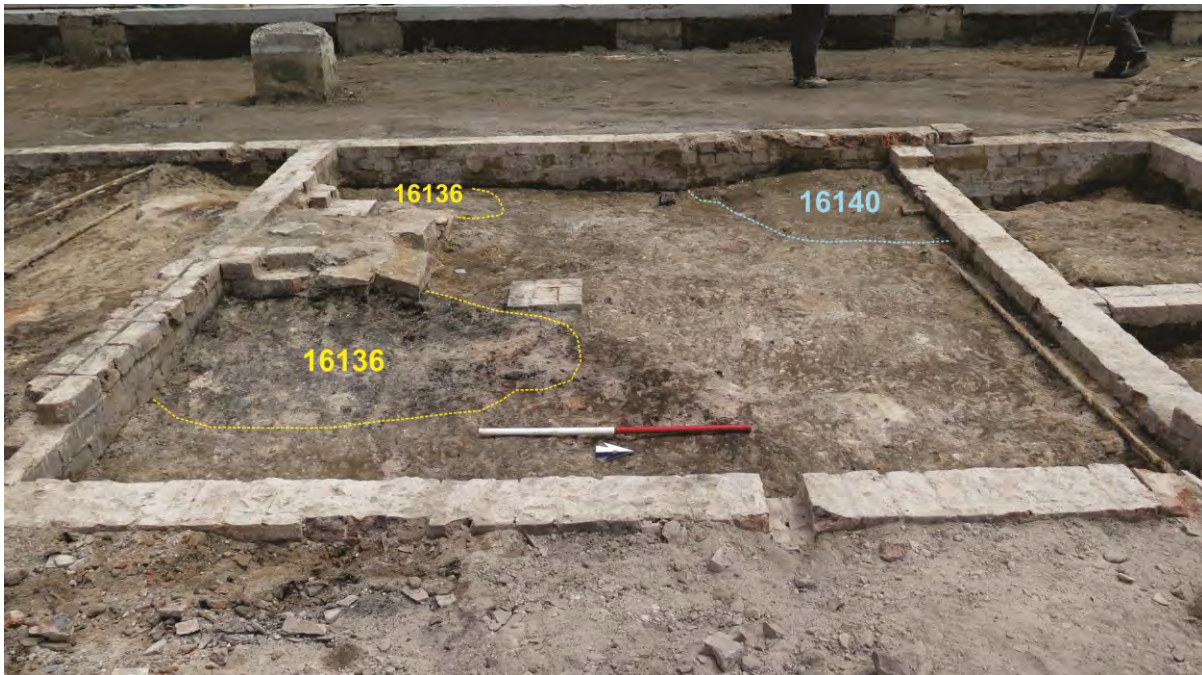
Figure 8.24: Room 5 (kitchen) prior to removal of underfloor deposits (16136 and 16140). An iron pipe (16138) runs along the north of the room, below underfloor deposit 16140. View to the west. Scale 1m. IMG_2906.

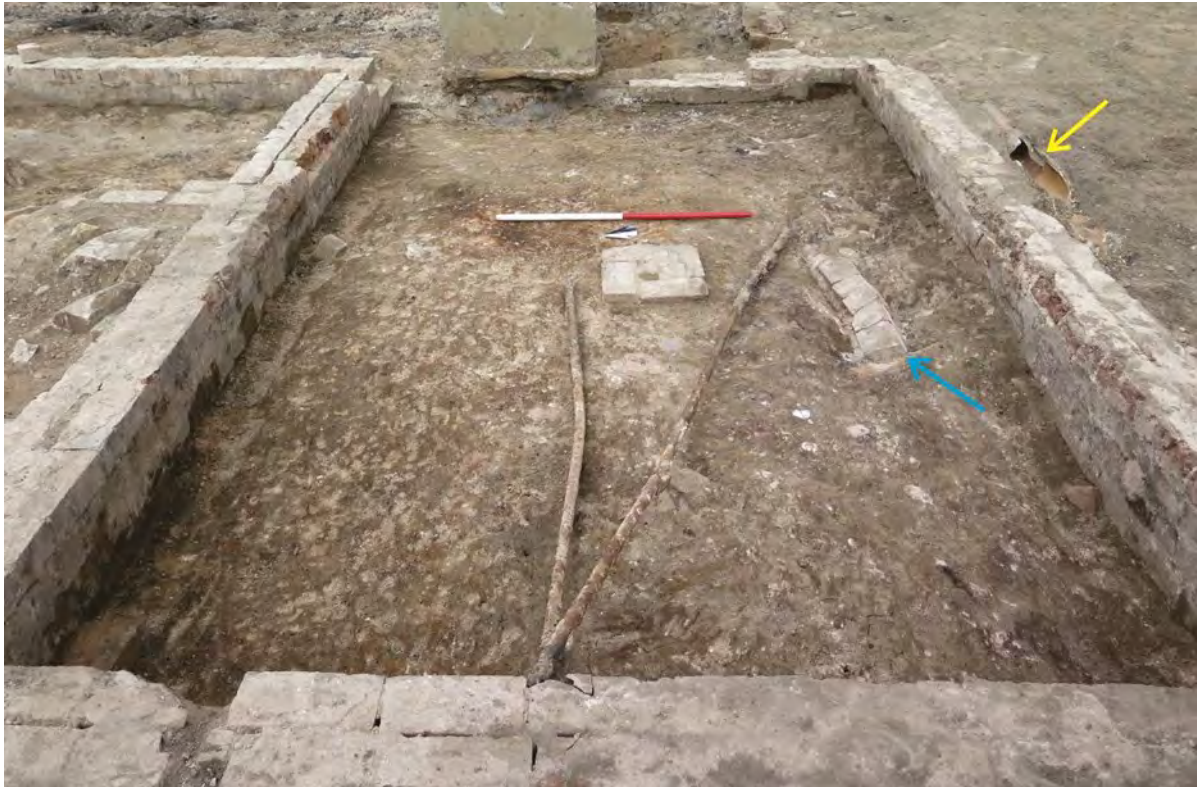
Figure 8.25: Room 6 (bathroom) after the removal of most of the demolition material down to the top of pre-construction fill 16124. The row of bricks (arrowed blue) is part of the remnant demolition fill. The yellow arrow points to a stoneware pipe to the immediate south of the room. View to the east. Scale 1m. IMG_2924.

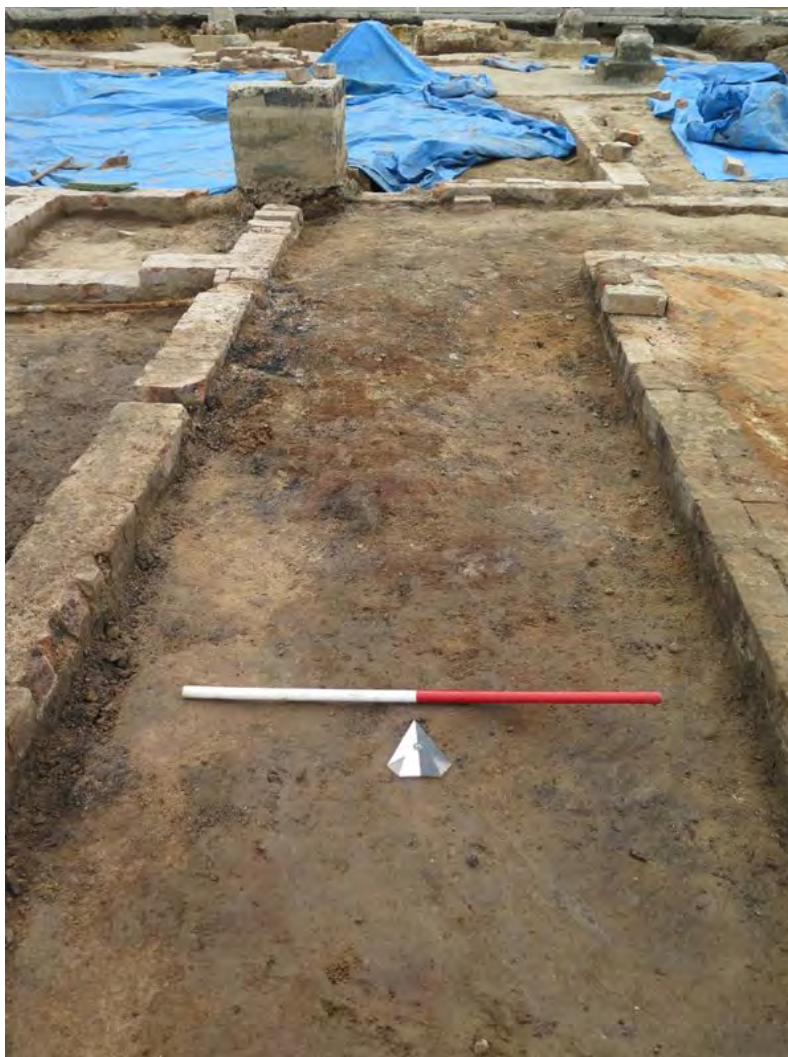
Figure 8.30: View along the length of the back verandah, after the removal of demolition material down to the level of context 16162. View to the north. Scale 1m. IMG_3065.

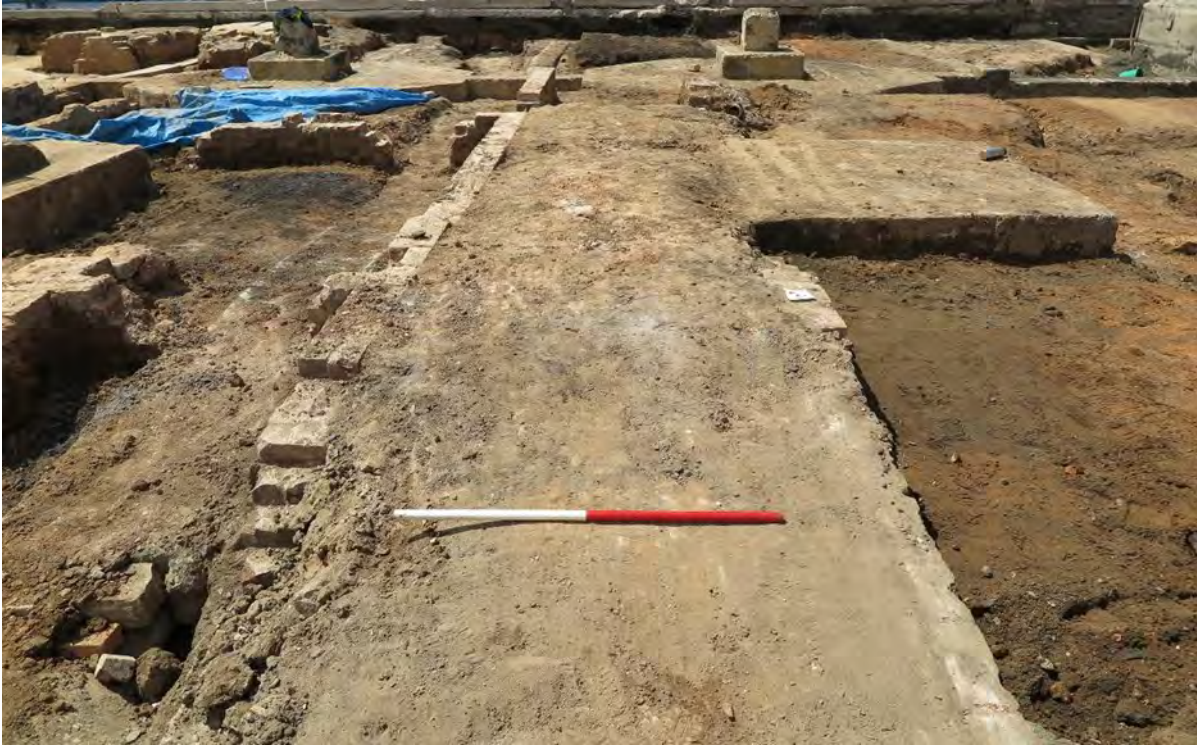
Figure 8.31: View along the eastern portion of the wraparound front verandah. View to the north. Scale 1m. IMG_3169.

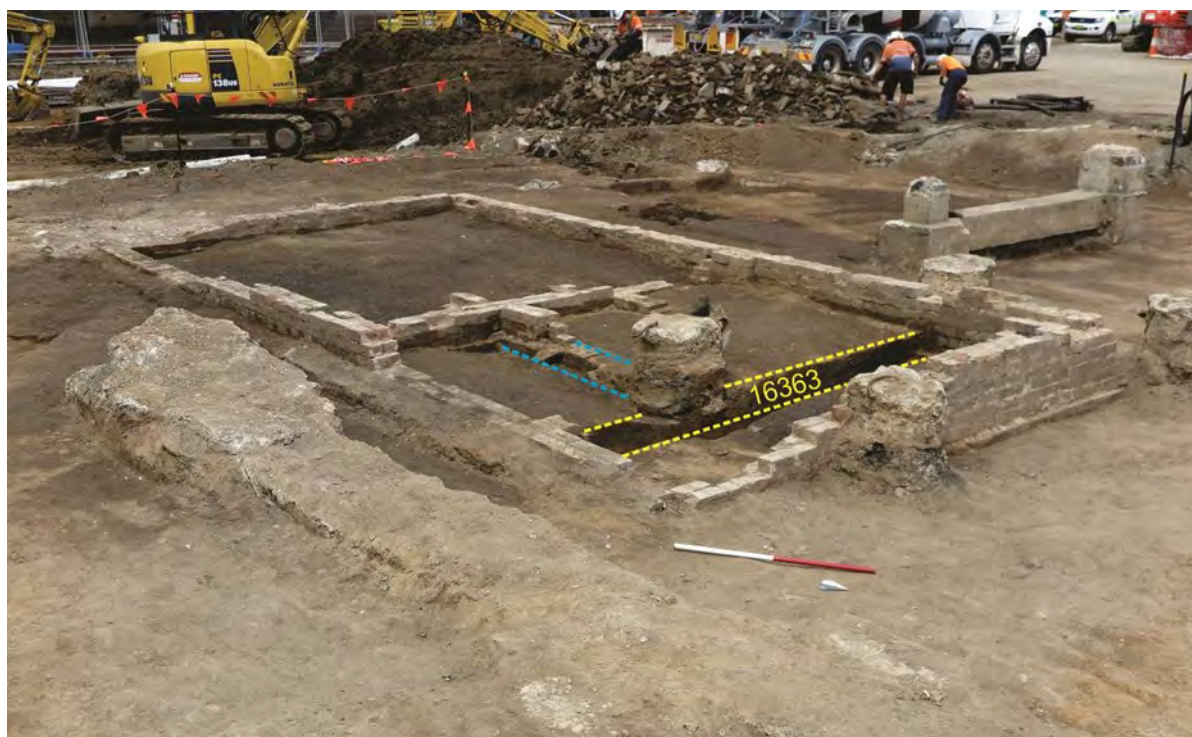
Figure 8.33: Laundry room (16342) showing robbed out wall trench (16363) and internal dividing wall (outlined in blue). The laundry is in the foreground and the lumber room in the background. View to the southwest. Scale 1m. IMG_4493.

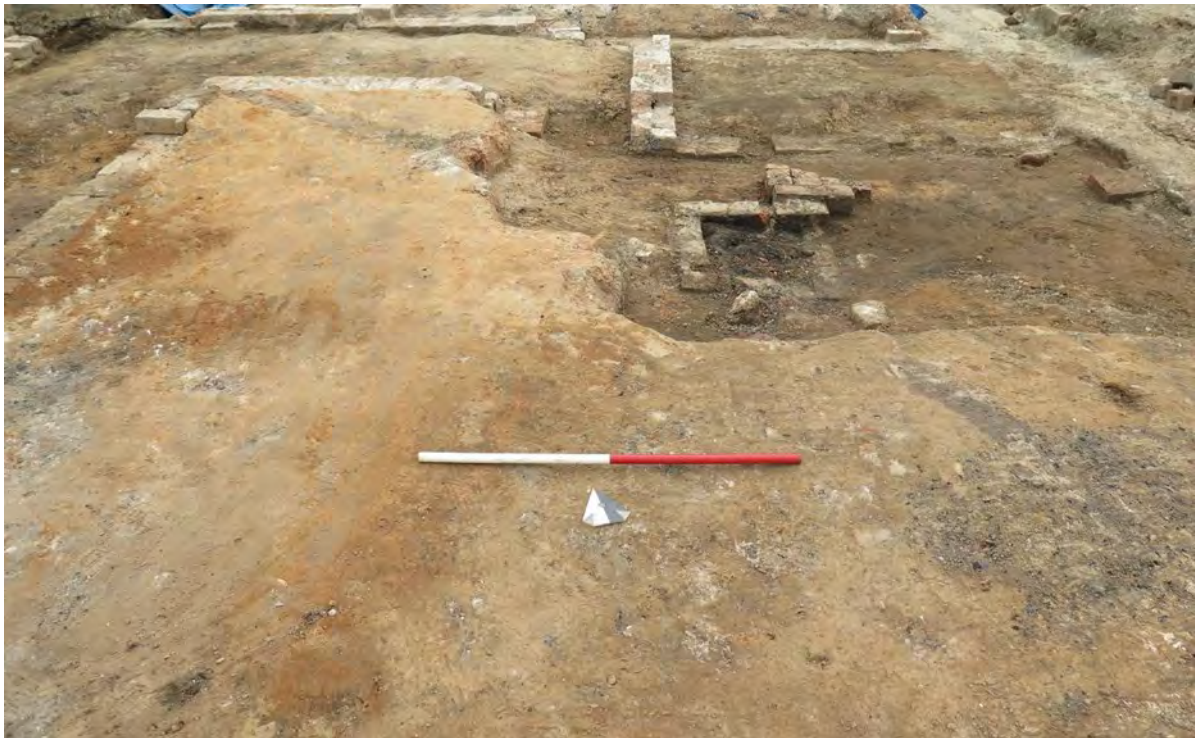
Figure 8.35: Yard fill (16163) abutting the south eastern footings of Cranbrook. View to the north. Scale 1m. IMG_3069.

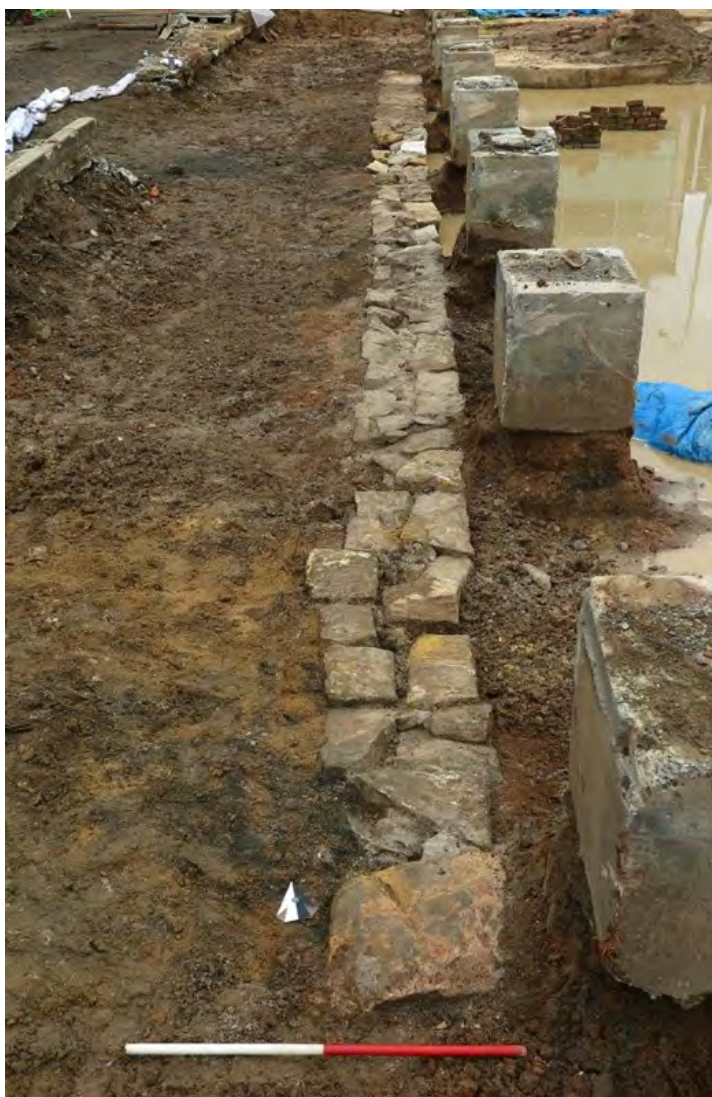
Figure 8.36: Sandstone wall (17275) on the western boundary of Area A. View to the north. Scale 1m. IMG_5042.

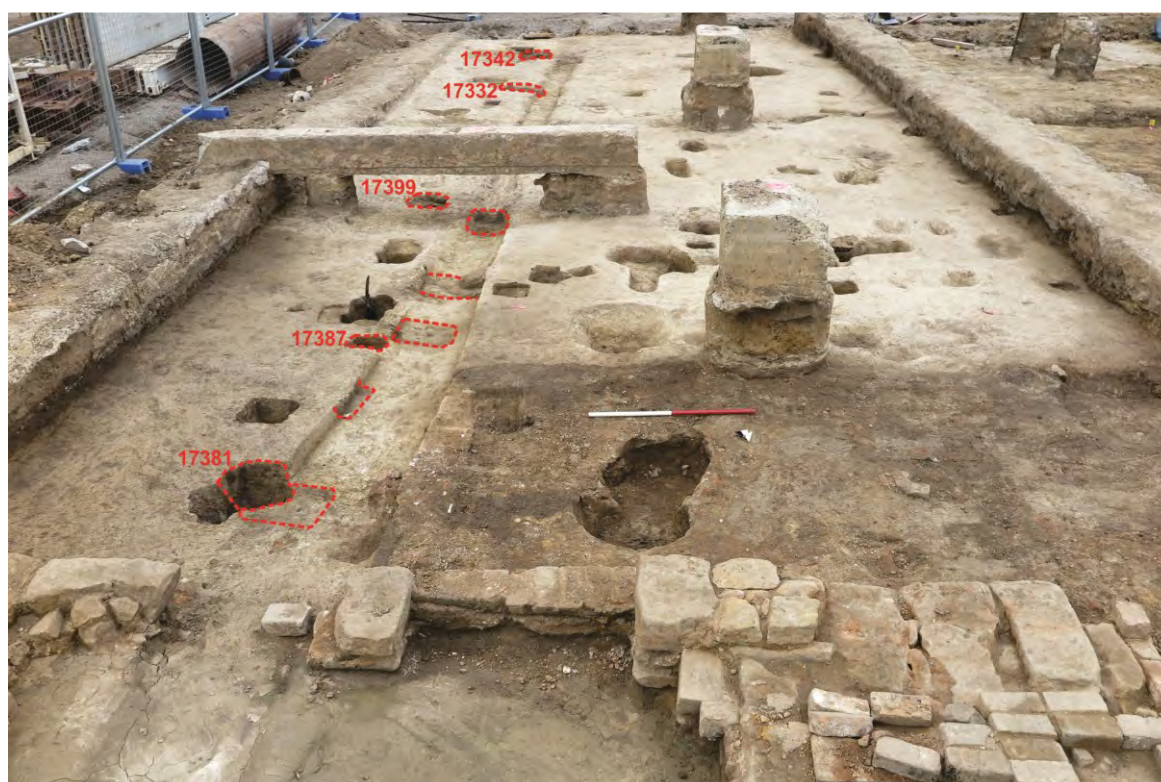
Figure 8.37: View along the southern portion of fence line 17575. Post holes which are part of 17575 are outlined in red and those with individual context numbers have been labelled as such. Service trench (17813) cuts through several of the post holes. View to the south. Scale 1m. IMG_4949.

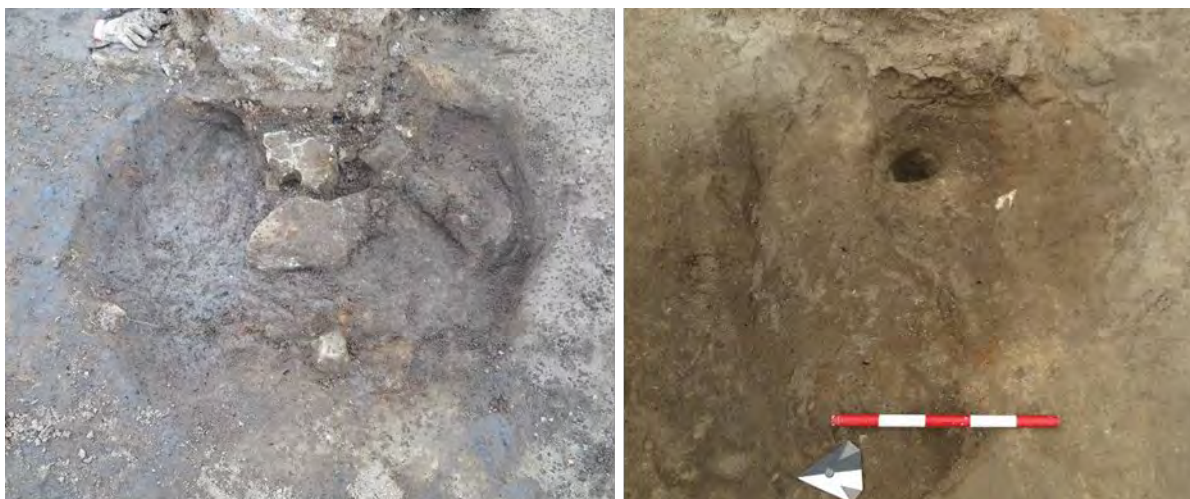
Figure 8.40: Posthole cut (16210), mid excavation showing concrete (left) and post-excavation showing post pipe (right). Both views to the east. Scale 500mm. IMG_3593 and IMG_3884.

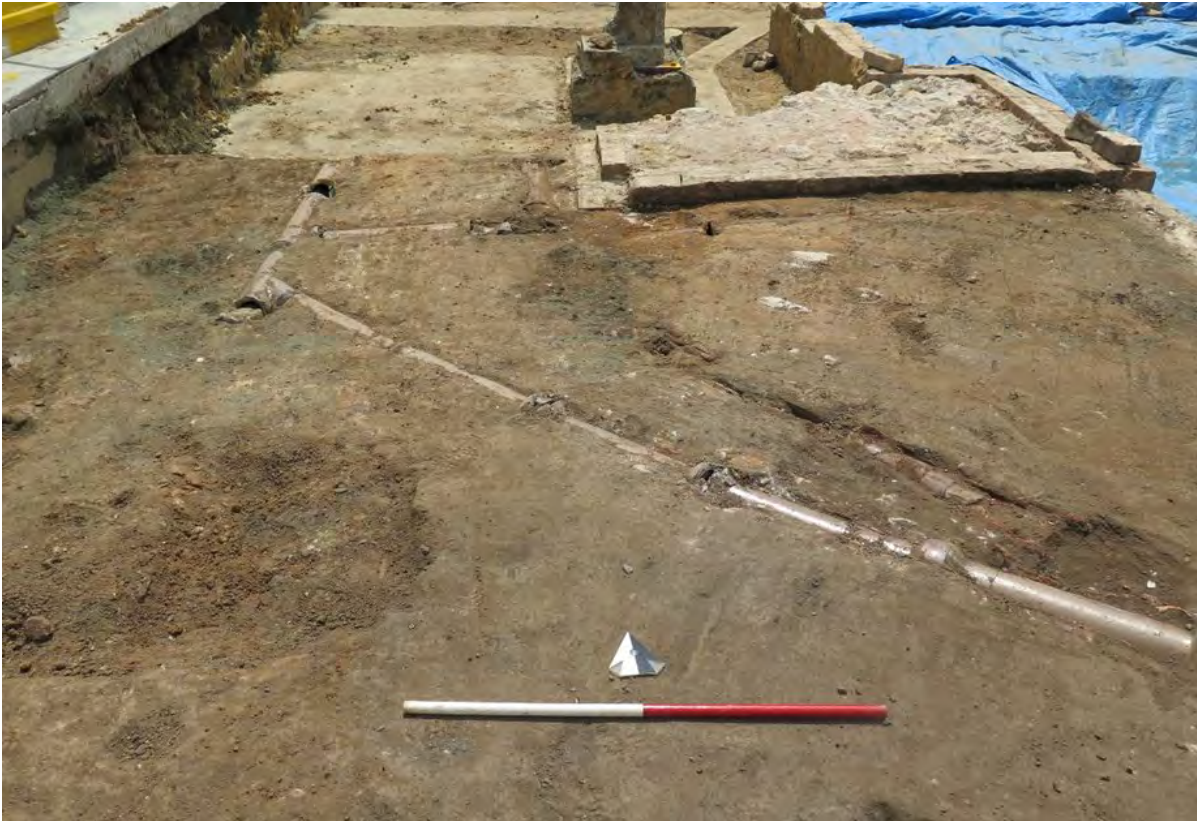
Figure 8.41: Service pipes in the western yard of Cranbrook. View to the north. Scale 1m. IMG_2896.

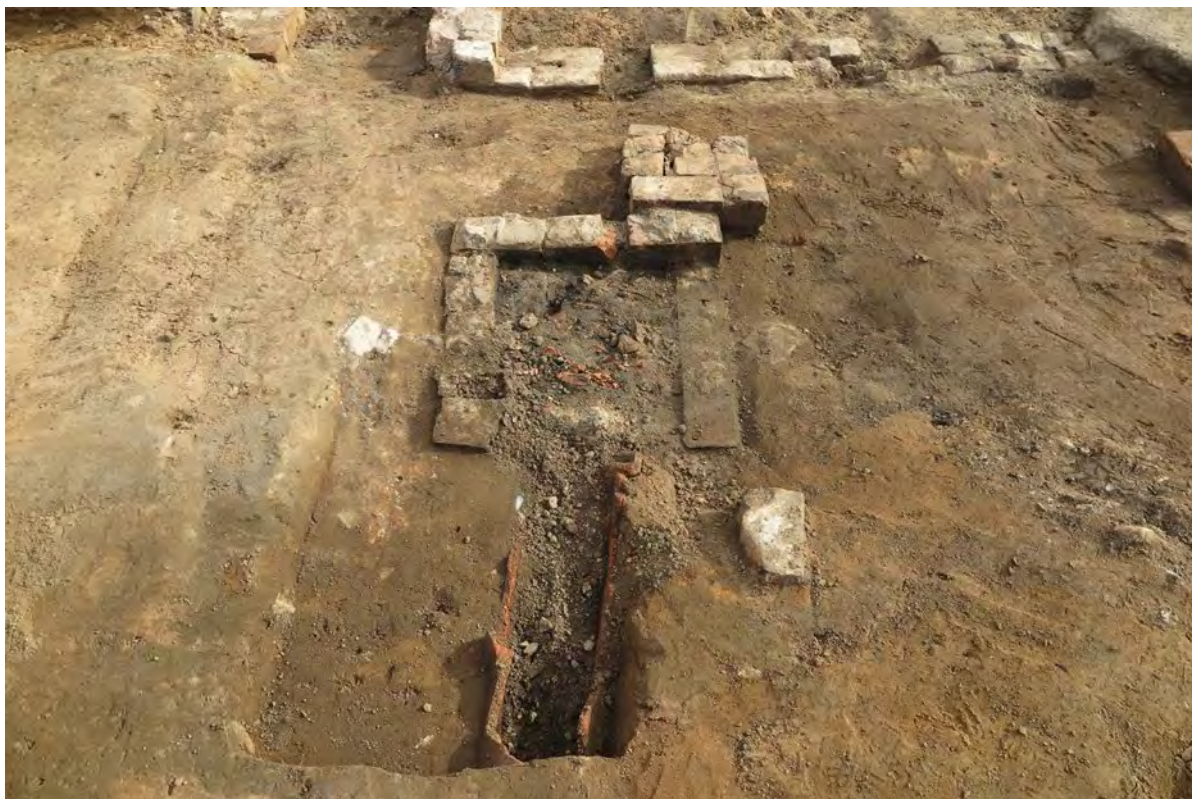
Figure 8.42: Brick sump (16178). View to the north. IMG_3142.

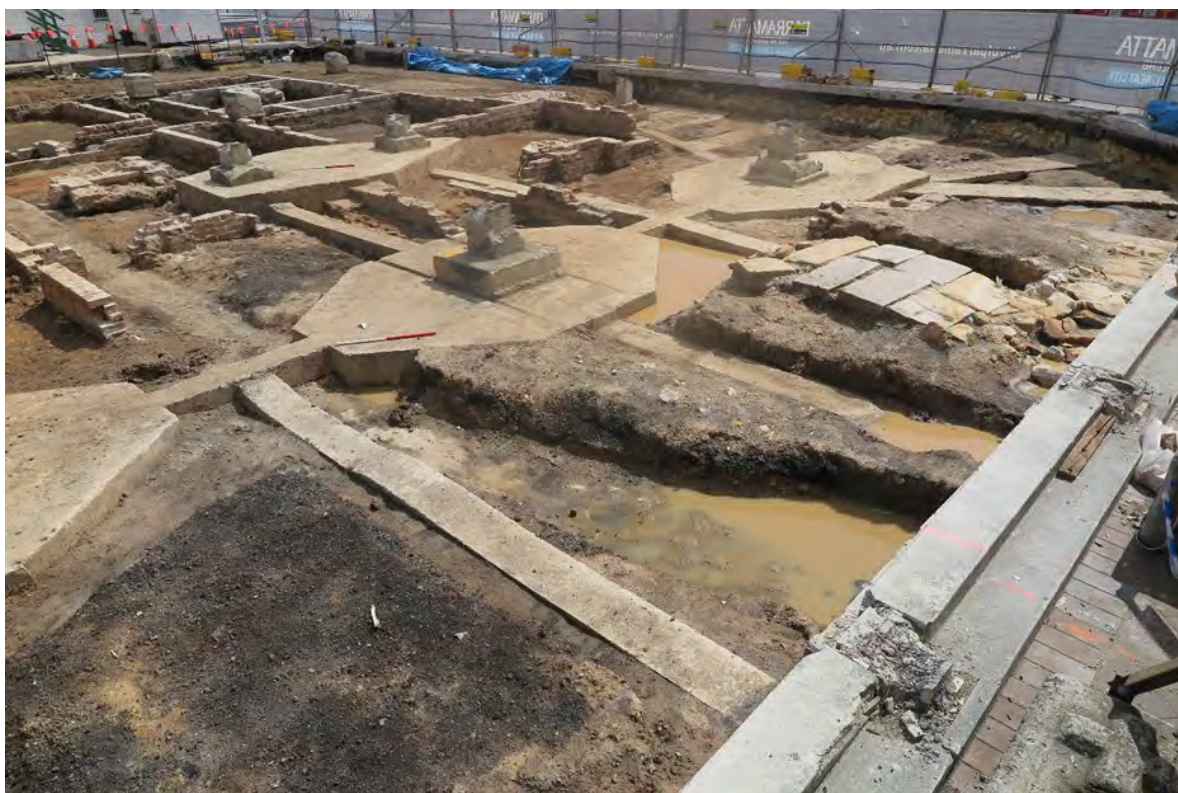
Figure 9.1: Concrete pads and beams (16109) forming the foundations for the Post Office cutting through earlier phases of archaeology. View to the southwest. Scale 1m. IMG_3222.

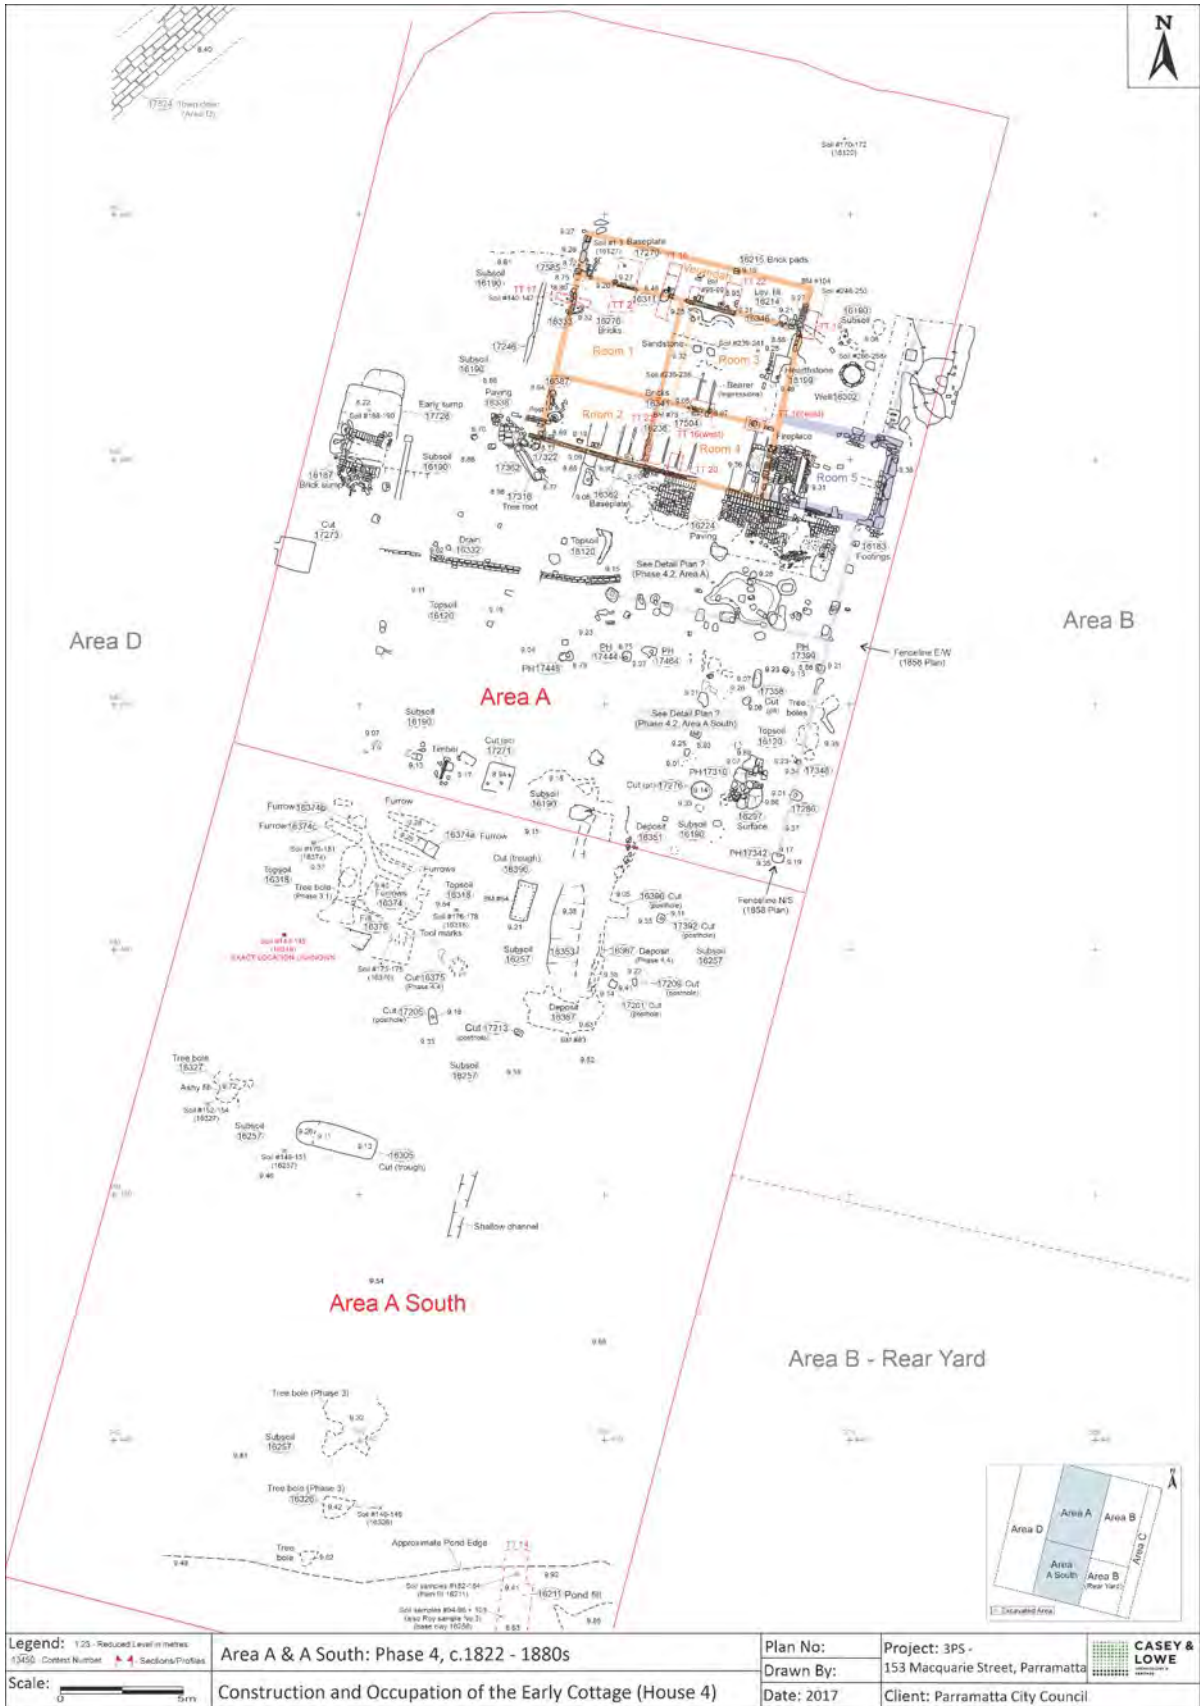
Figure 10.1: Plan showing the location of Area A and Area A South. The features shown on this plan are all from Phase 4. Area A South did not include as many archaeological remains as Area A.

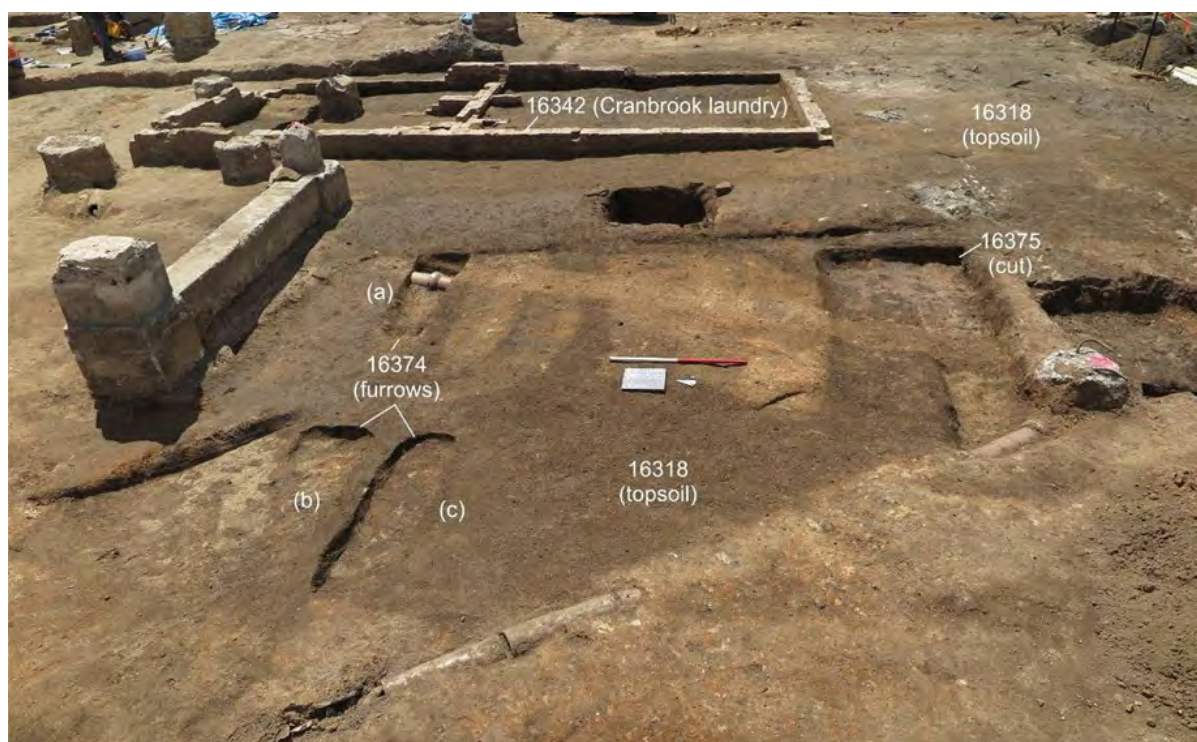
Figure 10.2: Linear features or furrows (16374) cutting the historic topsoil in the rear yard of Lot 30. These gardening or agricultural features were aligned east-west and were shallow. This area was greatly impacted by service trenches (16380 & 16381) and concrete footings and piers. View west. Scale 1m. IMG_4485.

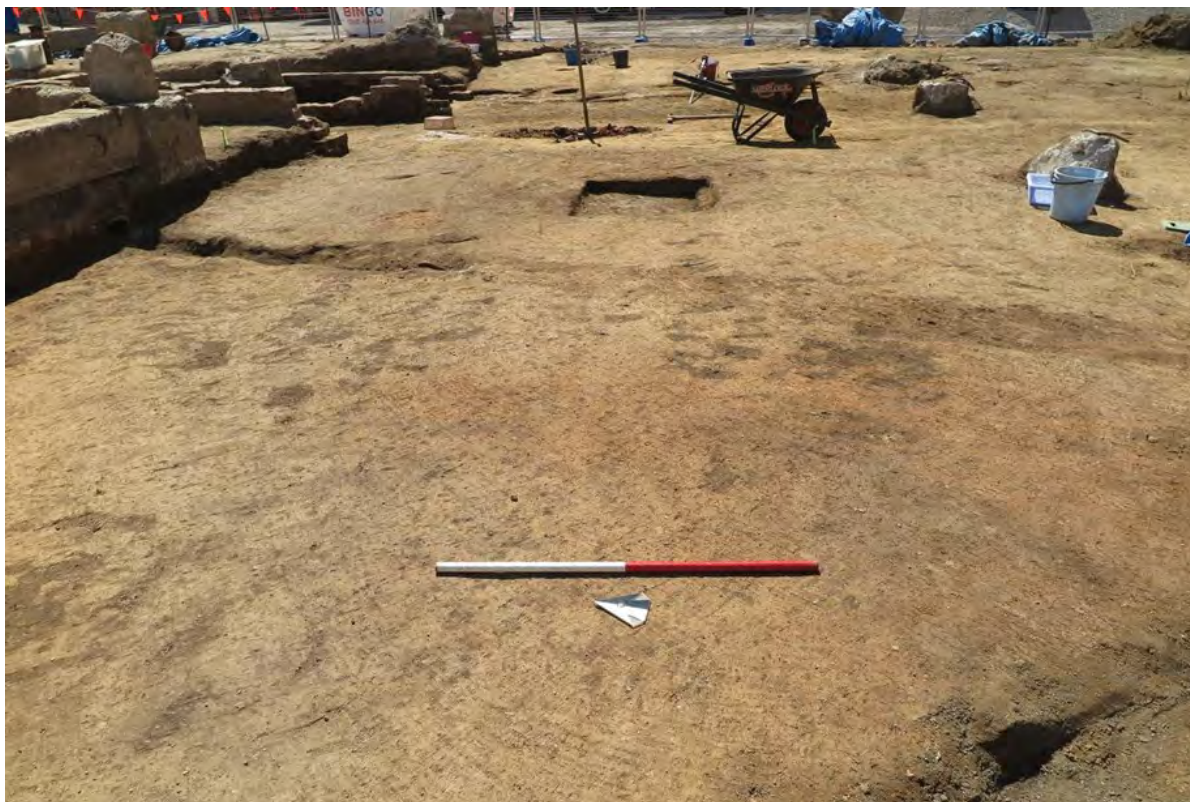
Figure 10.3: Tool marks visible in the subsoil after the topsoil was removed. These marks are in the same area as the furrows (16374) discussed above and are further evidence of gardening or agricultural activities in the rear yard of House 4. View east. Scale 1m. IMG_4561.

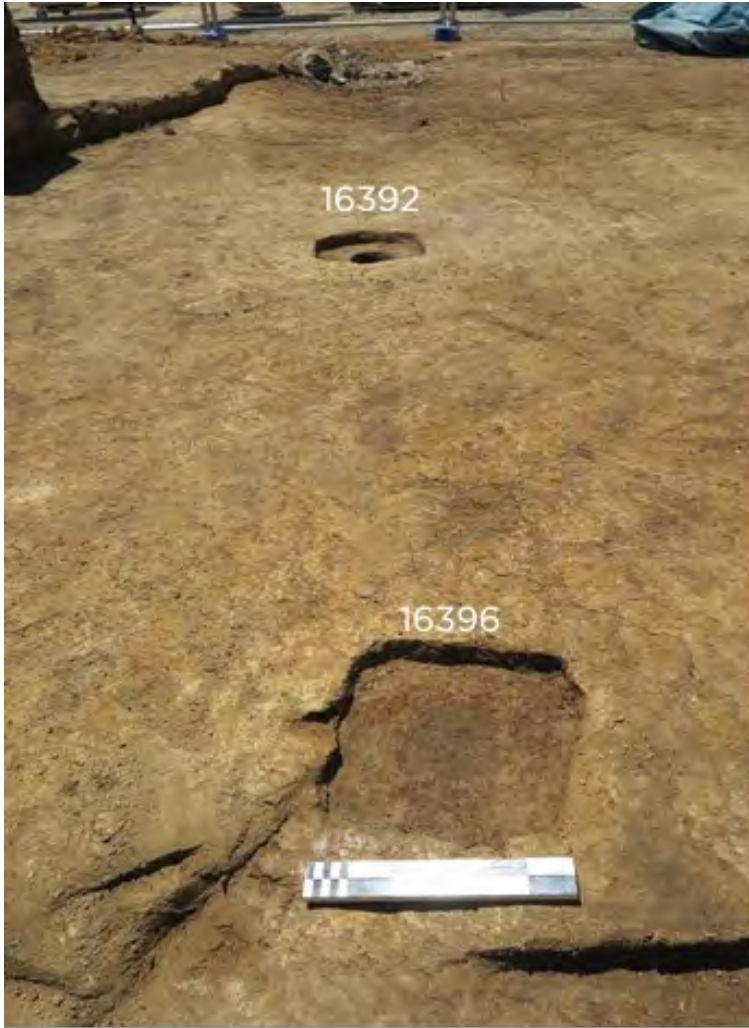
Figure 10.4: Two aligned square postholes (16392 and 16396) with similar fills and circular post-pipes. 16396 (in the foreground) did not have the post-pipe fill excavated in this photo. View east. Scale 30cm. IMG_4566.

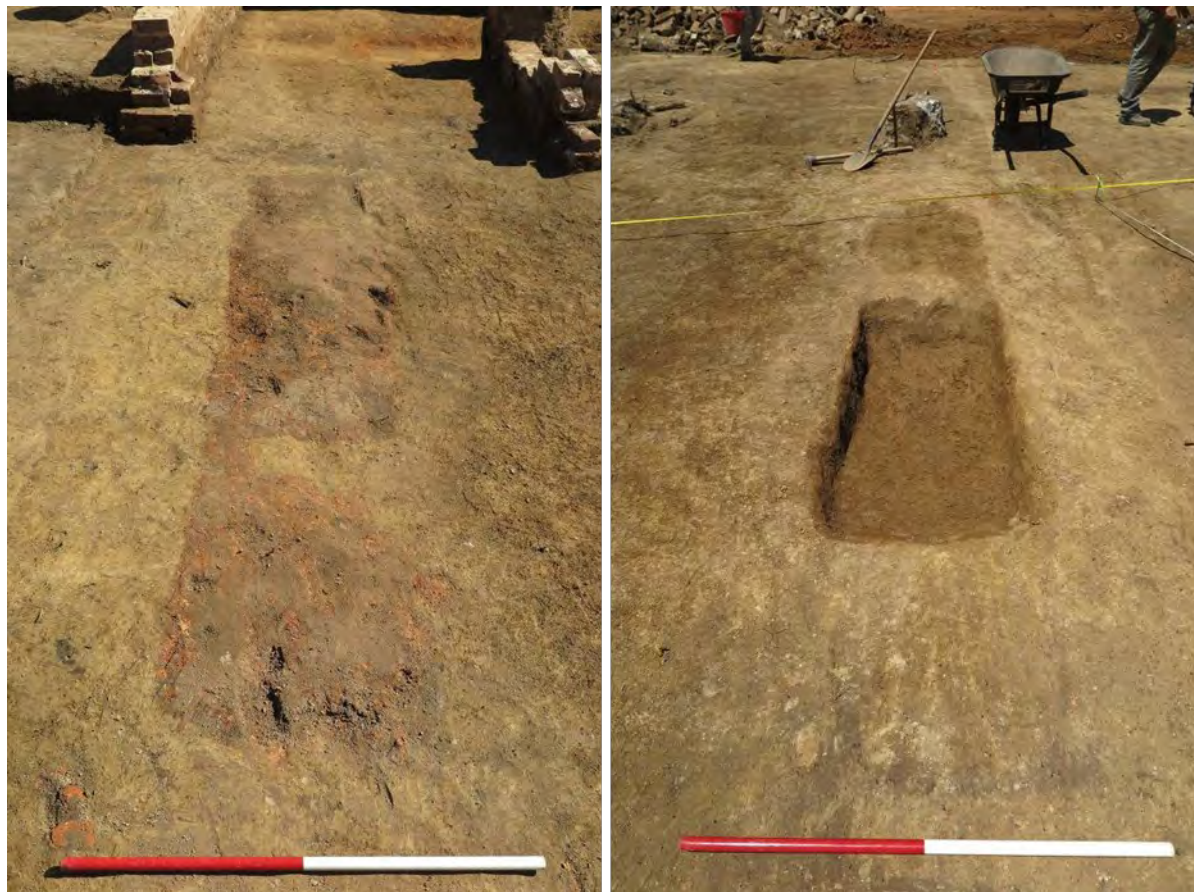
Figure 10.5 (left): Elongated cut (16190) with compacted brick rubble fill (16191). View south. Scale 1m. IMG_4552.

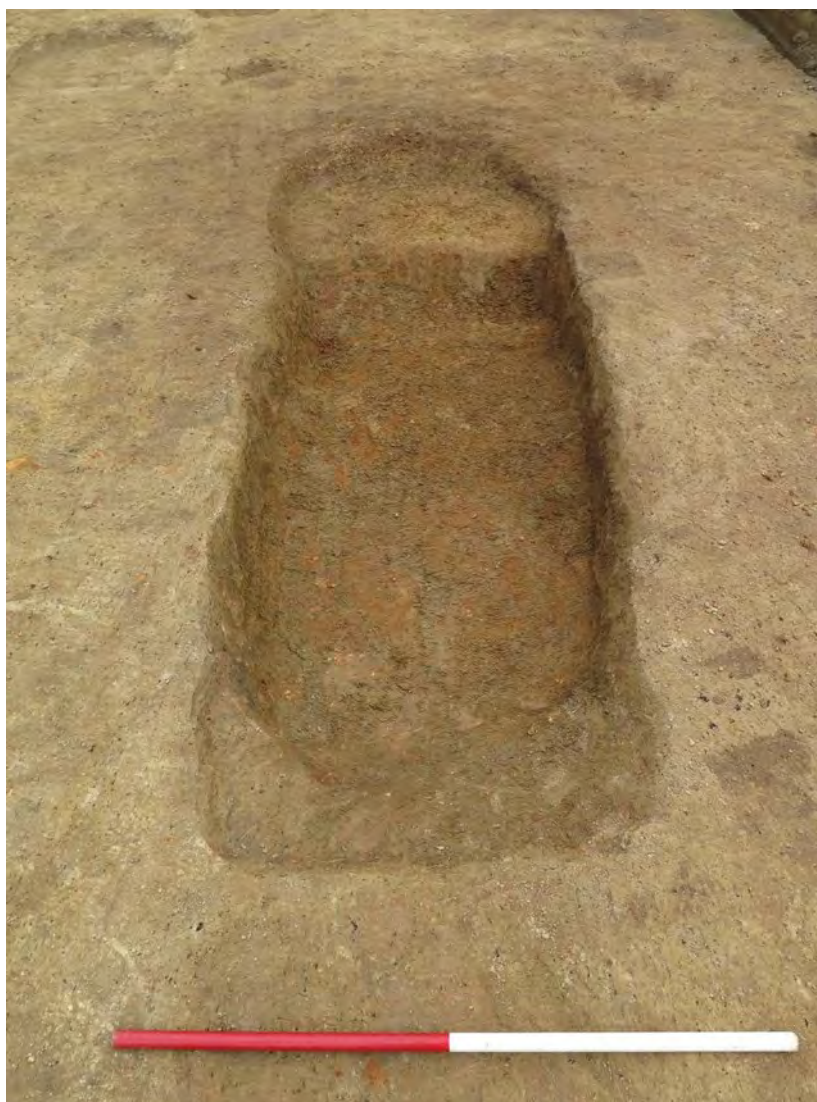
Figure 10.7: Post-excitation of elongated cut (16305), possible a trough for food or water that was orientated east-west at the rear of Lot 30. View west. Scale 1m. IMG_16305.
