3PS – 153 MACQUARIE STREET, PARRAMATTA

TRENCH REPORT – AREA A & AREA A SOUTH

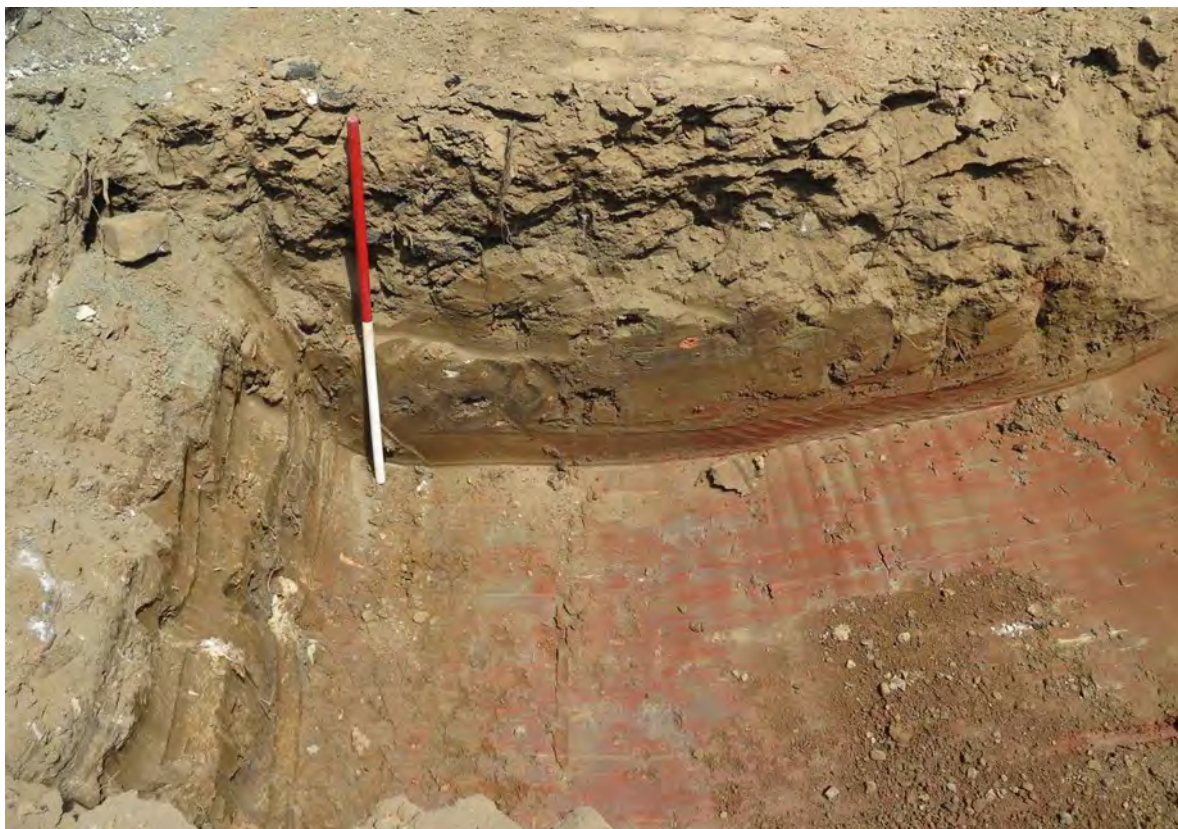
Figure 10.8: Machine excavated test trench (TT 14) through the pond (Phase 4.2) at the rear of Lot 30. East-facing section, showing the pond fills (16211) and the natural base clay (16256). View west. Scale 1m. IMG_3258(2).

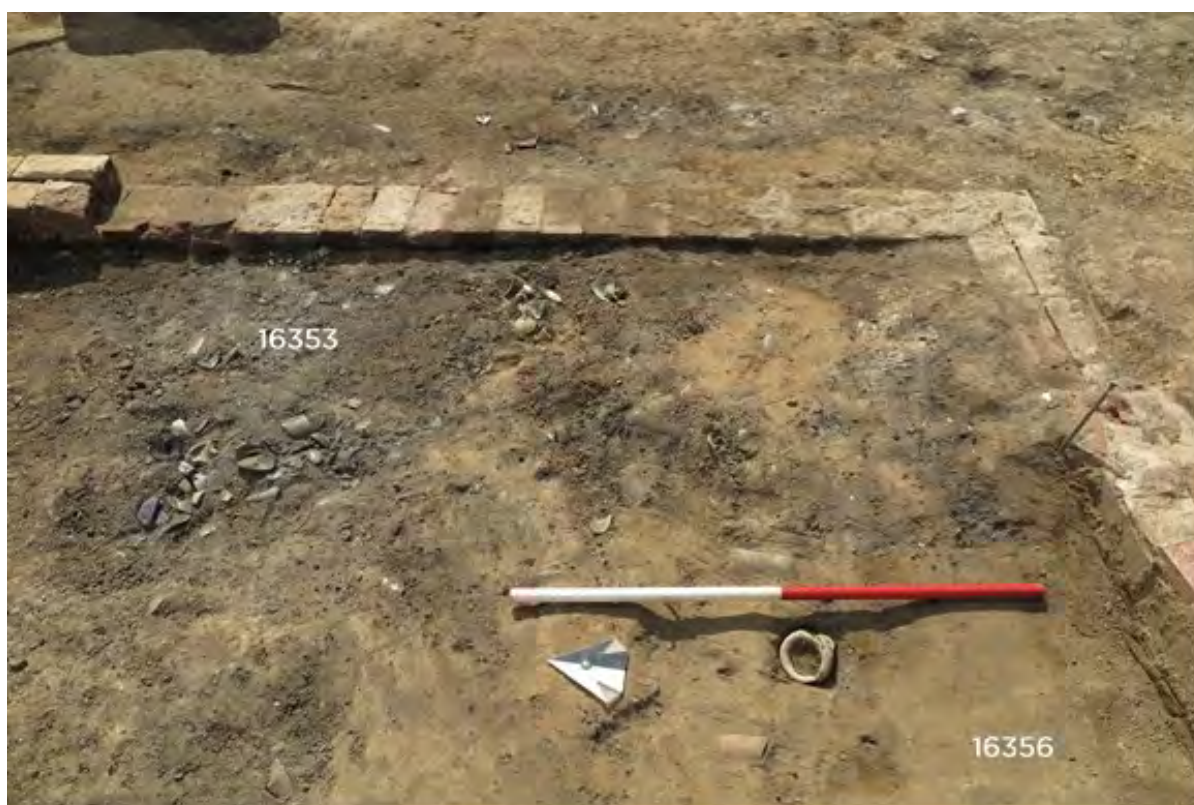
Figure 10.9: Large bottle dump (16353) below the imported levelling fill (16356) visible in the foreground and truncated by the footings of the Cranbrook laundry (16342). View east. Scale 1m. IMG_4392.

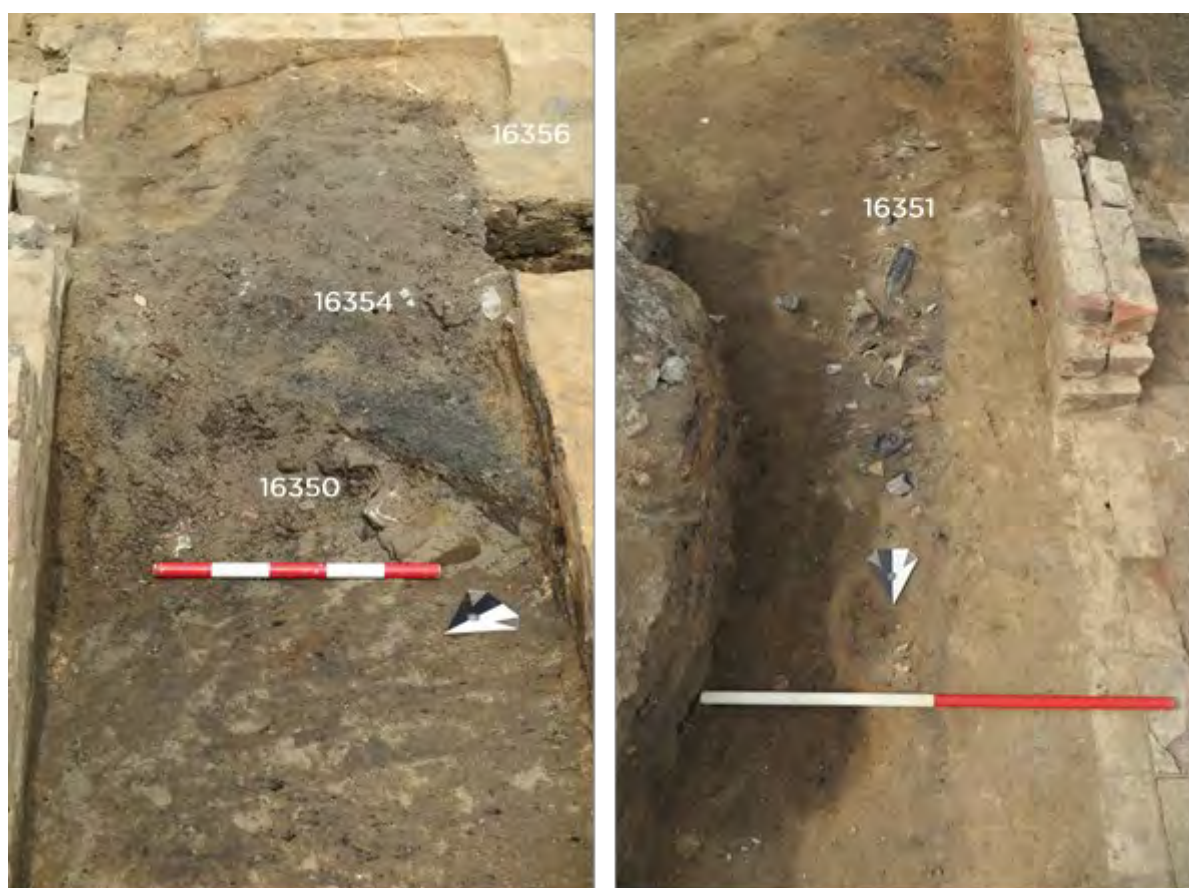
Figure 10.10 (left): Sequence of fills below the Cranbrook laundry footings. The lower deposit (16350) filled a dip in the topsoil while the darker brown-black fill (16354) sat directly above it. The levelling fill (16356) covered the bottle dumps. View southeast. Scale 1m. IMG_4408.

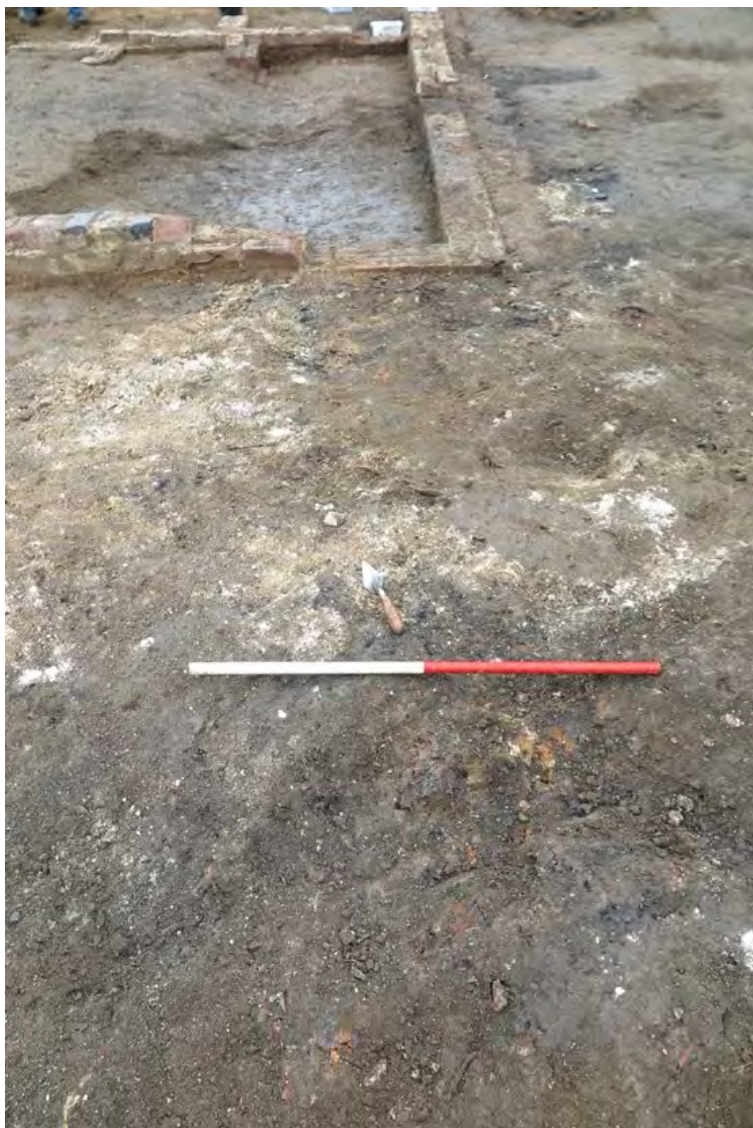
Figure 10.12: Pale sandy deposit (16367) truncated by the southeast corner of the Cranbrook laundry (16342). In the background (inside the building) you can see the depression in the topsoil after the rubbish dumps (16353 and 16354) were removed. View north. Scale 1m. IMG_4445.

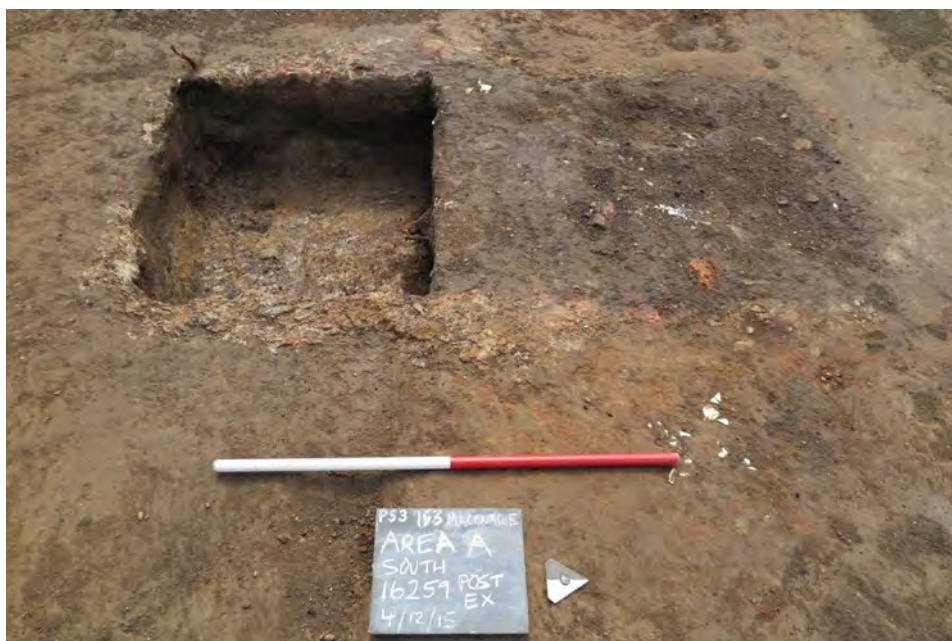
Figure 10.14: Half sectioned clay-lined 20th-century rubbish pit (16259). View west. Scale 1m. IMG_4020.

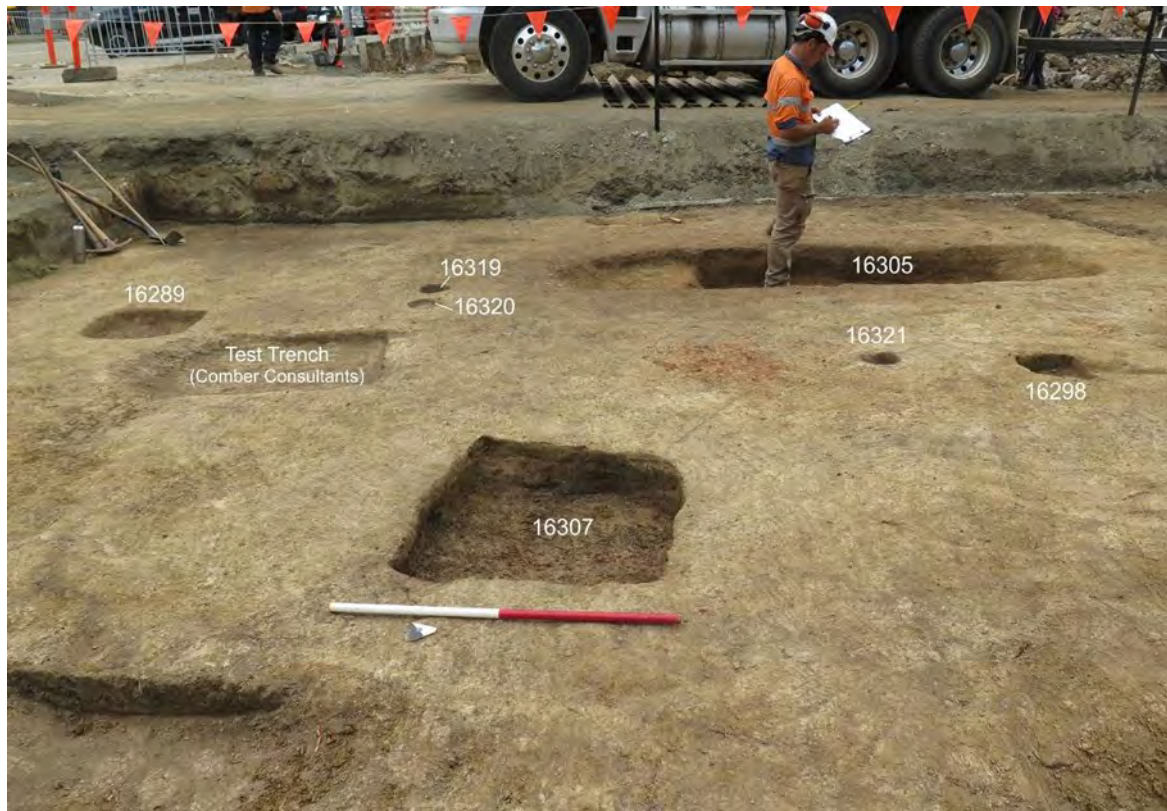
Figure 10.15: Excavated small features and postholes (Phase 5) cutting the subsoil. 16307 in the foreground contained 2 post-pipes that were later removed (see Fig 10.15). View north. Scale 1m. IMG_3307.
