3PS – 153 MACQUARIE STREET, PARRAMATTA

TRENCH REPORT – AREA C

JULY 2017

VOLUME 2, SECTION 7.3

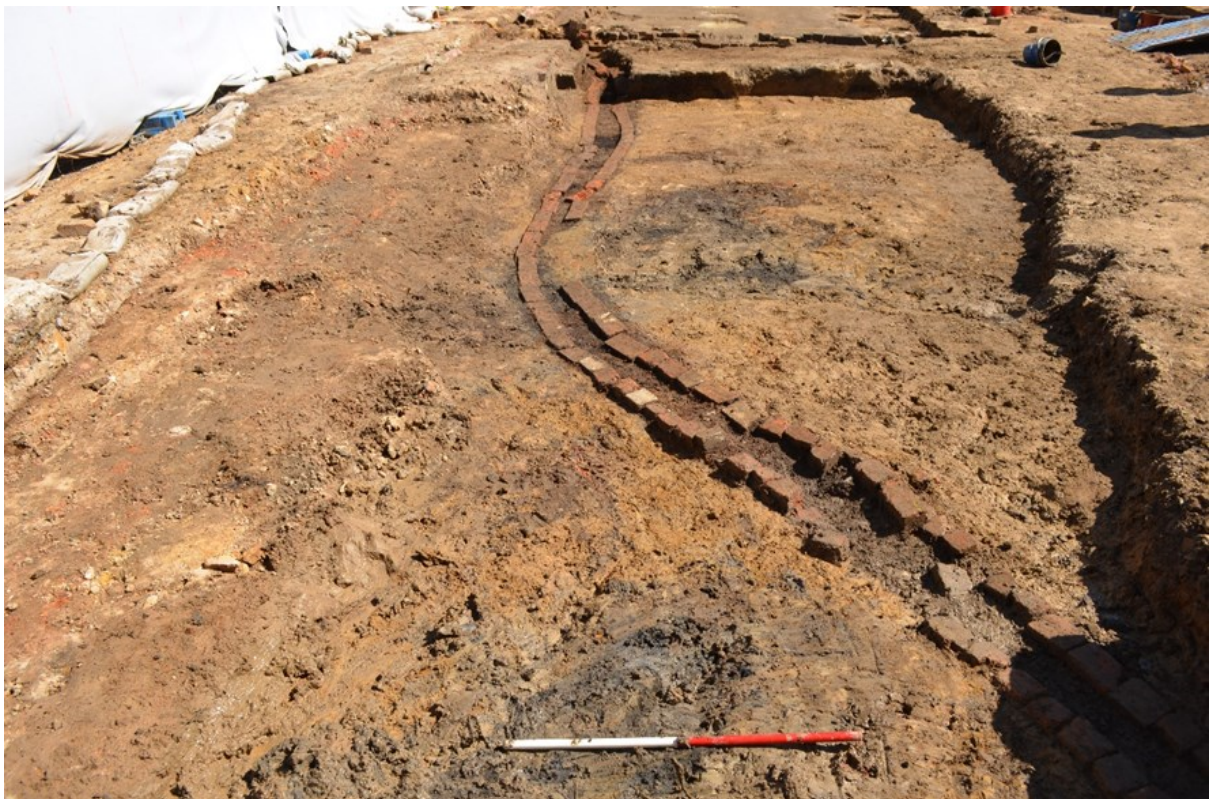
Photo of serpentine drain lined with sandstock bricks (16608). View to south, 1m scale. IMG_0743.

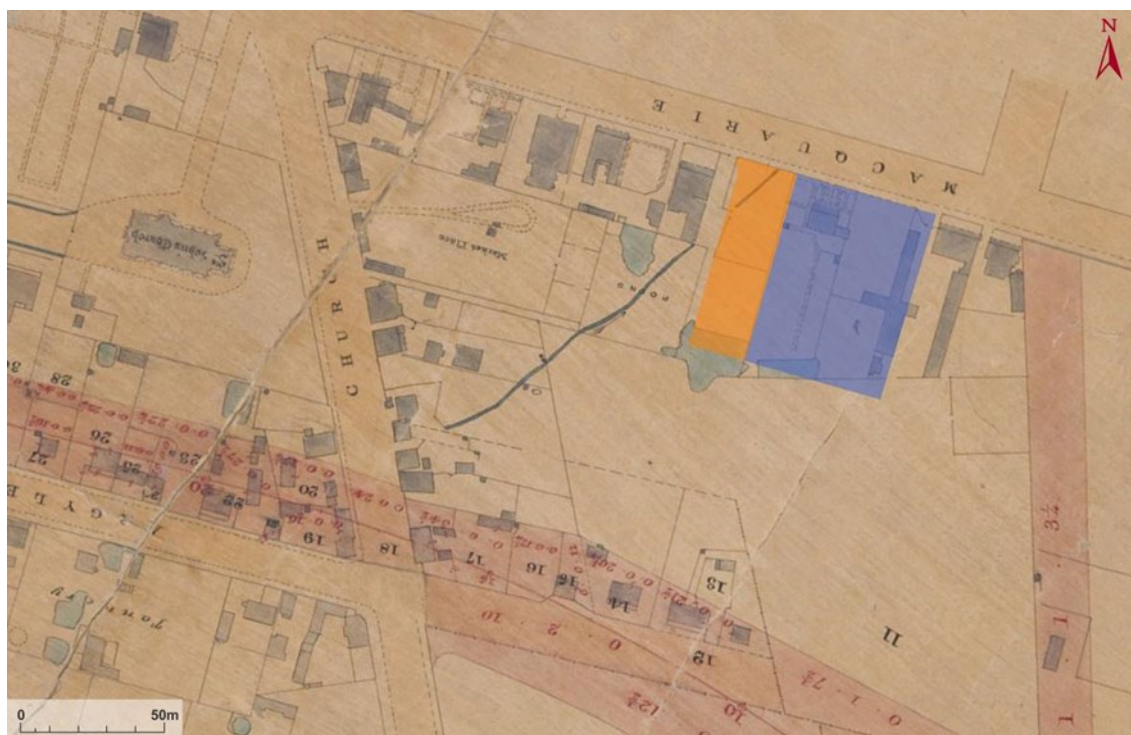
Figure 2.6: Detail of 1858 plan for the extension of the railway to Parramatta. Two long buildings have been built on the east and west boundaries of Lot 32: the t-shaped structure and smaller annex on the west side are within Area C, while the other structures are outside the 3PS study area. The western part of the t-shaped building extends into Area B, but is discussed in this report for completeness. SRNSW NRS 15244, item [1].

It is worth noting that while the east-west aligned structure that appears on the 1858 plan (Figure 2.6) is interpreted as being a single building that extends across the boundary fence between Lot 32 (White Horse Inn) and Lot 30 (Holland property), the eastern and western sections of the t-shape may in fact have been entirely separate buildings. It is unusual that a building occupied by a single owner would extend into land owned by someone else. Perhaps the configuration shown on the 1858 plan is actually depicting an L-shaped building on Lot 32 and a smaller rectangular outbuilding on Lot 30 abutting the White Horse Inn stable and sheds. However, the use of layered crushed brick and ironstone gravel as a surface on the interior of both Section B and Section C is an indication that these two structures were constructed, in use or modified at the same time using the same material, despite being constructed in slightly different ways and probably used for different purposes. For ease of recording all postholes associated with this building (Section C) have been included in the Area C matrix.

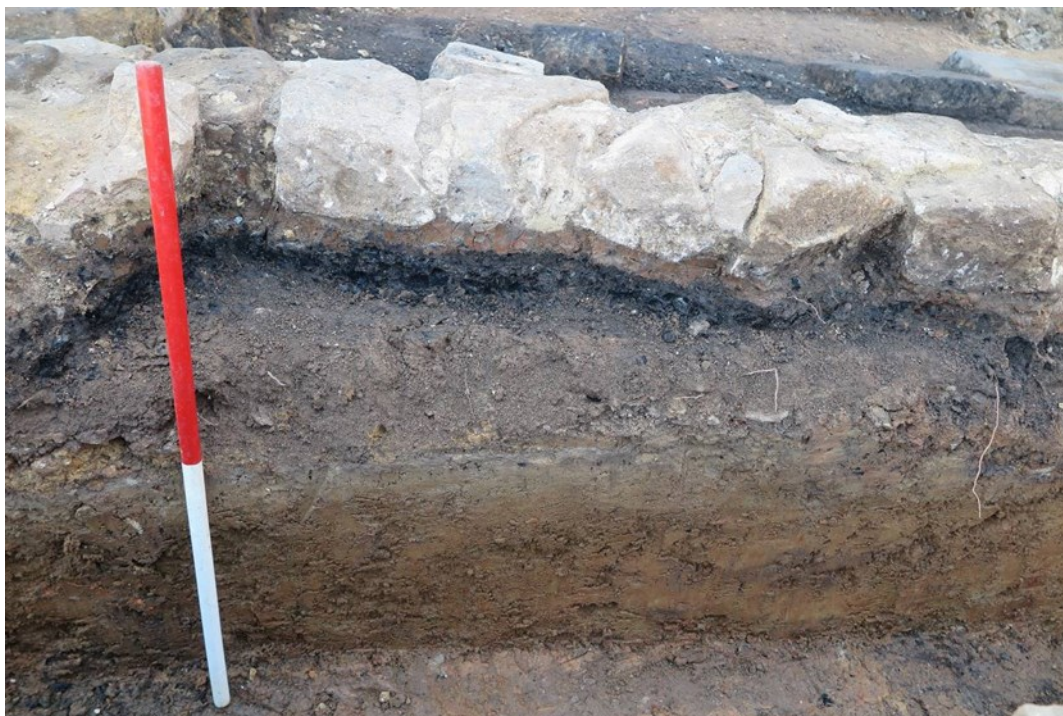
Figure 4.1: Photo showing the brownish red plastic clay parent material or C-horizon in the lower half of a modern service trench in Area C. Note how the historic fills sit directly on the pale yellowish subsoil, with no surviving historic topsoil. View to east, 1m scale. IMG_0990.

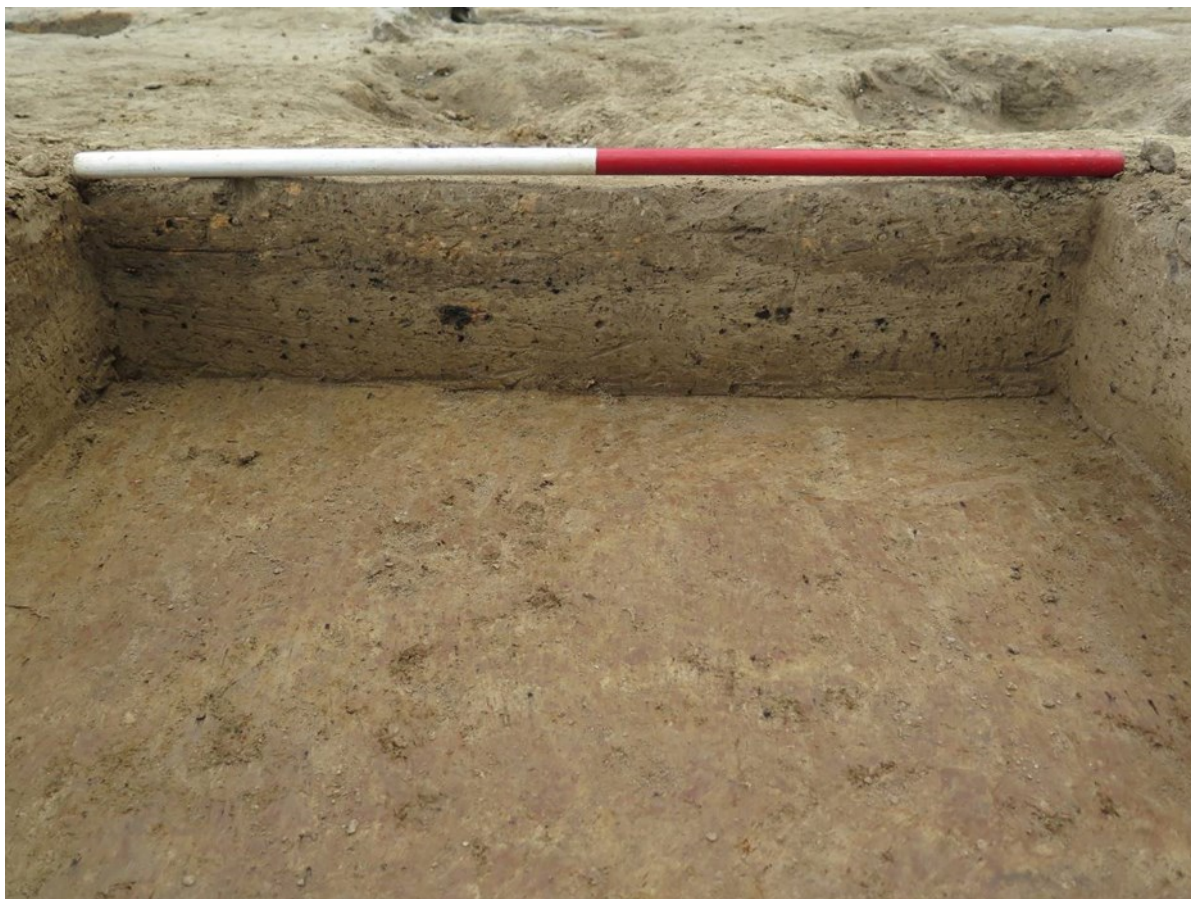
Figure 4.2: Photo showing the paler yellowish grey subsoil with charcoal flecks in between the darker historic topsoil with small orange burnt clay pieces above, and the reddish-brown plastic clay parent material below. The soil profile was recorded in Aboriginal test trench M35 (Area B), but is representative of the stratigraphy across both Area B and C. View to north, 1m scale. IMG_3082.

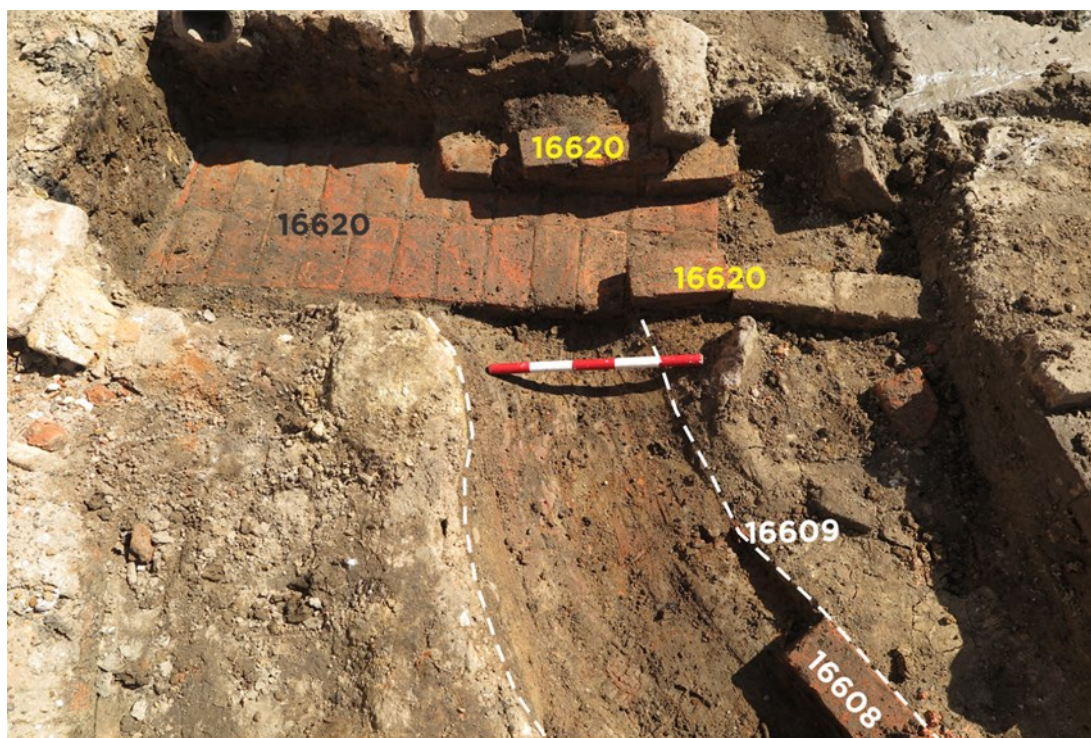
Figure 7.1: Photo showing the intersection of the three drain elements. View to south, 500mm scale. IMG_0813.

The brick sides were missing from the southern end of the drain (Figure 7.1) where it intersected with the flat section of drain (16620), suggesting there may have been repairs to the drain, or impacts after it ceased to be used. The drain continued to the northwest, below a footing from the 1966 Post Office building, outside the boundary of the study area. It is unknown whether the serpentine drain feeds into a larger drain or water management system in Macquarie Street, however the depth of the feature compared to the current street level would suggest the serpentine drain is at too shallow a depth and is too informal to be worth connecting to a deeper channelized drainage system.

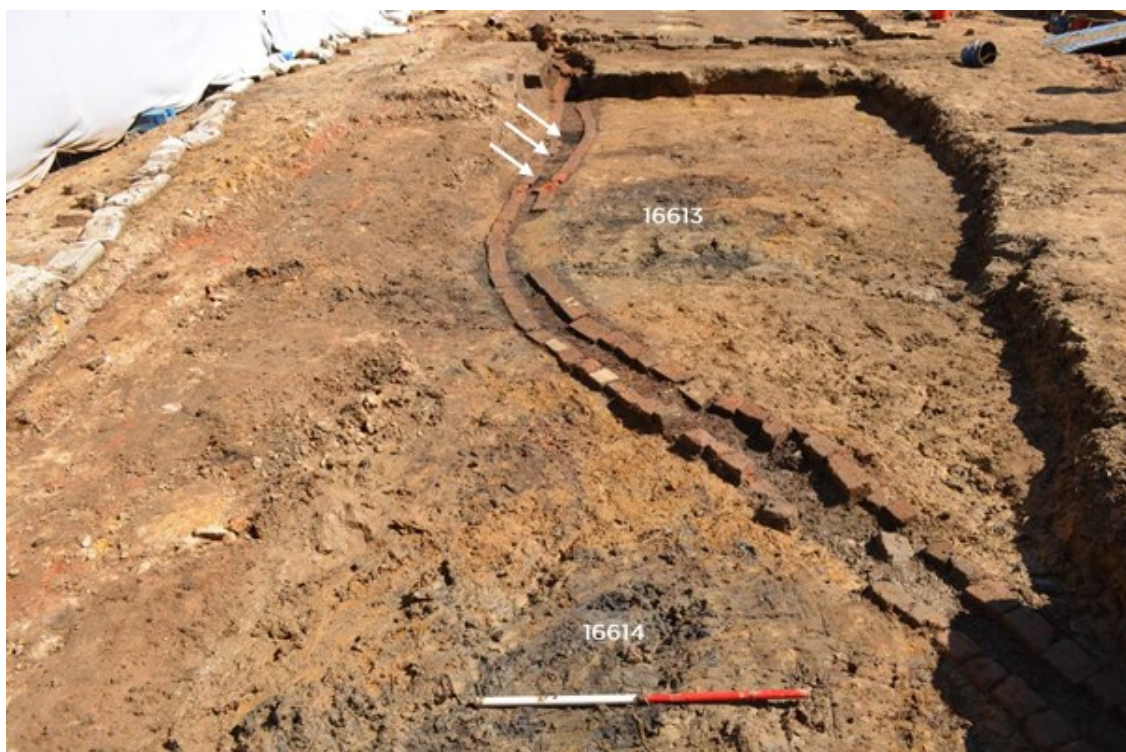
Figure 7.2: Photo showing the full length of brick-lined drain 16608. The patches of decayed timber, possibly the drain's capping, are arrowed and two tree boles are numbered in white. View to south, 1m scale. IMG_0743.

The drain had probably fallen out of use by the late 1840s, when the stable and sheds were built to the south. There were two fills recorded within the drain (given one context number 16611): the upper fill was a soft, mid-grey silty clay with some rust-coloured sand, charcoal, ceramic and glass inclusions; the lower fill was a clean yellowish brown, or greyish brown clayey sand. Pollen analysis of the lowest fill suggested that the surrounding ground was poorly drained (unsurprising, considering there were three early drains recorded in the northern part of Area C), with sedges, ferns and hornworts growing on damp bricks or sediment within the drain. Analysis of Pollen Sample #49 (location on Plan 14, Vol. 4, Sec. 10) taken from the build-up in the base of the drain indicated that it was still in use relatively late into the 19th century (Pollen Report, see Vol. 3. Sec. 8.5).

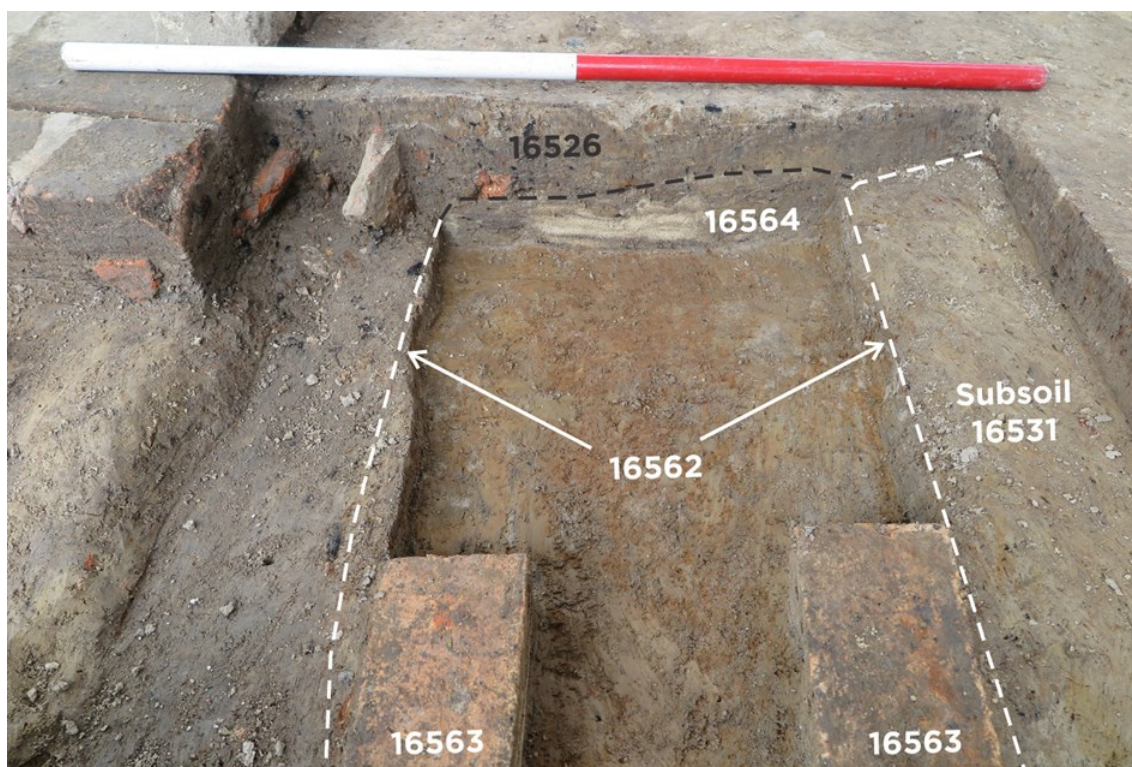
Figure 7.3: Section photo showing the sandstock brick lining 16563 along the sides of the drain cut 16562. After the drain stopped being used, it silted up with lenses of sand (16564) before being covered with a compact mixed clay fill (16526). View to east, 1m scale. IMG_0627.

An east-west running cut (16562), also lined with sandstock bricks (16563, BM Sample #24) is believed to be contemporary with the serpentine south-north running drain. The vertical sided, flat-bottomed cut had a maximum length of 4.5m, width of 460mm and depth of 150mm, or approximately two brick courses high. The sandstock bricks of the lining were non-continuous along the length of the cut, surviving two courses high in places and completely missing in others (Figure 7.3). The bricks had average dimensions of 230 x 110 x 70mm slightly smaller than those in the serpentine drain (BM sample #24). The base of the drain was not lined with bricks. This drain ran parallel to a later gutter (16471) on the north side of the stables and sheds structure, but was cut into the subsoil at a lower level. The fill (16564) recorded within the drain structure consisted of moderately soft bands of white, grey and orange iron-stained fine grained sands with a rippled or marbled effect, caused by water activity. The fill was thicker in the eastern part of the drain, becoming thinner towards the west indicating that the water was draining from the west down towards the east, where it probably intersected either the flat gutter 16620, or serpentine drain 16609. This drain was buried by fills associated with the construction of the t-shaped structure on Lot 32, therefore the drain may have only been in use for a short time prior to the construction of the stables or sheds of the White Horse Inn. A short period of use and/or early date of backfill of the drain is supported by pollen analysis of the water affected fill (16564, Pollen Sample #37) which showed a high proportion of native casuarina pollens and only rare exotic pollen such as pine and cereals, giving an early-mid 19th century date (Pollen Report, p40-42: see Vol. 3, Sec. 8.5).

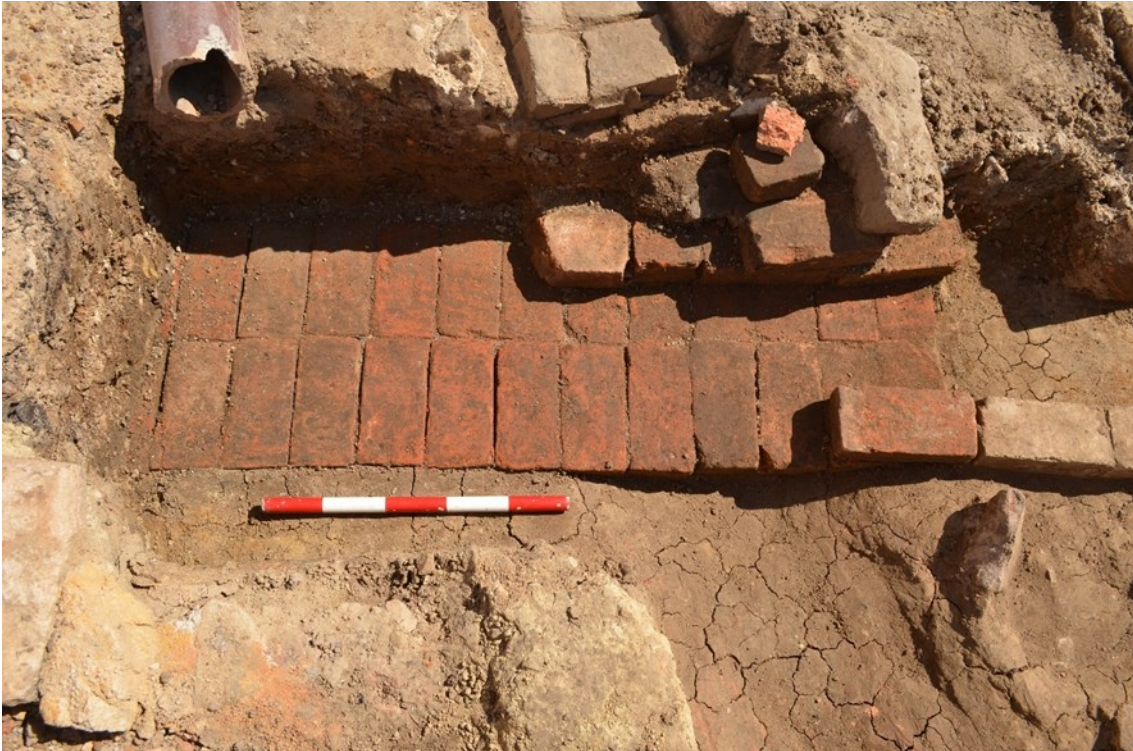
Figure 7.4: Flat sandstock bricks forming the base of a gutter, drain or sump (16620), intersecting with the north-south serpentine drain 16609 (bottom) and east-west drain 16562 (right). View to south, 500mm scale. DSC_9192.

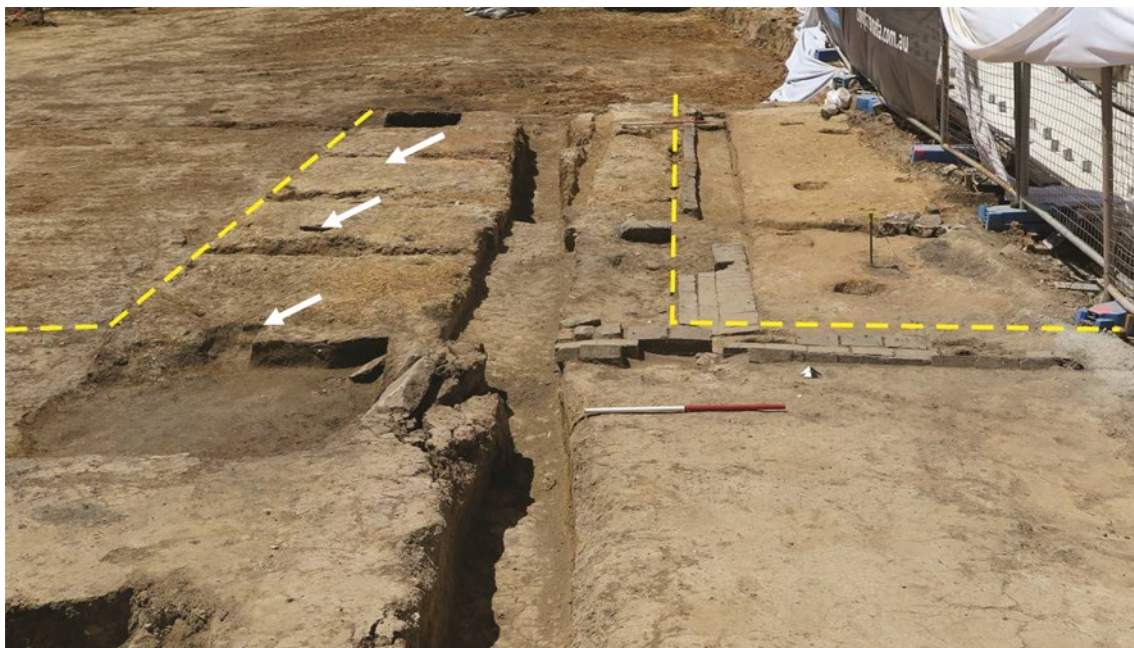
Figure 7.5: Photo showing the different alignments of the postholes for the walls of the central section of the stables and sheds (Structure 5) in yellow, and three of the postholes believed to be the earliest boundary fenceline arrowed white. View to north, 1m scale. IMG_1201.

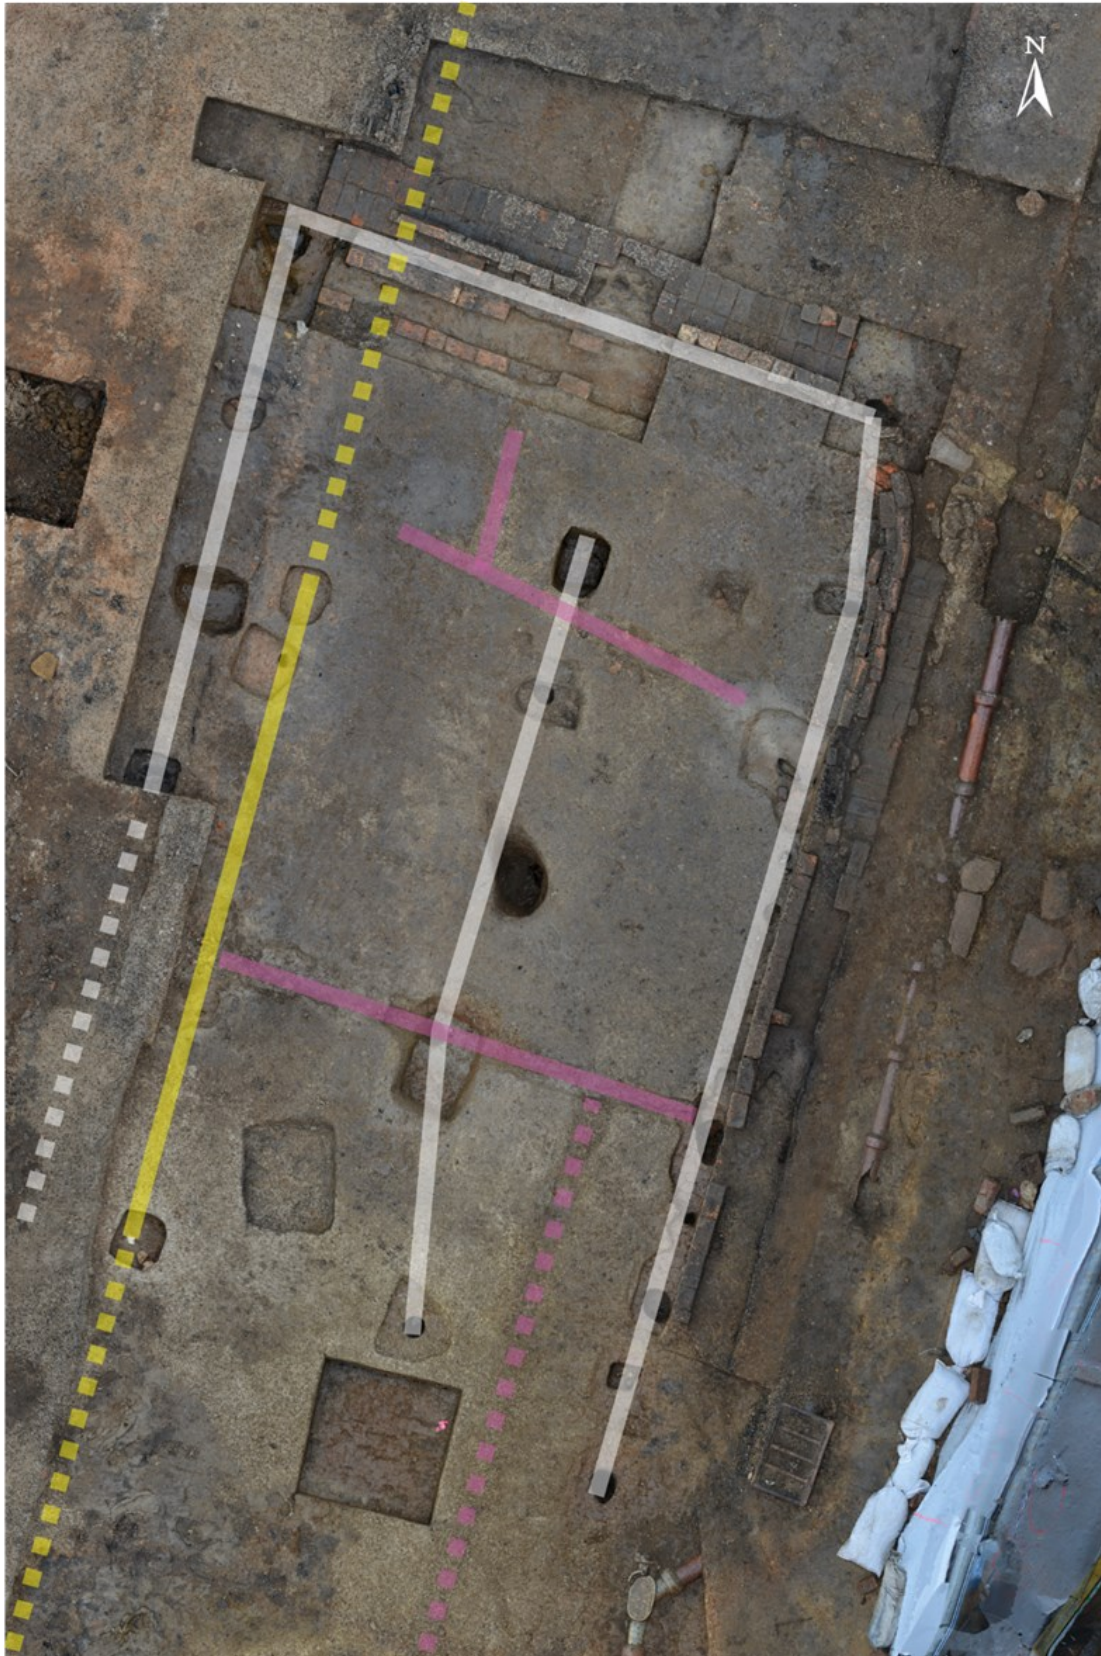
Figure 7.6: Orthophoto showing the different alignments of the postholes for the walls of the northernmost part of the stables and sheds (Structure 5) in white, the internal dividing walls in pink and the postholes believed to be the earliest boundary fenceline in yellow. The inferred extensions of the walls are dotted.

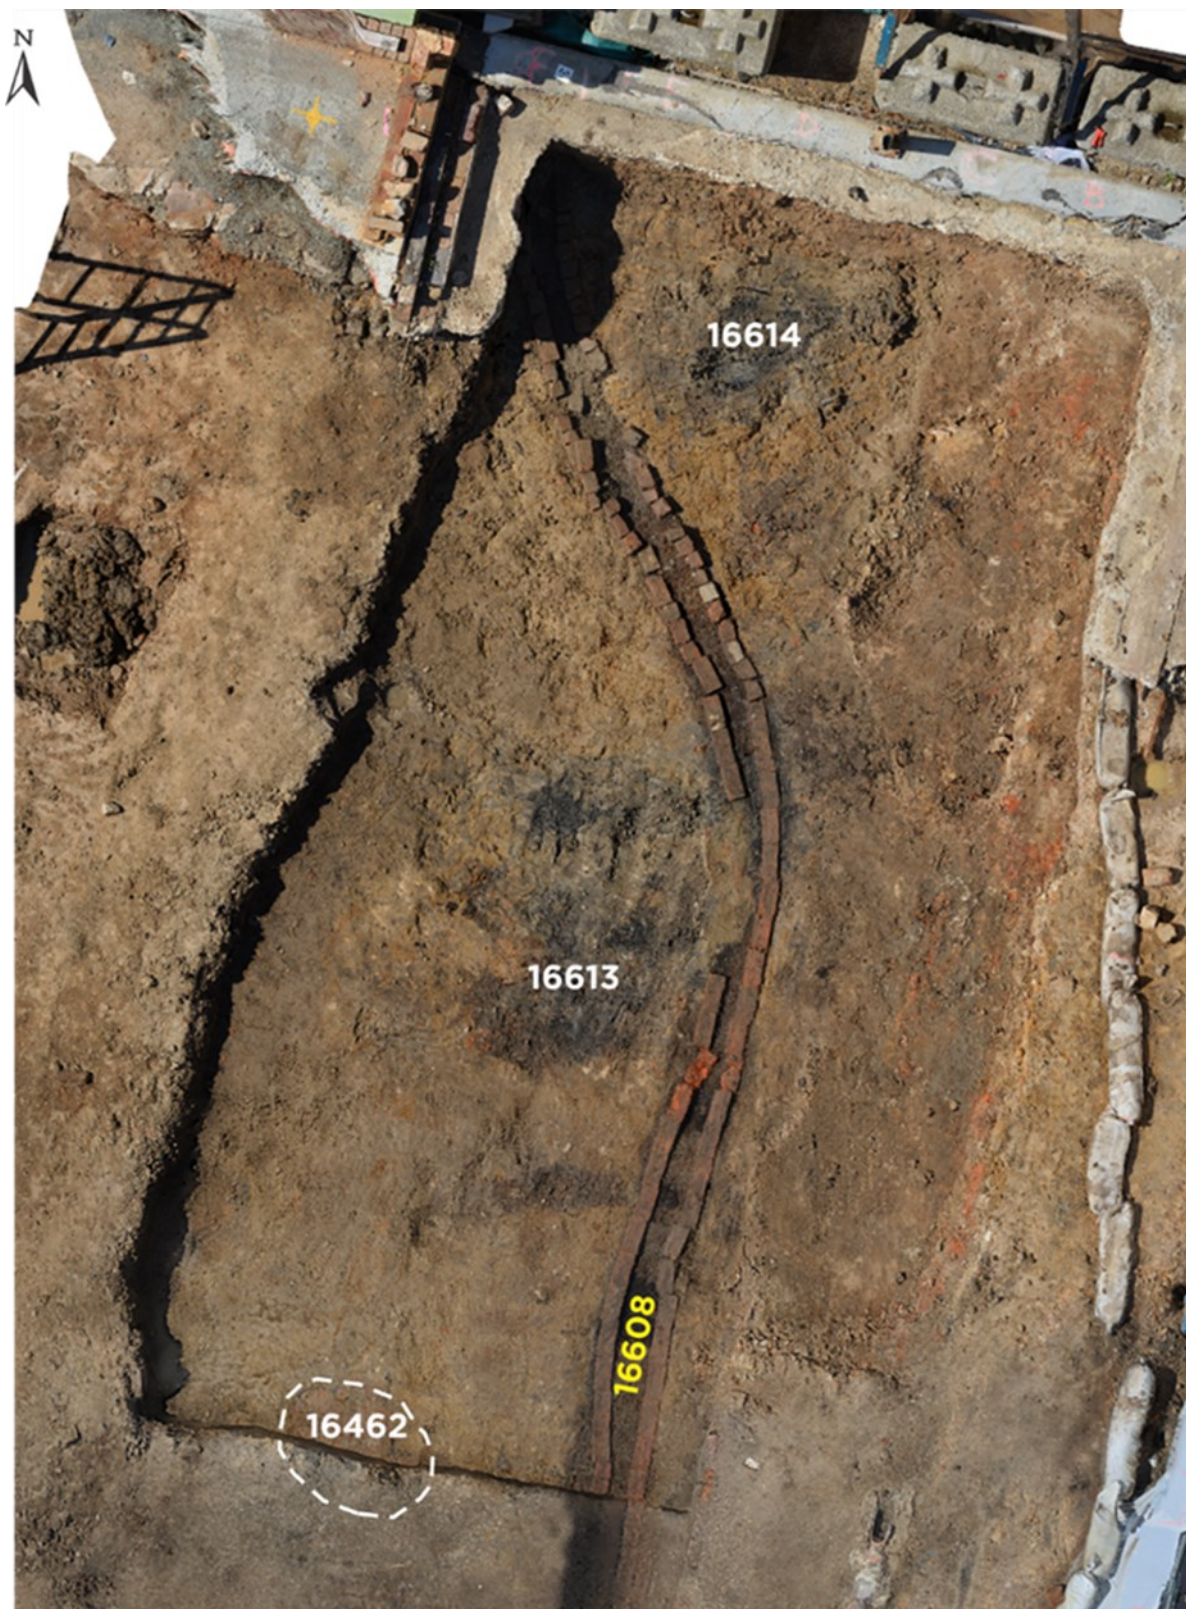
Figure 7.7: Orthophoto showing location of three tree holes in the northwest corner of Lot 32/Area C in relation to the serpentine drain 16608.

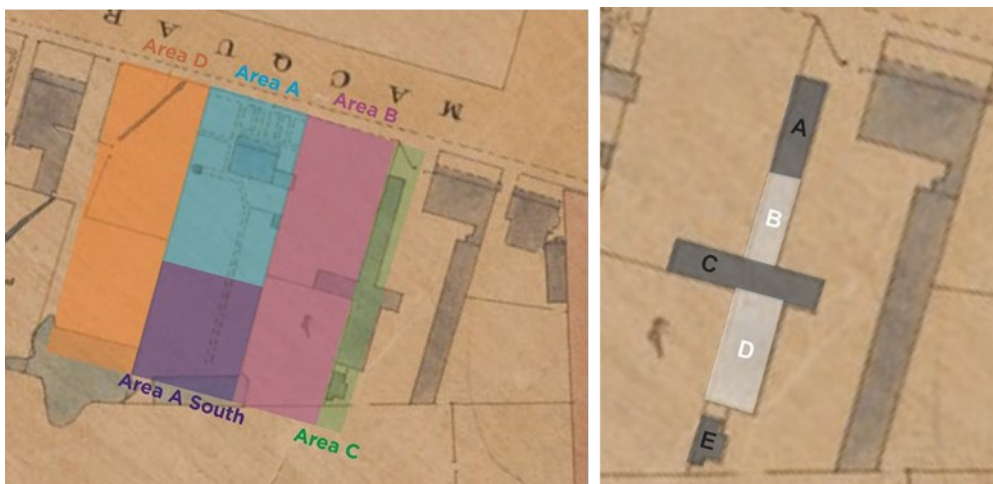
Figure 7.10: 1858 baseplan showing the approximate location of the 3PS excavation areas (left) and the discrete sections of the stables and sheds labelled A to E (right). The area to the east of Area C was excavated by GML Heritage as 1PS – 143-169 Macquarie Street in 2014-2015. North is to the top.

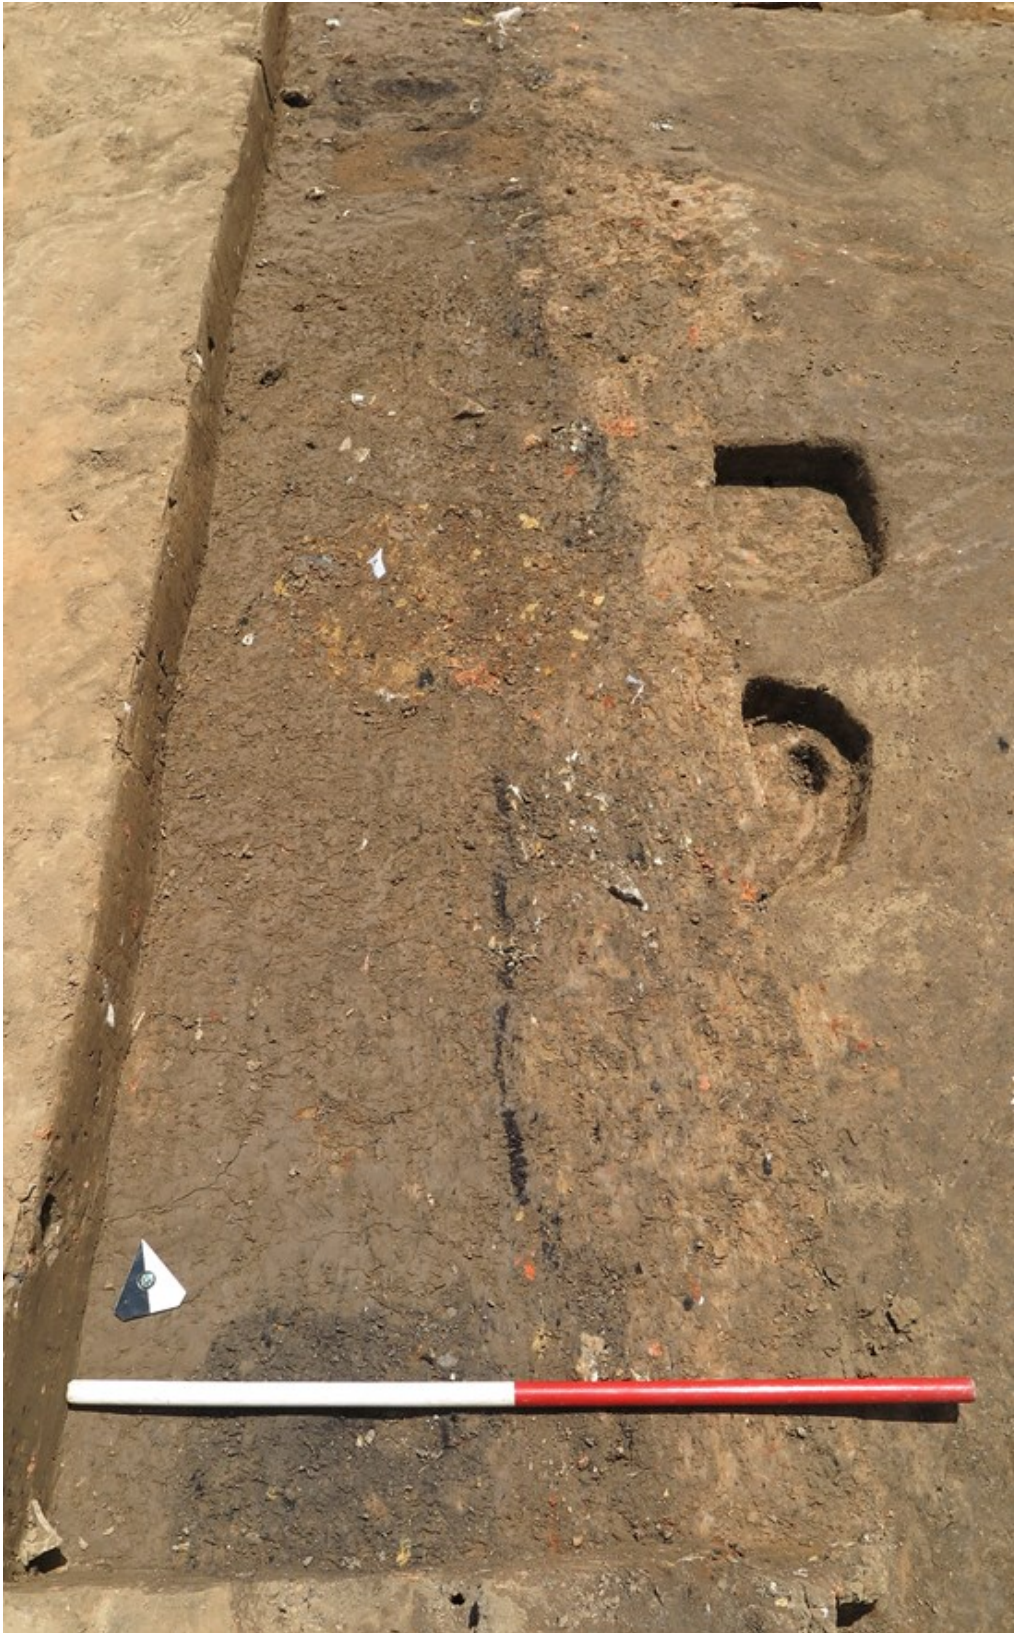
Figure 7.11: Photo taken after the removal of the dish drain, but prior to the excavation of the features below, showing a thin line of dark timber staining (unnumbered) along the western wall of Section A and a number of postholes. View to north, 1m scale. IMG_0595.

Investigation of the western row of postholes showed two sections of a faint, north-south linear stain (unnumbered) from decaying timber suggesting that at least the western wall of the shed was constructed of post-and-plank, or timber slab walls (Figure 7.11). This construction technique is where the space between the postholes is infilled with timber planks (set vertically), or timber boards (set horizontally). Alternately, the staining could be the decayed remains of a timber baseplate however, as the stain was relatively narrow, it is more likely to be from the edge of a single timber board. The fact that the timber staining is extremely narrow may also be evidence that the infill timbers were laid horizontally rather than vertically. The postholes that formed the western wall of the shed were only revealed after a section of the later dish drain (16421) was removed, meaning only the six most northerly postholes were uncovered and recorded, as well as a section of timber staining (Figure 7.11). The southern section of the western wall was not investigated, although it is assumed to be the same as the northern section. Two pairs of postholes were very close together, suggesting they may have been repaired, recut or reinforced, although

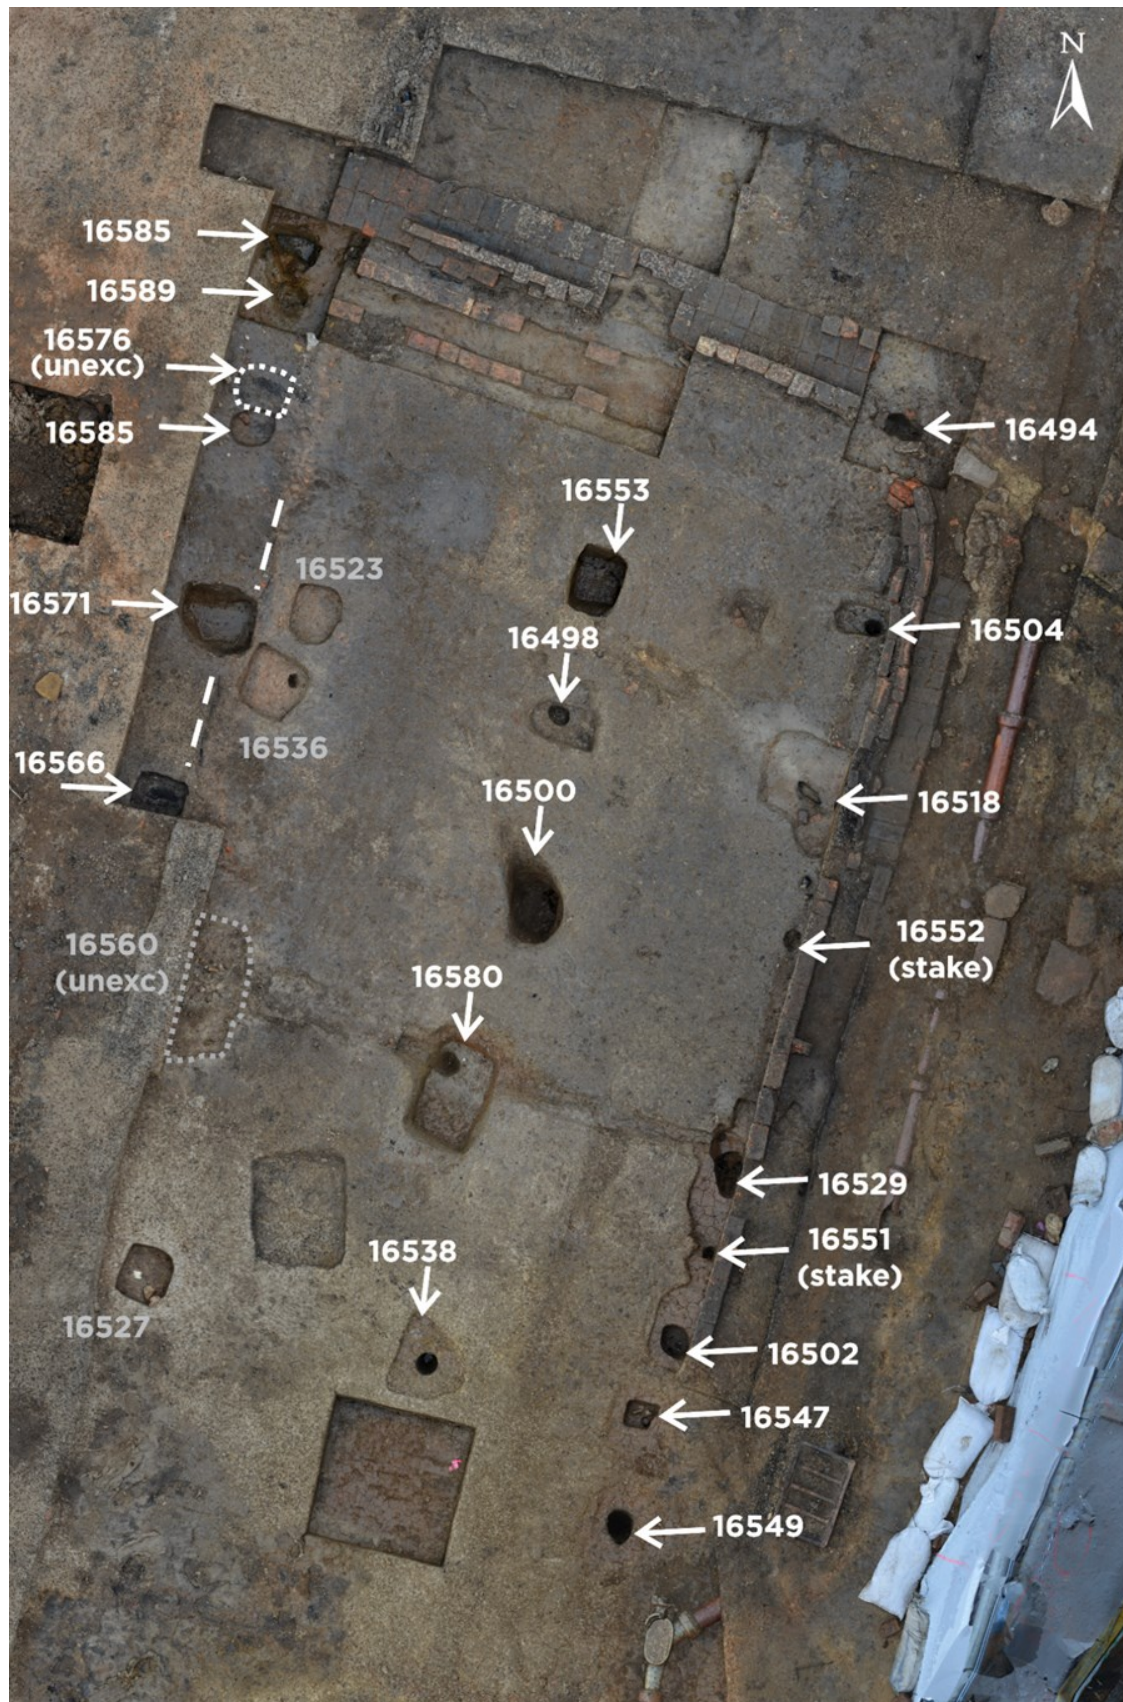
Figure 7.12: Orthophoto showing the various postholes (numbered in white) forming the west wall (left), central wall and east wall (right) of Section A of the stables and sheds. The unnumbered linear timber stain is dashed in white. The postholes associated with the earlier fenceline are numbered in grey.

The postholes that formed the central wall of the structure were generally larger, and much deeper than the other two walls. No linear timber staining was noted in between the central postholes, so it is not clear whether the central wall was solid (with horizontal slabs), or simply a row of posts (with gaps in between). It is possible, but highly unlikely, that the central row of postholes is another north-south fenceline or other type of non-structural linear feature, such as a line of hitching posts for horses, and not associated with the shed structure at all, but the equidistant spacing between the three rows suggests that they are contemporary, even if the actual function of the central row remains uncertain. The details of these postholes are given in Table 7.4 below and illustrated in Figure 7.12.

Smaller, more closely-spaced postholes made up the eastern wall of the structure, including at least two tiny stakeholes (16551 and 16552). Entry or access to this outbuilding or shed must have been through this wall, as it opens onto the yard of the White Horse Inn. The entry may either have been through any number of designated, built doorways, or the entire eastern side of the building may have been open. The identification of more closely-spaced postholes and stakeholes in the southern part of this wall may be due to a different type of construction, or a number of different repairs to a doorway or panel in this area, although this could not be firmly established. The details of these postholes are given in Table 7.5 below and illustrated in Figure 7.12.

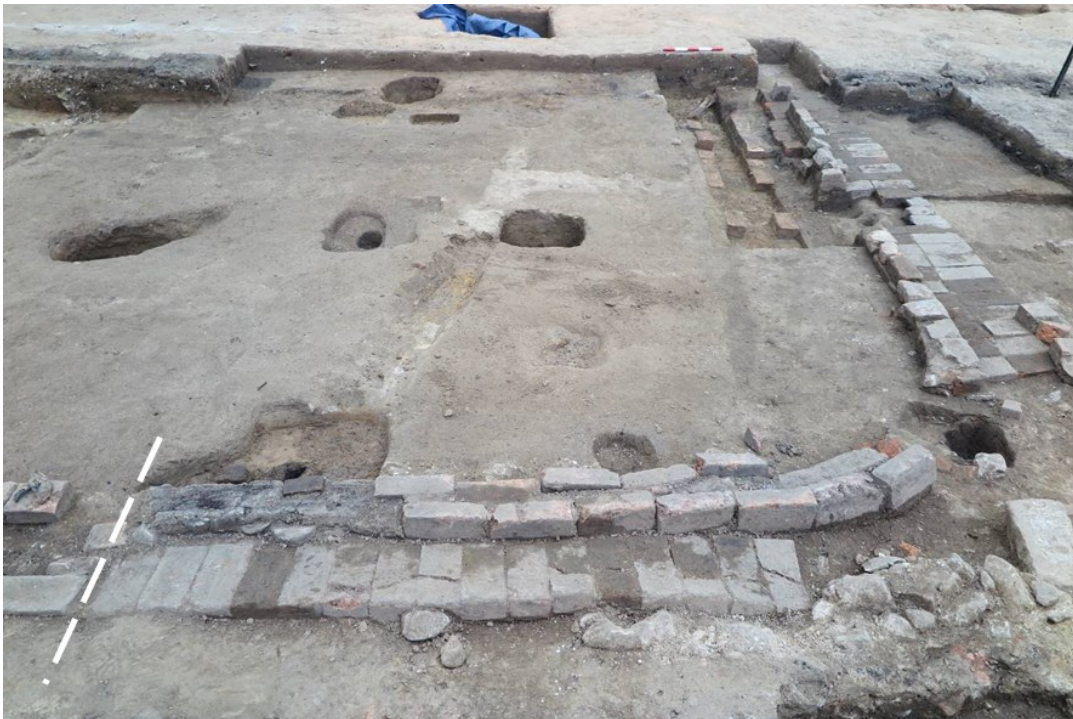
Figure 7.13: Photo showing the sandstock brick gutter context 16471 along the northern (right) and eastern (foreground) exterior sides of the outbuilding/shed. The intersection between the gutter (16471, right) and the drain (16662, left) is dashed in white. View to southwest, 500mm scale. IMG_0643.

A gutter or shallow drain below the drip line made from sandstock bricks (16471, BM Samples #22 and #23) ran along the outside of the northern side and northeastern sides of the structure, probably collecting the water run-off from the roof or eaves (Figure 7.13). The east-west running part of the gutter measured 3.3m long x 500mm wide. Two rows of bricks, laid head-to-head, created the flat base of the gutter, and a second course of half or broken bricks laid along the southern side formed an edge to prevent water running into the interior of the structure. Some of the edging bricks to the west consisted of half-bricks laid on their ends (Figure 7.14), while those to the east were laid flat.

The same gutter turned at the northeastern corner and continued south along the eastern side of the building for roughly 3.9m. Along the eastern side, the gutter was 450mm wide and consisted of a single row of bricks laid flat to form the base and an upper course of two rows of edging bricks laid on their sides. Towards the south, the gutter transitioned or intersected with a brick, timber and sandstone drain (16662, discussed in Section B below). Unfortunately, the precise area where the gutter and drain would have intersected had been badly damaged, so the exact relationship between the two had been lost.

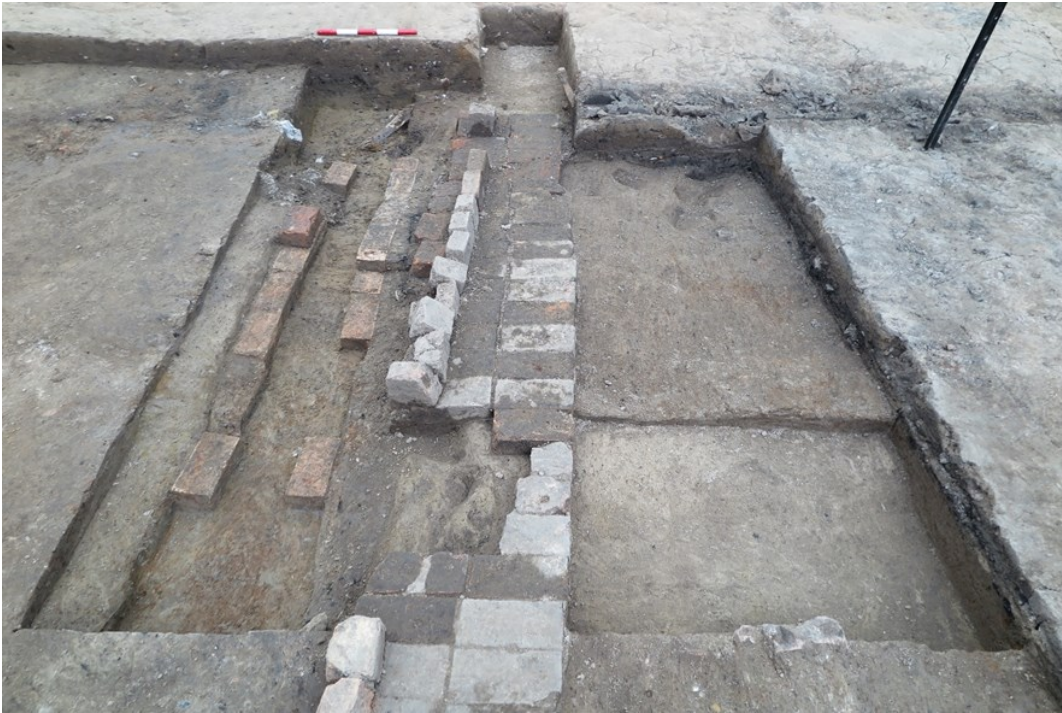
Figure 7.14: Photo showing how half-bricks were used to form the southern edge of the gutter along the northern side of Section A (centre). Cut 16562 and bricks 16563 of an earlier drain can be seen on the left. View to west, 500mm scale. IMG_0638.

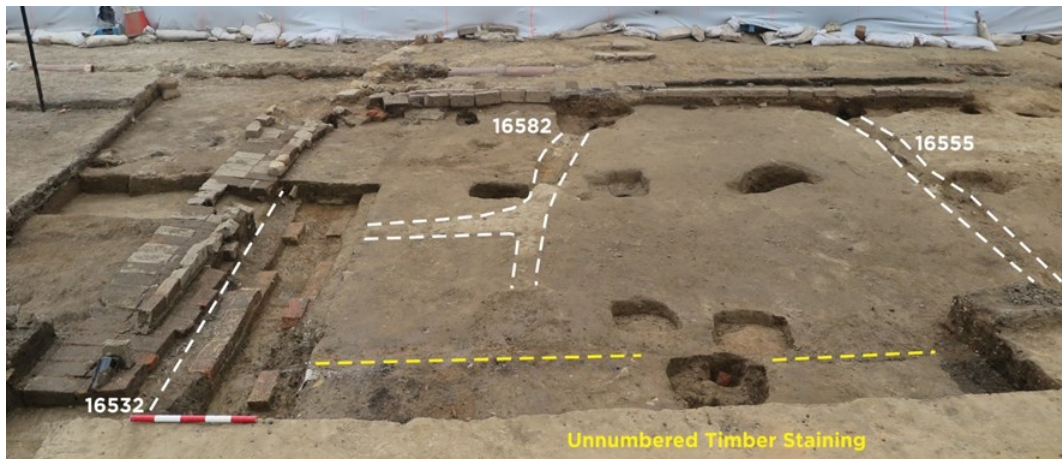
Figure 7.15: Photo showing the two east-west running cuts or impressions (dashed white). The unnumbered timber staining that formed the western wall is dashed in yellow. Photo taken looking east, 500mm scale. IMG_0640.

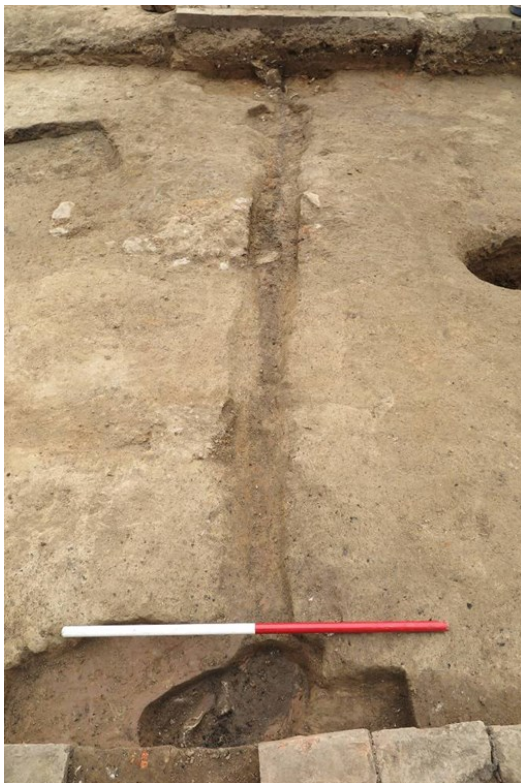
Figure 7.16: Photo of the southernmost cut or impression (16555) after the excavation of the decayed or burnt timber fill (16556) in the v-shaped base. One of the postholes of the eastern wall (16529) is visible in the foreground. View to west, 1m scale. IMG_0549.

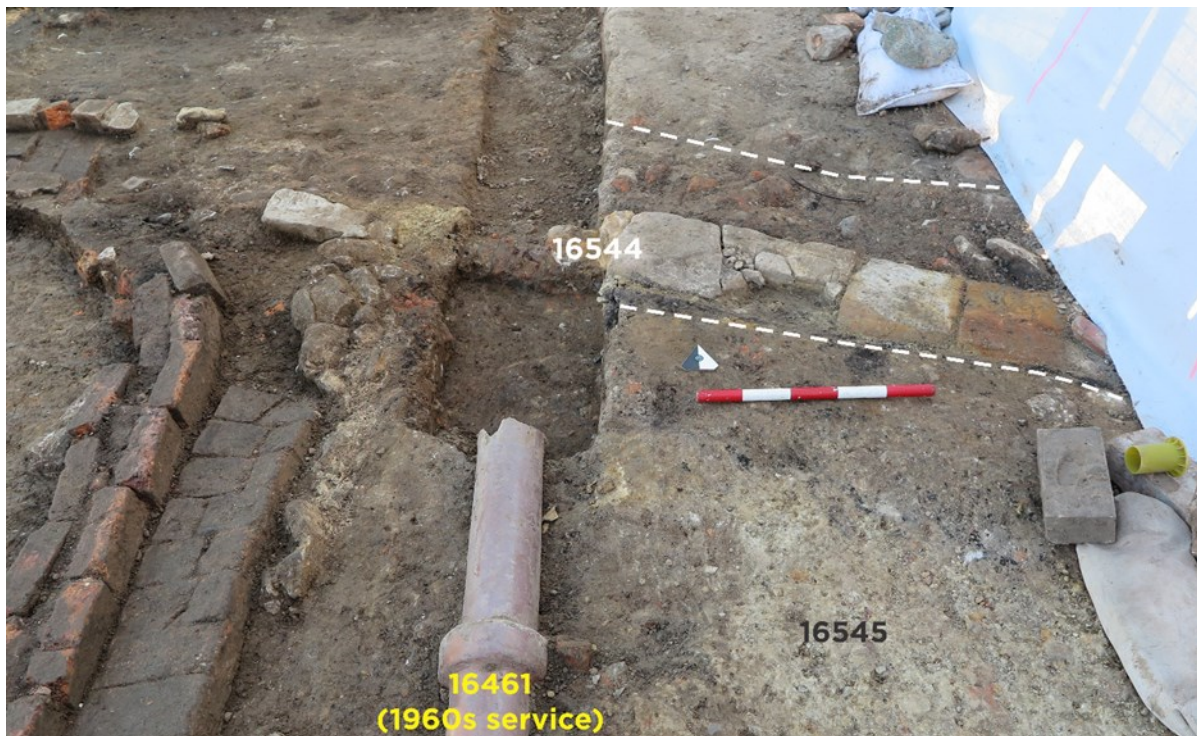
Figure 7.17: Photo showing the northernmost sandstone and timber feature 16544 and compact pale yellow surface 16545. The timbers set on edge are dashed in white. The feature was cut by the 1960s service trench. View to north, 500mm scale.
