3PS – 153 MACQUARIE STREET, PARRAMATTA

TRENCH REPORT – AREA C

JULY 2017

VOLUME 2, SECTION 7.3

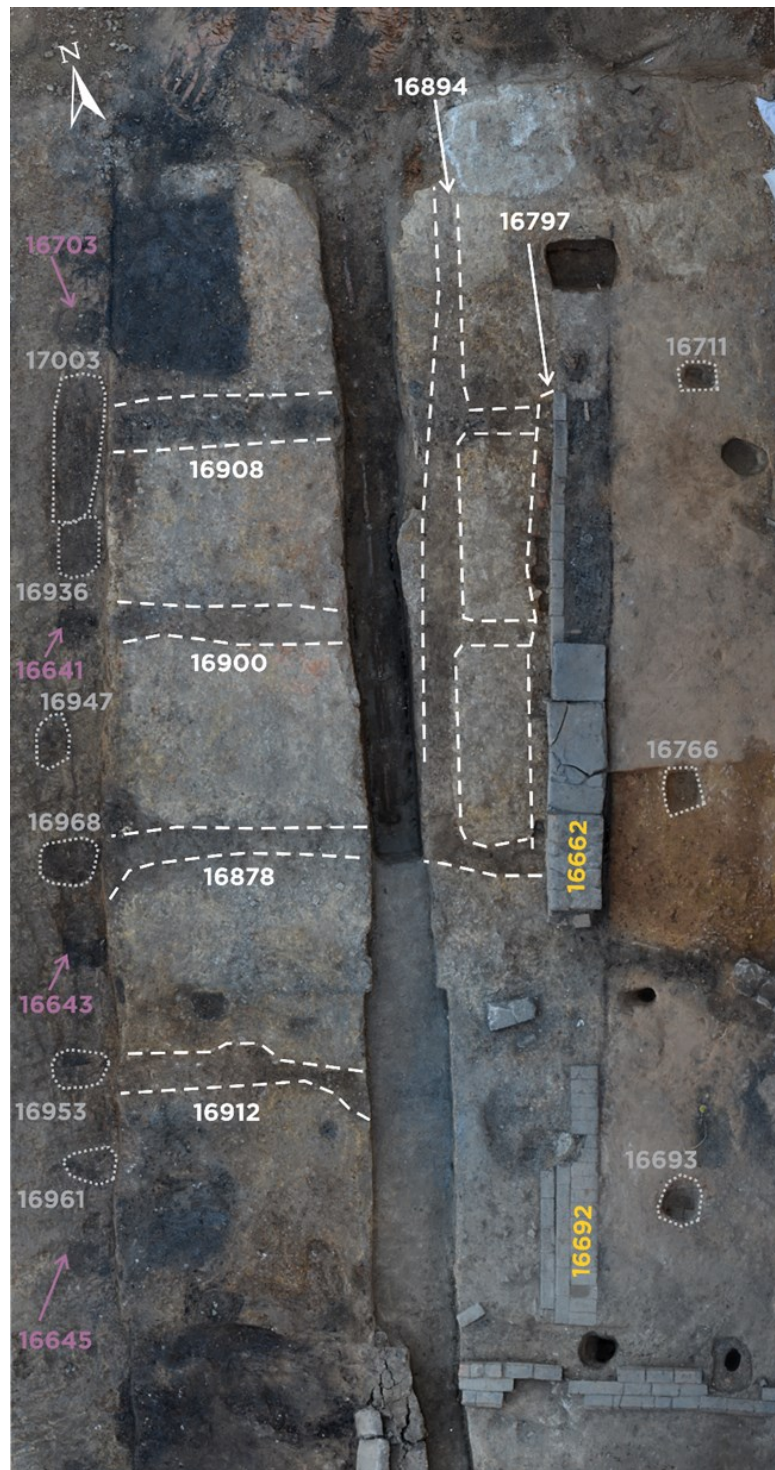
Figure 7.18: Orthophoto showing the postholes (dotted grey) forming the west wall (left) and possible eastern veranda (right), the linear cuts for the internal dividing walls (dashed white) and the gutter and drain along the east wall (yellow). The remnant bases of the later Phase 5.1 postholes are arrowed pink. North is at the top.

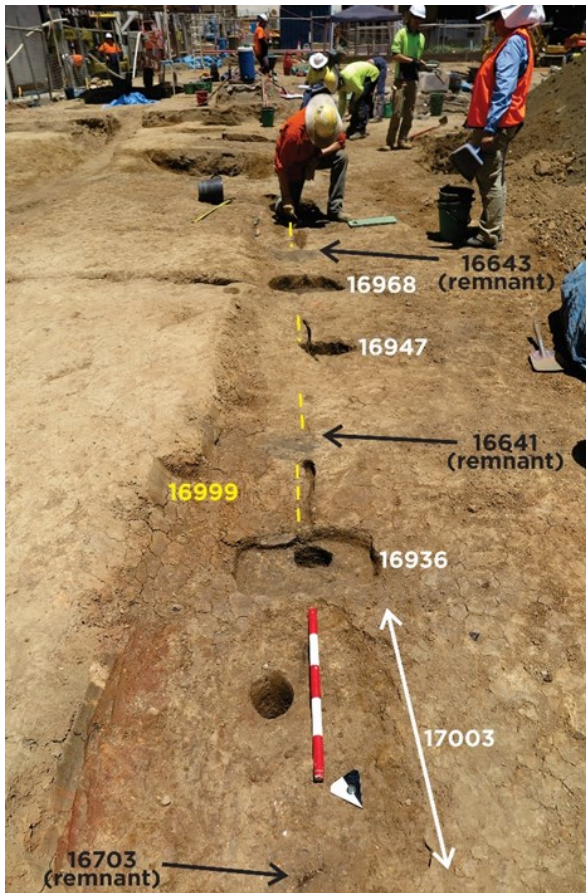
Figure 7.19: Photo showing the postholes (white) and linear cuts (dashed yellow) that form the western wall of Section B. The remnant bases of the later Phase 5.1 postholes are arrowed black. View to south, 500mm scale. IMG_1335.

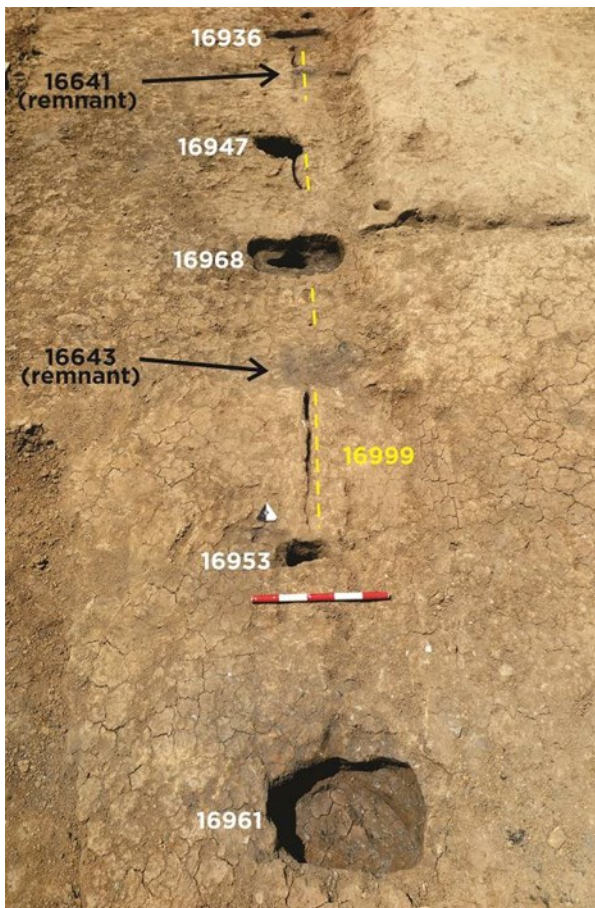
Figure 7.20: Photo showing the postholes (white) and linear slots (dashed yellow) that form the western wall of Section B. The remnant bases of the later Phase 5.1 postholes are arrowed black. View to north, 500mm scale. IMG_1340.

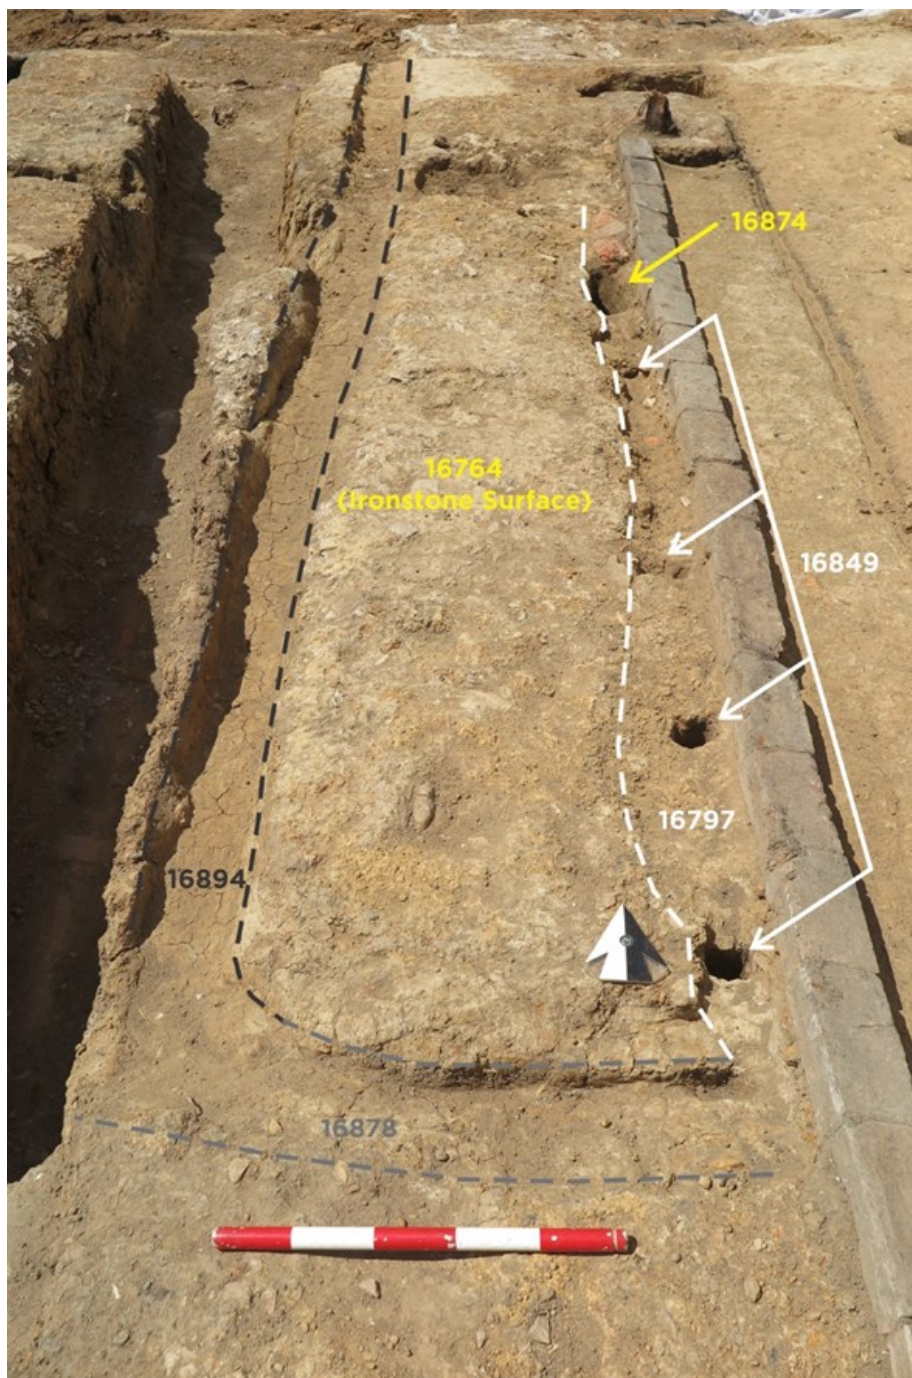
Figure 7.21: Photo showing the two north-south aligned wall cuts or slots. The interior slot (16894) is visible on the left. The eastern slot (16797, right) contained a single posthole (16874, arrowed yellow) and five stakeholes collectively numbered 16849 (only four stakeholes are visible, arrowed white). The row of bricks on the right was part of the covered drain (16662). View to north, 500mm scale. IMG_1216.

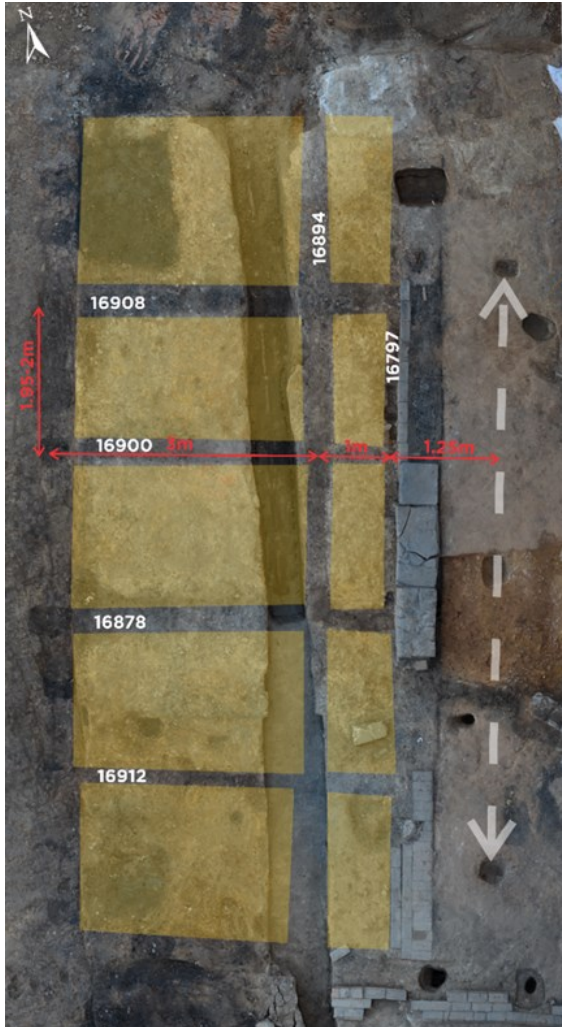
Figure 7.22: Orthophoto showing the internal spaces with ironstone surfacing (16764), adjusted slightly to show how the spaces would originally have been proportioned (yellow). The internal dividing wall cuts are labelled white and the overall space dimensions in red. The alignment of the possible verandah is dashed in white.

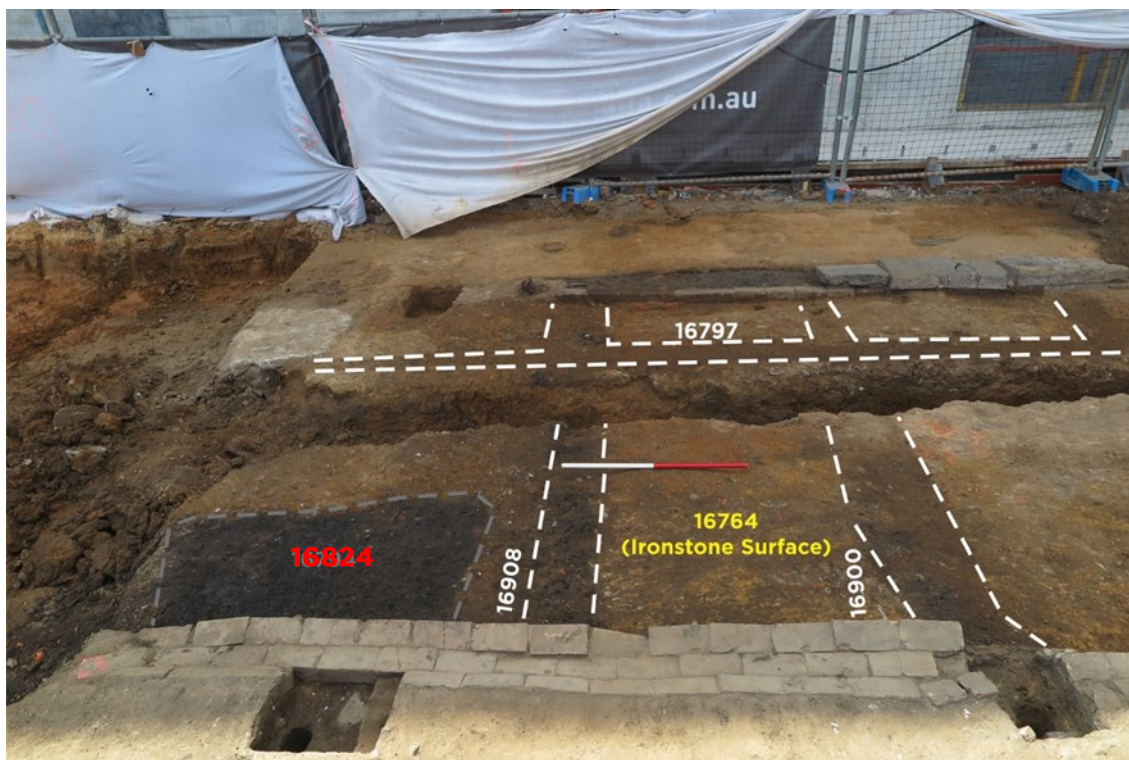
Figure 7.23: Photo showing the yellow ironstone, grey shale or mudstone and bright red crushed brick that made up surface 16764 just after they had been uncovered and the colours were brightest. The east-west dividing wall cuts 16908 (left) and 16900 (right) are also visible in the foreground. View to east, 1m scale. IMG_1069.

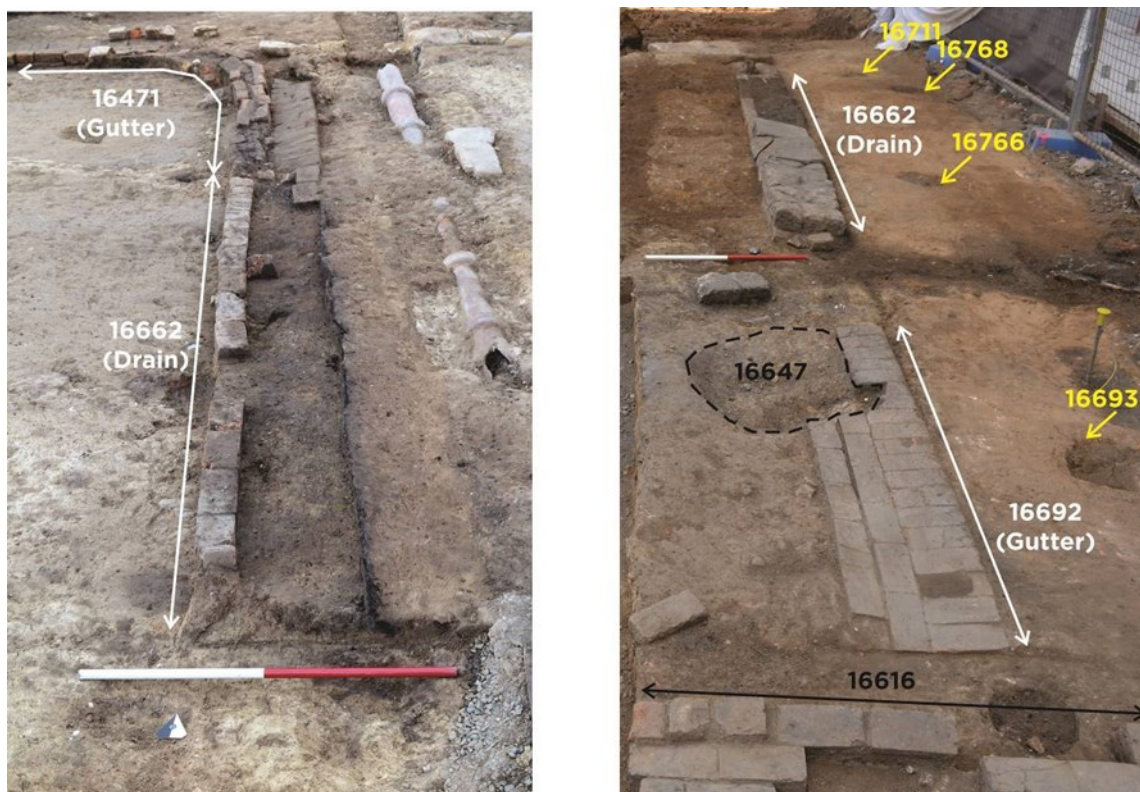
Figure 7.24: Photos showing the sandstone, brick and timber drain 16662 along the eastern side of Section A (left) and Section B (right). Note the intact sandstone capping on the southern end of the drain in Section B. The postholes that might be a possible veranda structure on the east side of Section B are arrowed yellow. Both photos view to north, 1m scale.

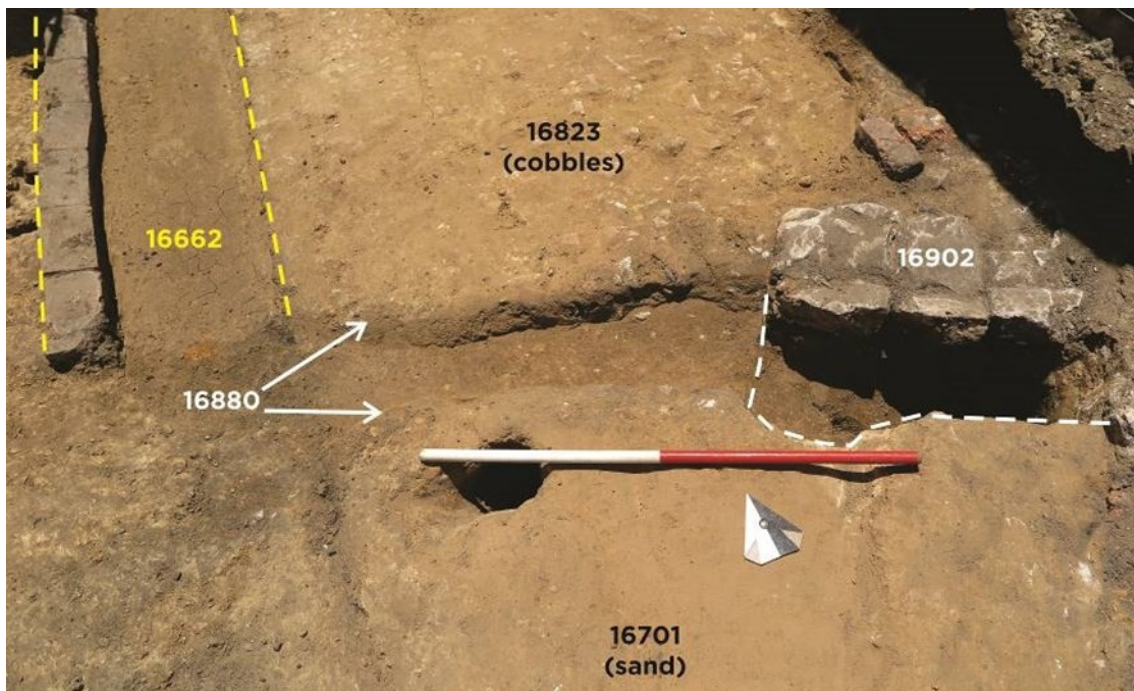
Figure 7.25: Photo showing the two cuts of the drainage feature 16880 (arrowed) and 16902 (dashed) in relation to the box drain 16662 (yellow). Note the sandstone cobbles 16823 on the north side and pinkish brown sand 16701 on the south side. View to north, 1m scale.

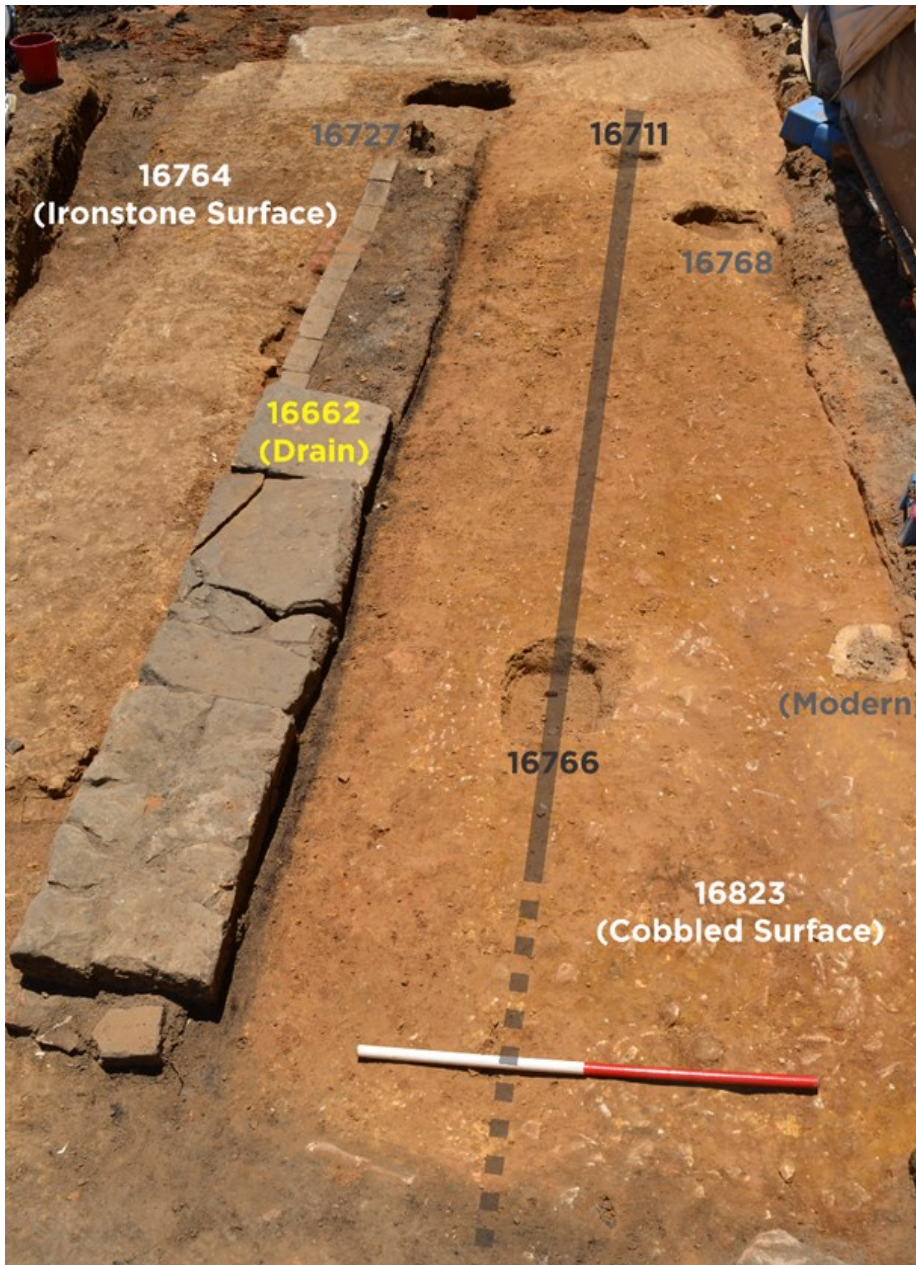
Figure 7.26: Photo showing the ironstone surface on the interior of Section B (left) and cobbled surface on the exterior (right). The postholes and line of the possible verandah is shaded black. View to north, 1m scale.

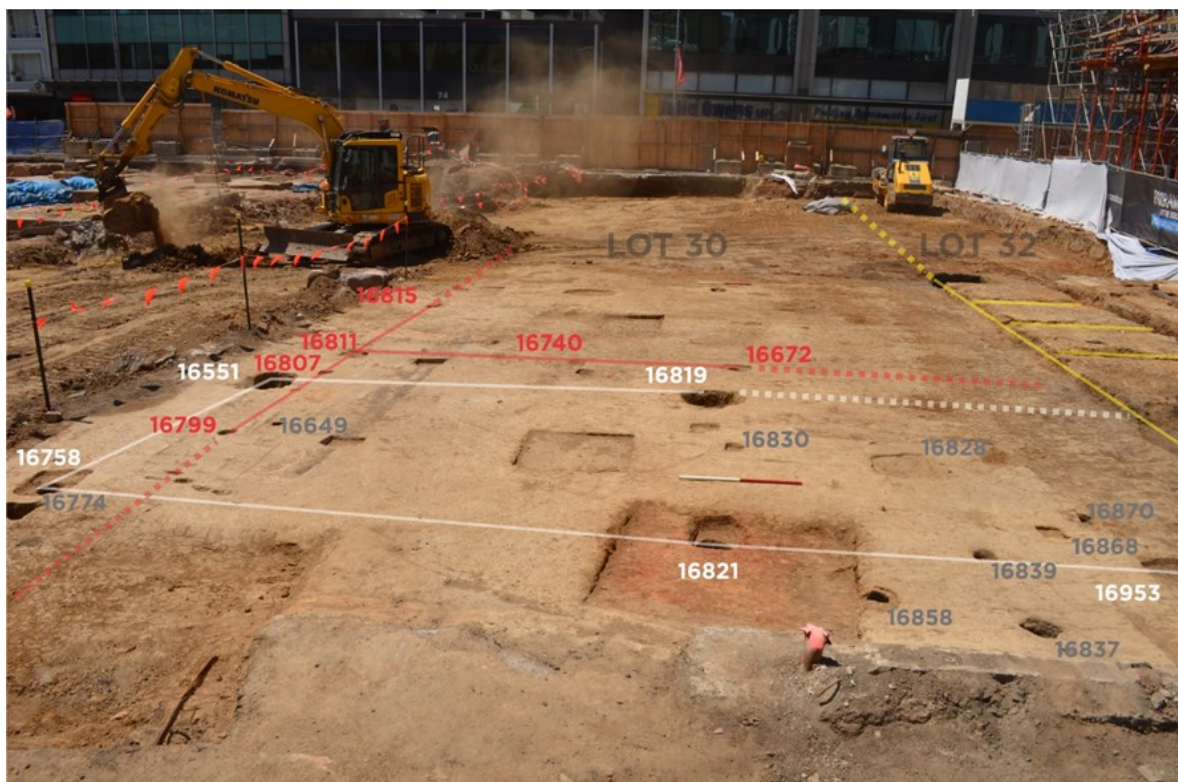
Figure 7.27: Photo showing the postholes forming the walls of Section C (white). Section B is shown in yellow, while later c.1870s fencelines are shown in pink. A number of postholes that do not appear to align with this structure are labelled grey. The inferred continuation of the structures are dotted. View to north, 1m scale. DSC_9285.

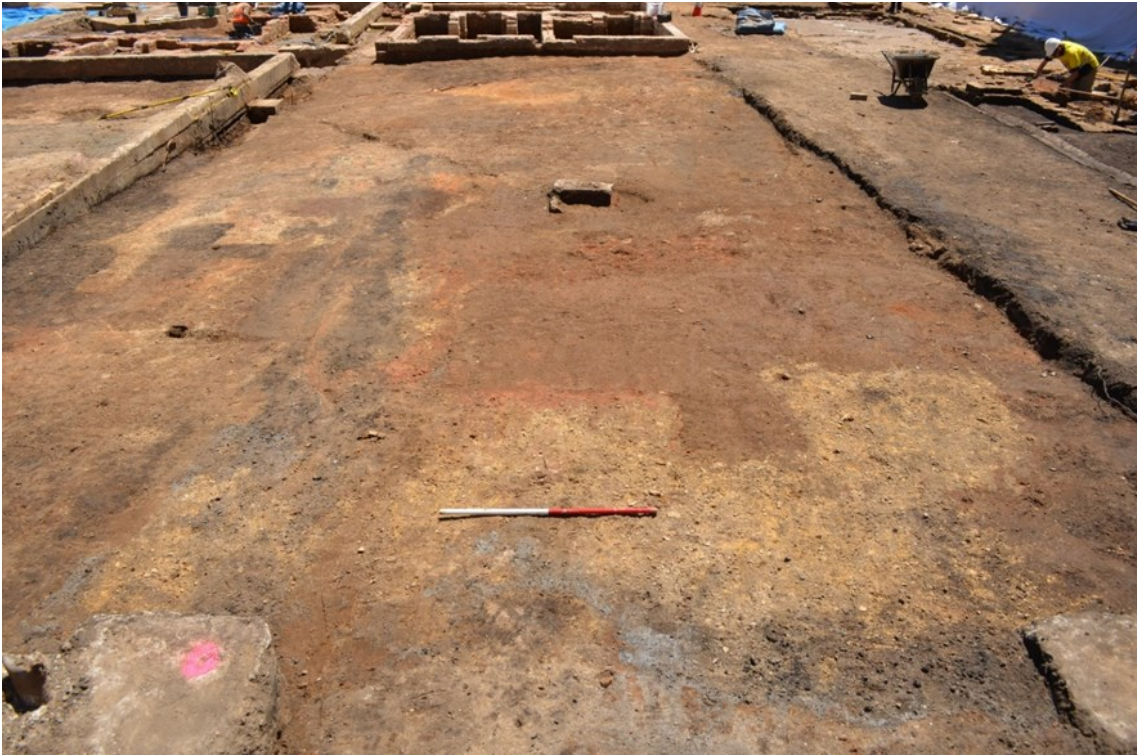
Figure 7.28: Ironstone surface 16595 or 16698 inside the footprint of Section C. The postholes that formed the walls of this structure were only revealed once the surface and some of the surrounding historic topsoil were machine excavated. View to north, 1m scale. DSC_9164.

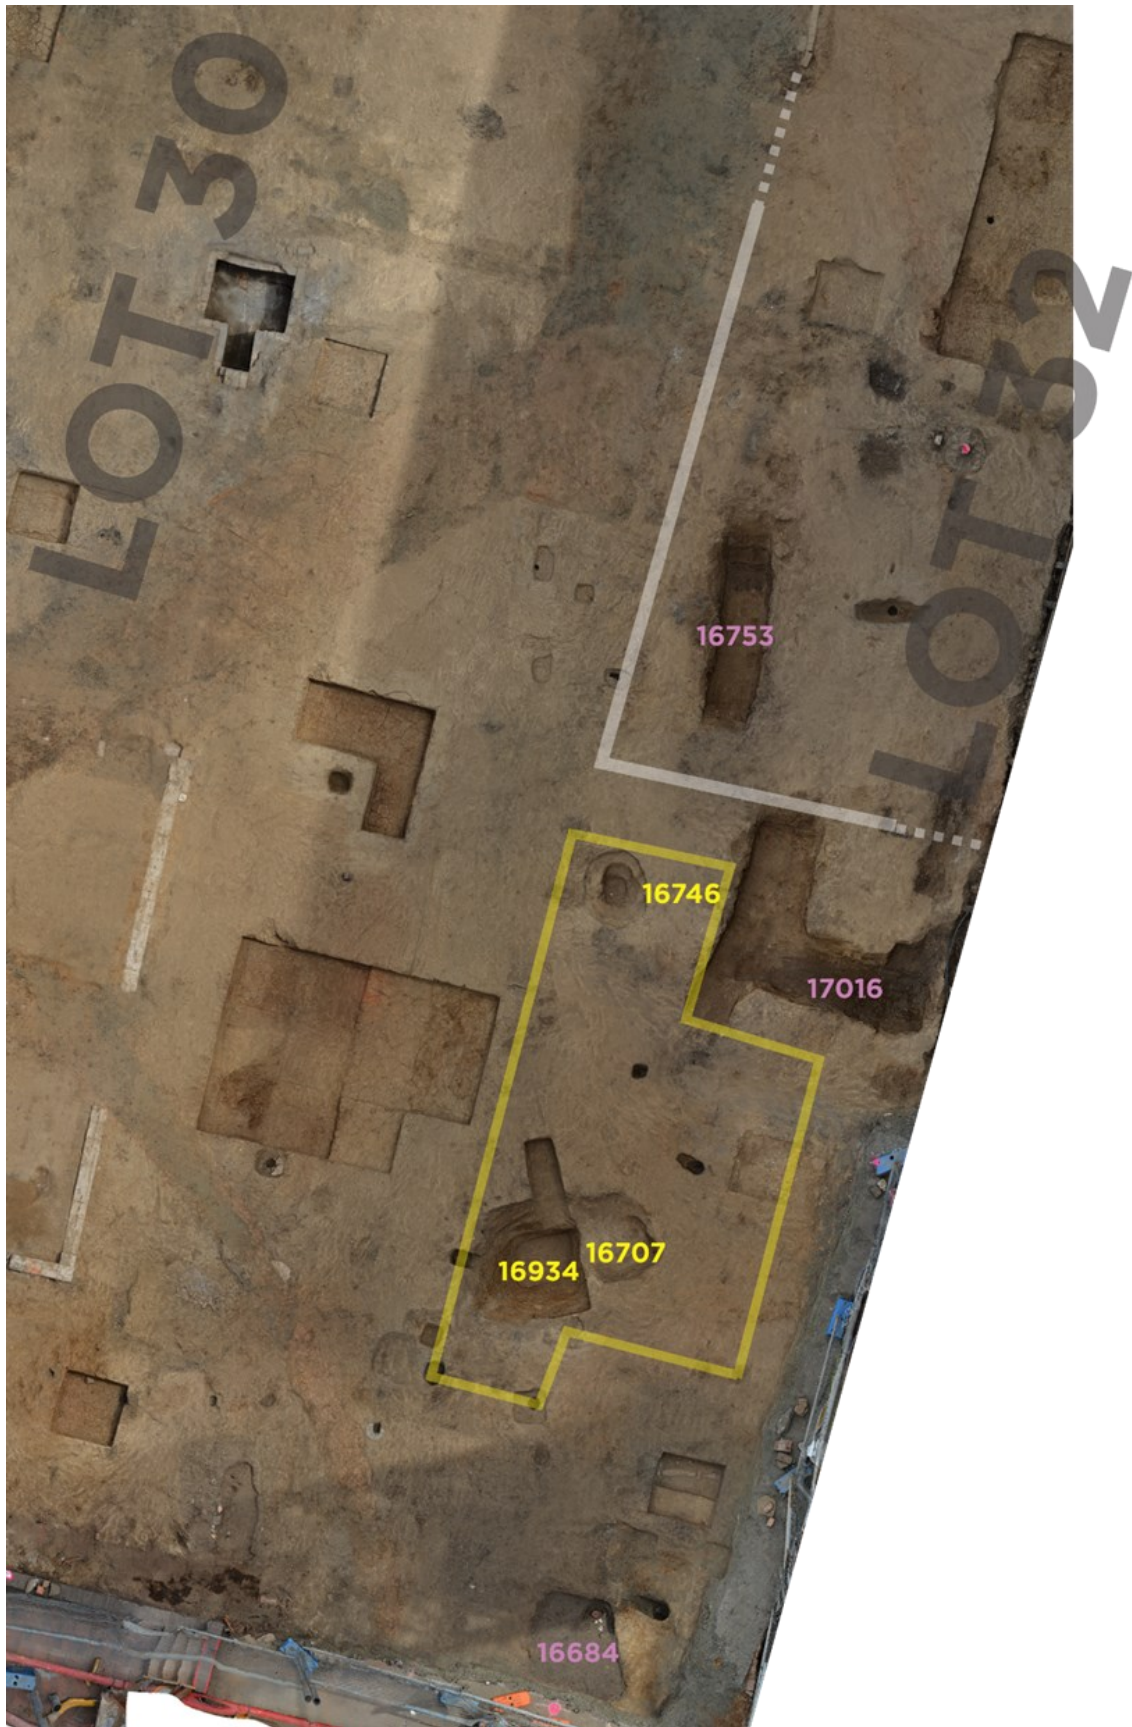
Figure 7.29: Orthophoto showing the approximate outlines of Section D (white) and Section E (yellow). Three 20th century pits are labelled in pink. The western walls of the structures likely formed part of the boundary fenceline between Lot 30 (left) and Lot 32 (right).

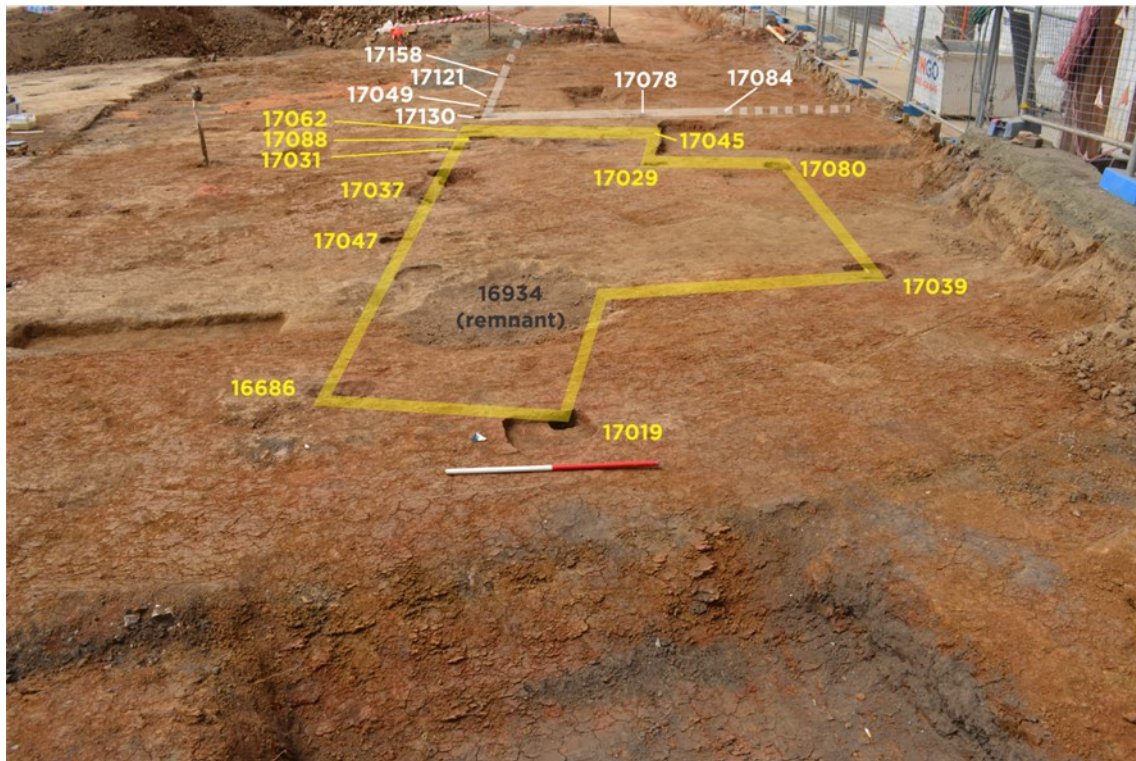
Figure 7.30: Photo showing some of the postholes for Section E (yellow) and Section D (white). The photo was taken after the area had been mechanically stripped to the red clay natural (16549), so postholes 16680 and 17043 (given in Table 7.12, Table 7.13) are no longer visible. View to north, 1m scale. IMG_1529.

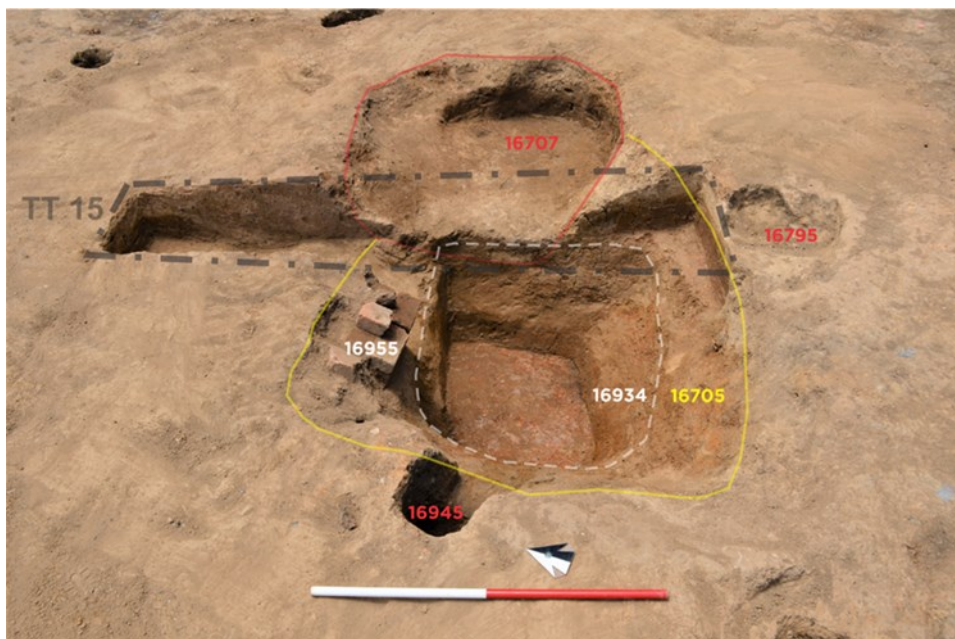
Figure 7.32: Photo of squarish pit and bricks of the original pit (white), with the later robber or demolition cut (yellow). These features were cut by two early-mid 20th century pits and a posthole (red). View to northeast, 1m scale. DSC_9322.

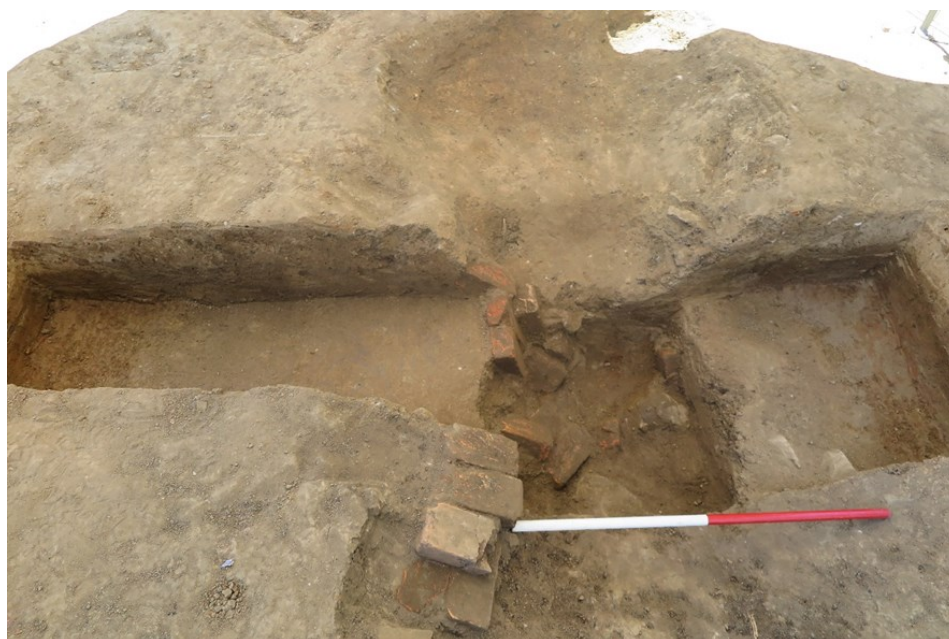
Figure 7.33: Photo showing the brownish grey fill 16755 in the centre of Test Trench 15. Note the high frequency of broken brick fragments. View to northeast, 1m scale. IMG_3745.

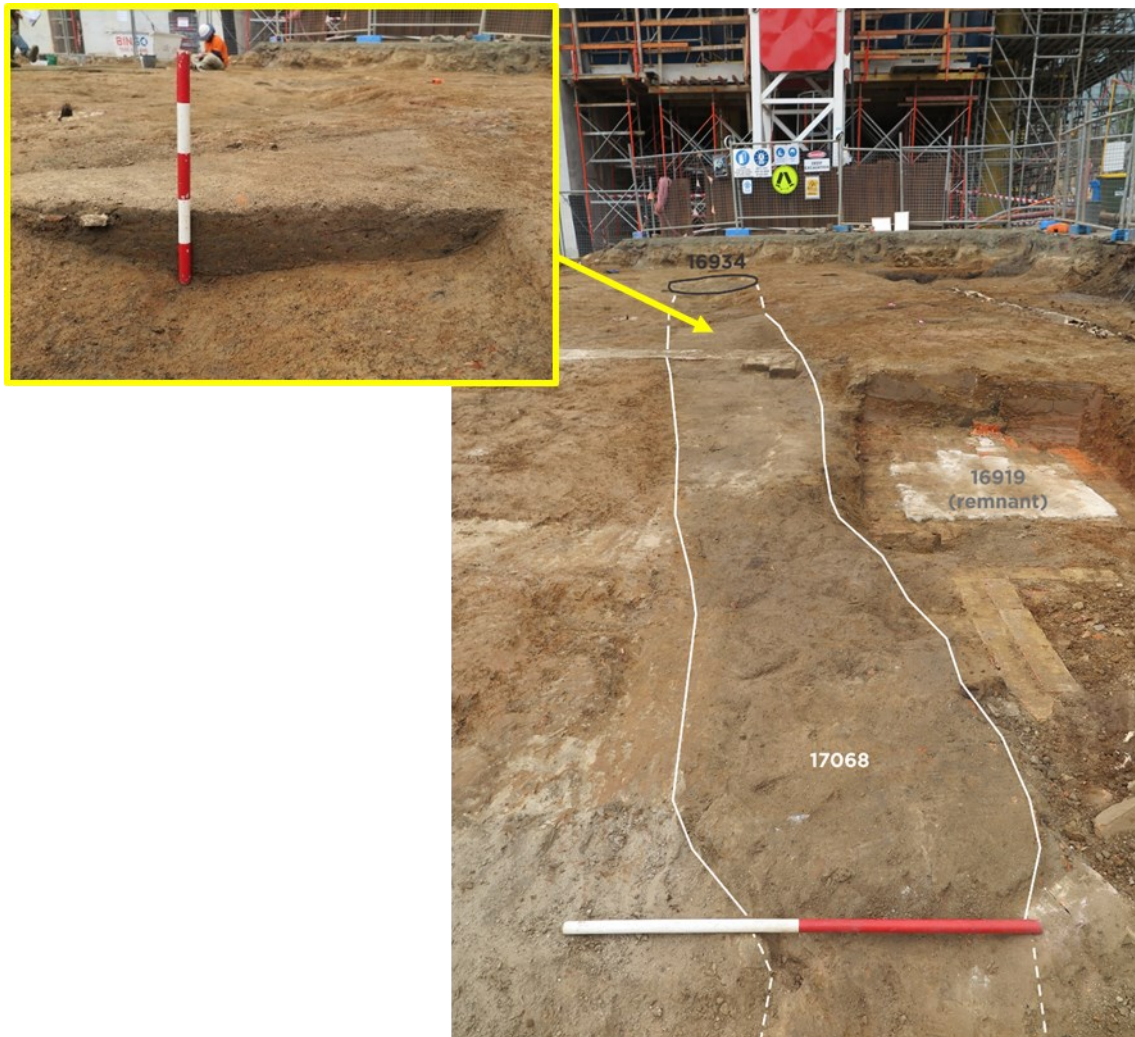
Figure 7.34: Photo showing the linear drainage channel (Area B) in relation to the cesspit 16934 (right) and west-facing section through the fills in TT 21 (above). Both photos view to east, 1m scale (right) and 500mm scale (above).

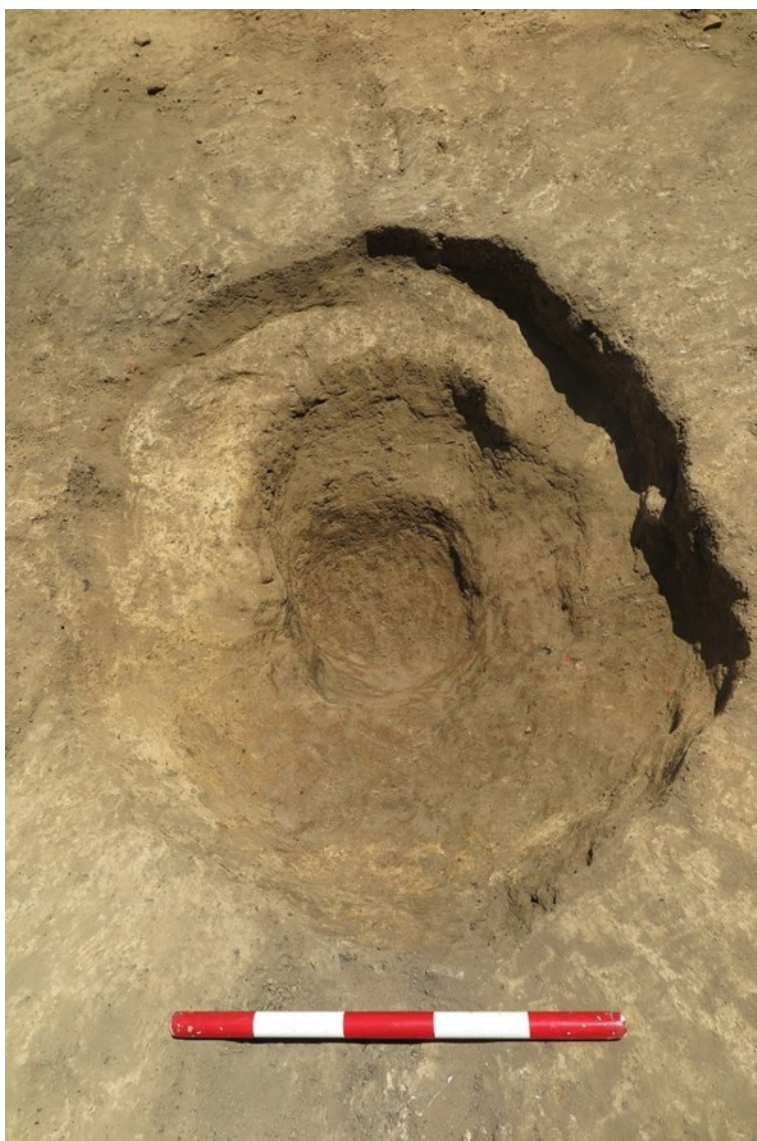
Figure 7.35: Photo of possible pit 16745 showing the different slopes of the sides. View to north, 500mm scale.

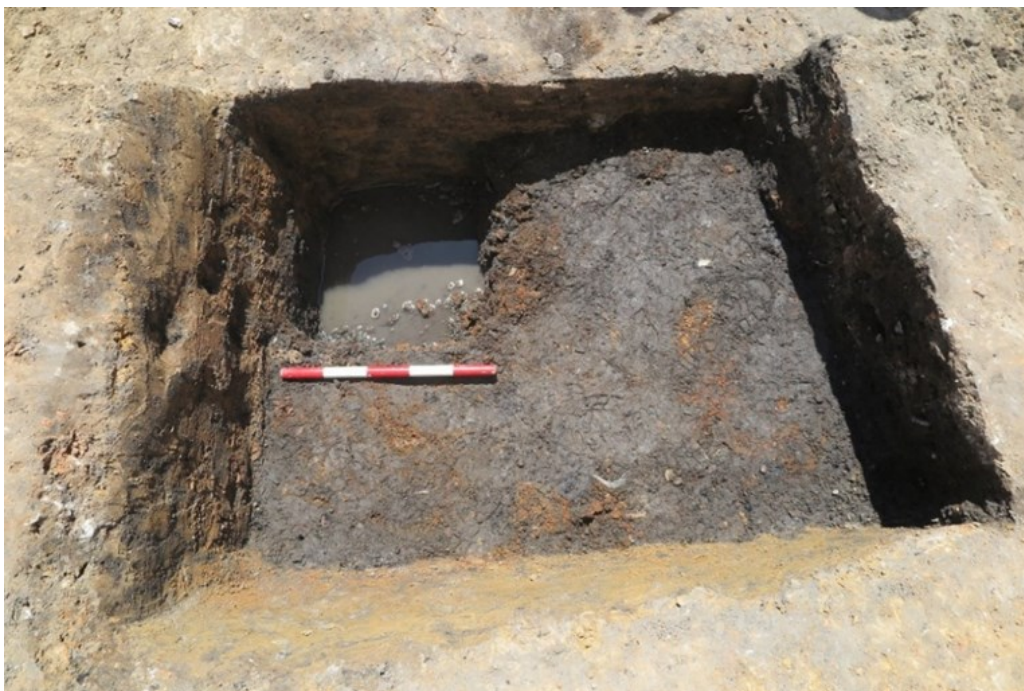
Figure 7.36: Cut 16824 of the northern pit, small sondage with water seepage through fill 16825. View to north, 500mm scale.

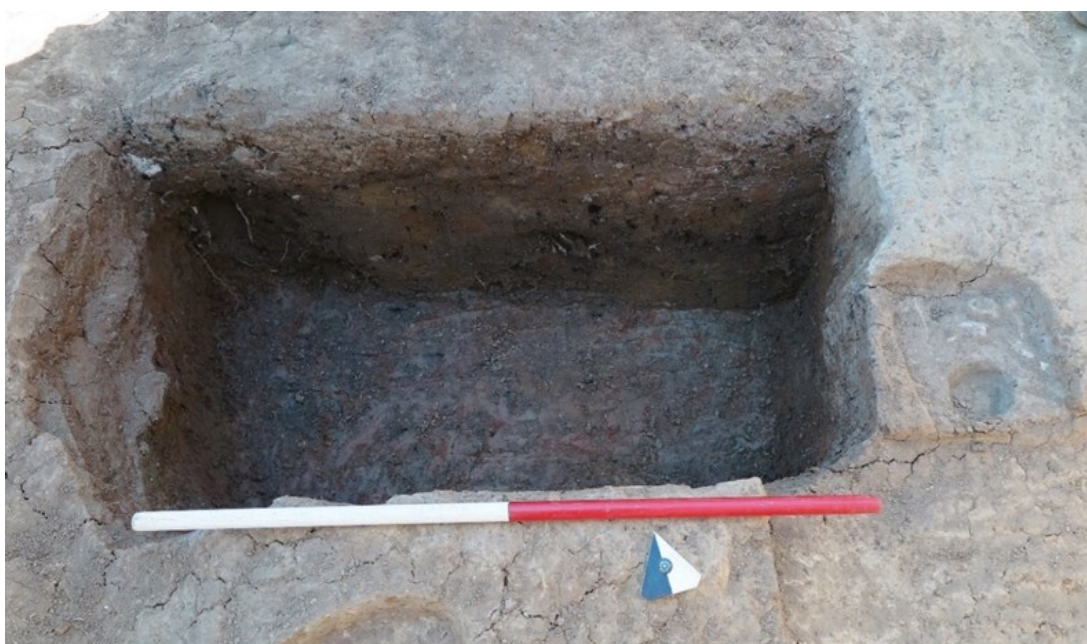
Figure 7.37: Cut 16930 and fill 16931 (half sectioned) and posthole 16956. View to north, 1m scale.

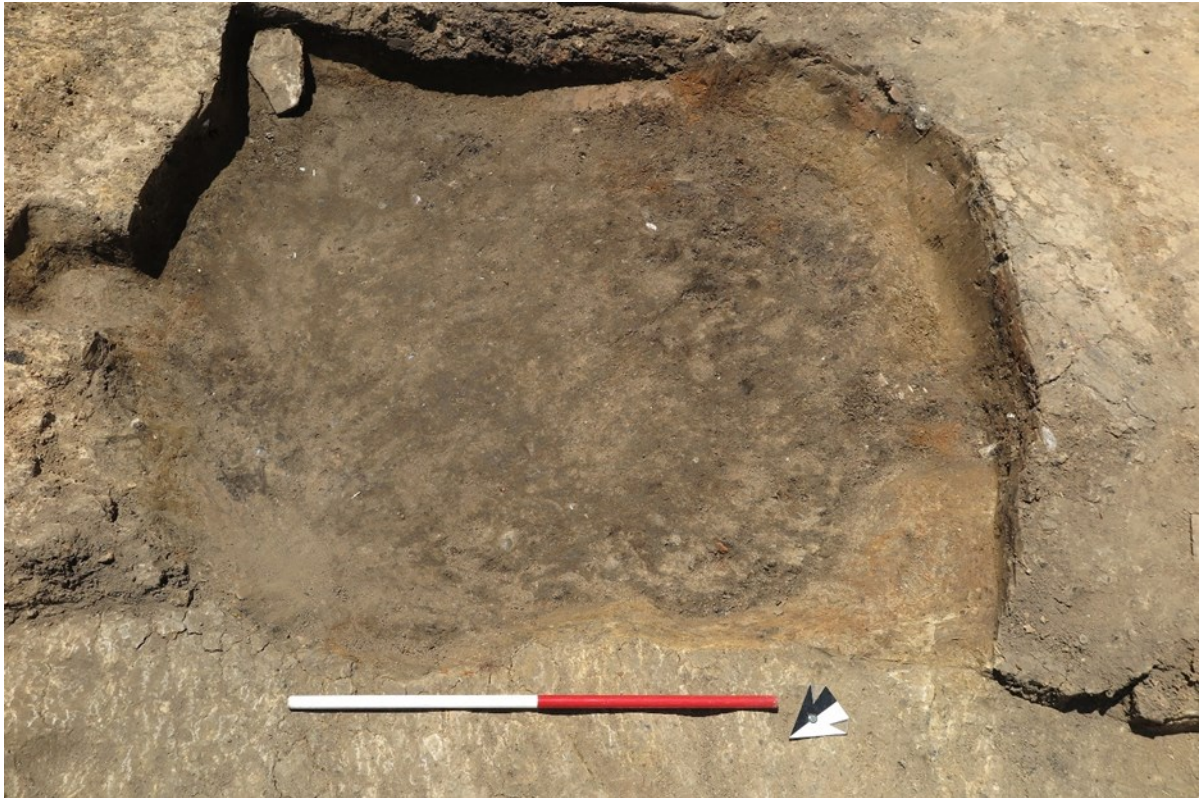
Figure 7.38: Photo showing irregular pit 16736 and possible posthole (left hand side). View to east, 1m scale. IMG_1171.

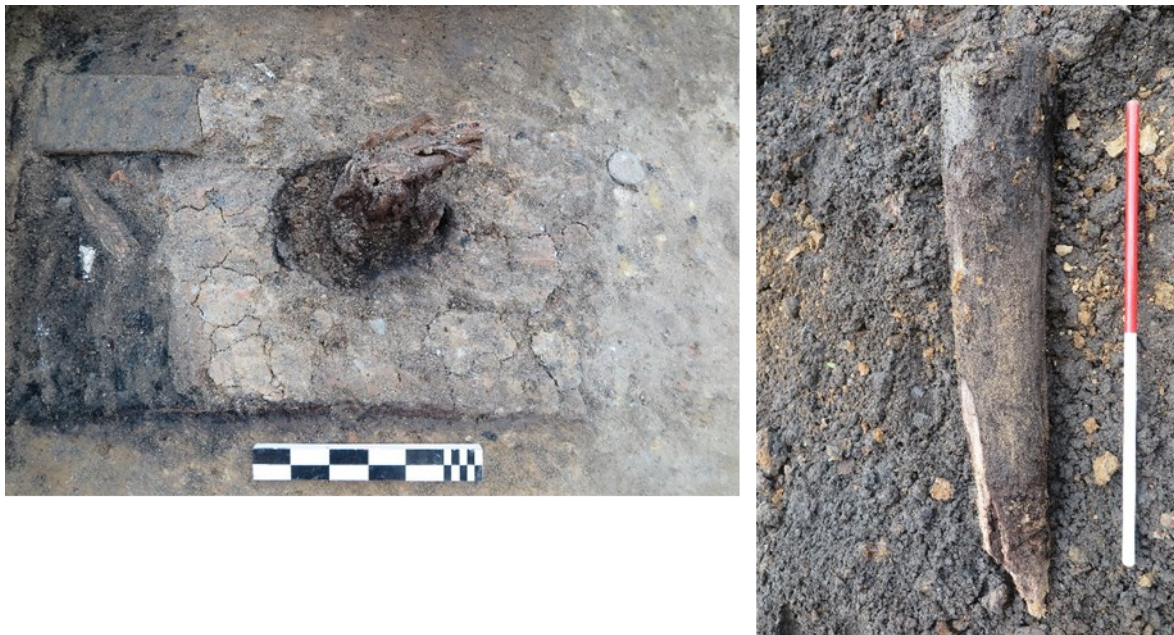
Figure 7.39: Photos of in situ post 16727 before excavation (left) and after machine excavation (right). Photo on left: view to northwest, 300mm scale, IMG_1042. Photo on right: detail, 1m scale, IMG_1220.

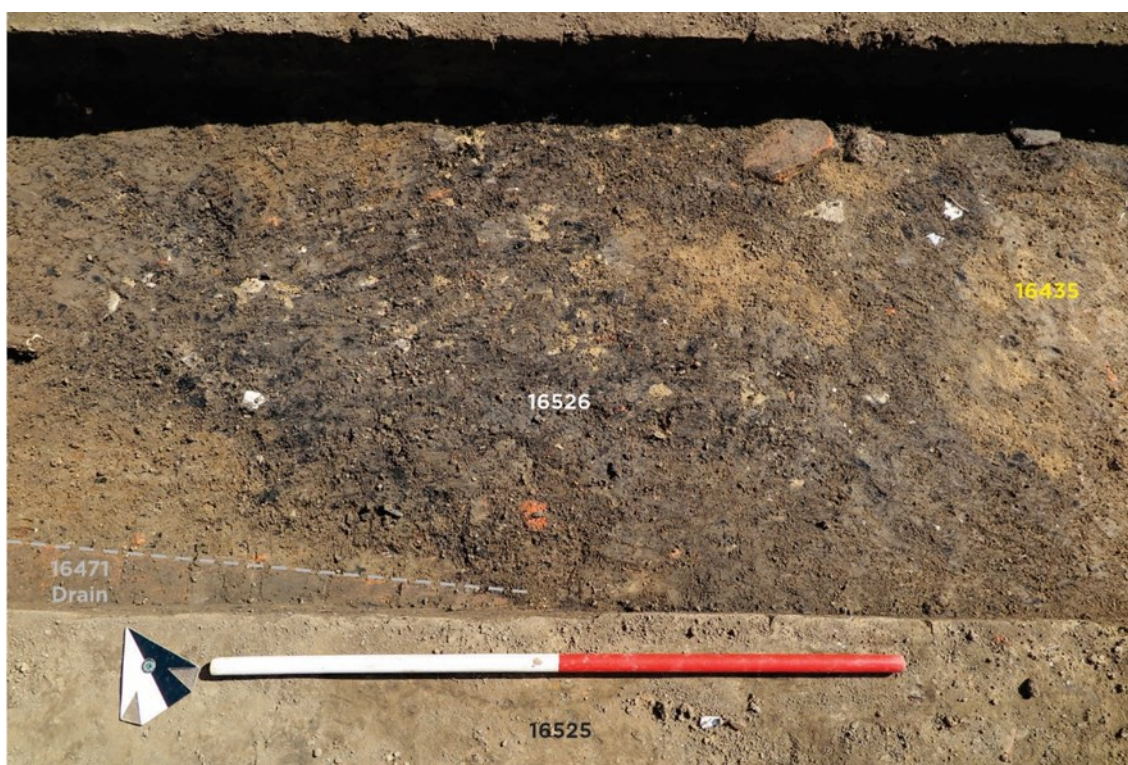
Figure 7.40: Photo showing lower fills 16526 and 16435 in Test Trench 5. Note the bricks of drain 16471 in the lower left corner. View to north, 1m scale. IMG_0114.

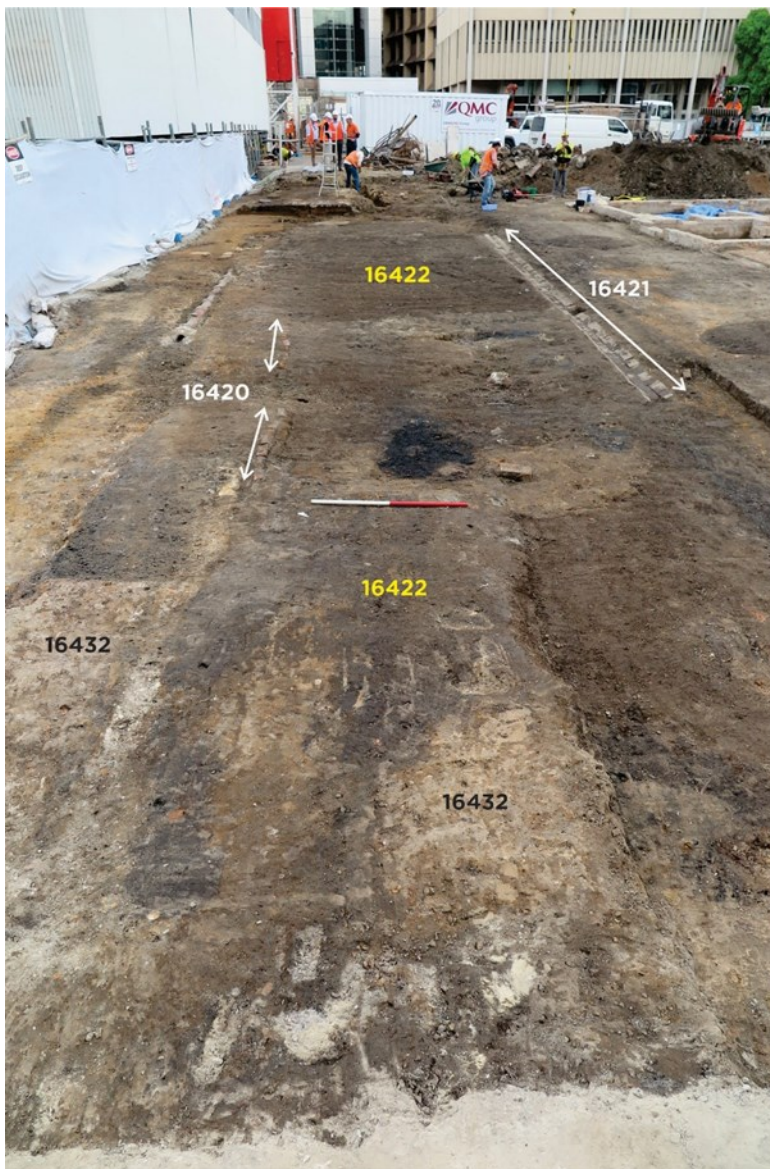
Figure 7.41: Photo showing the blackish brown, timber-rich fill 16422 and lighter brown, less humic fill 16432 across the northern end of Area C. The brick edging (16420) and dish drain (16421) are discussed below in Phase 5.1
