3PS – 153 MACQUARIE STREET, PARRAMATTA

TRENCH REPORT – AREA C

JULY 2017

VOLUME 2, SECTION 7.3

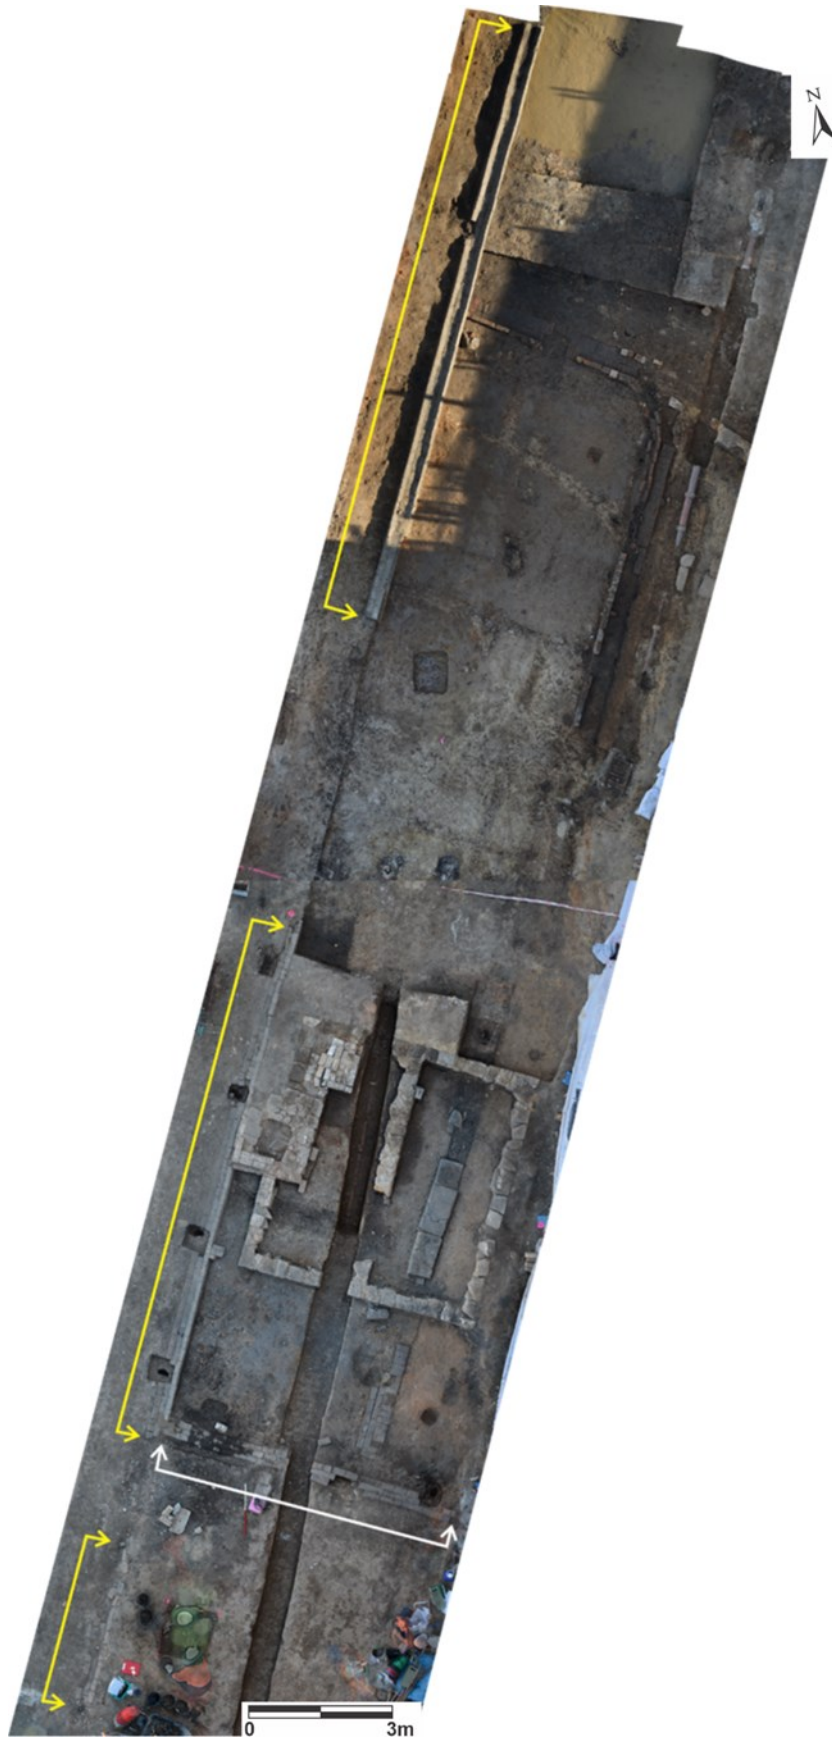
Figure 8.3: Composite orthophotos showing the location and alignment of dish drains 16421 (arrowed yellow) and 16616 (arrowed white). Note the damaged southernmost section of drain 16421 (bottom left).

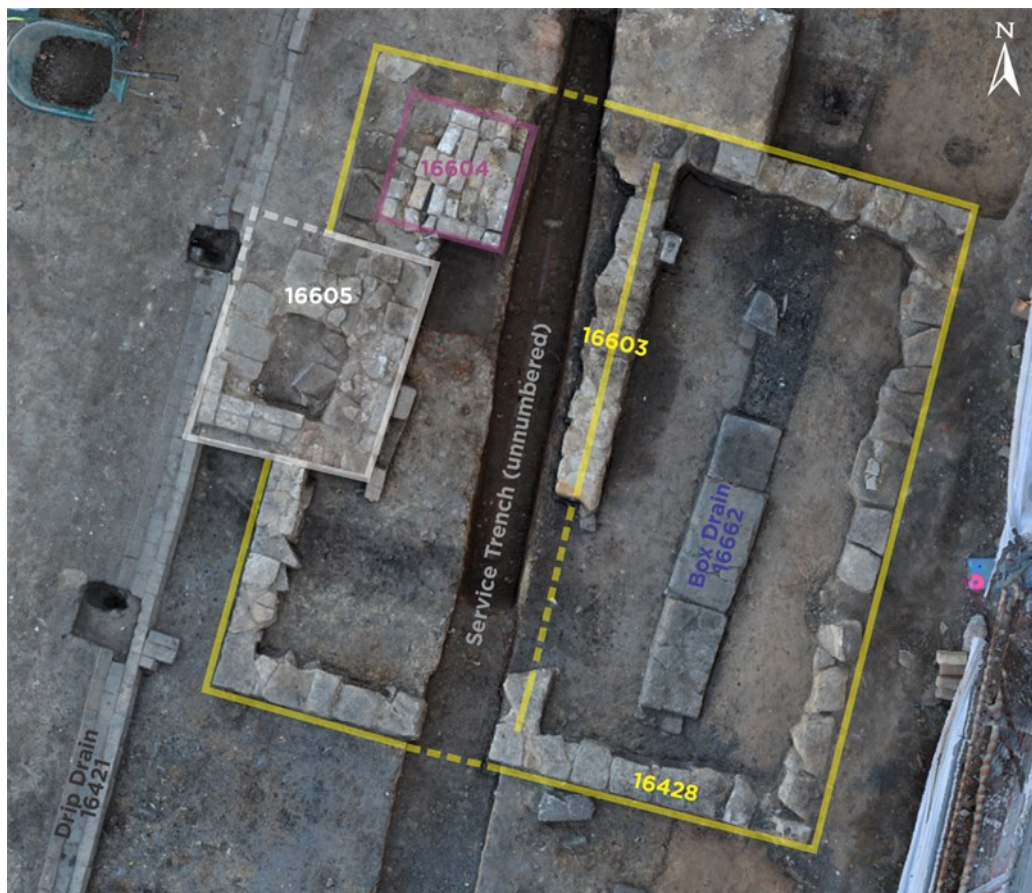
Figure 8.5: Photo showing the external walls and internal dividing wall (yellow) of Structure 6. The chimney or fireplace structure is outlined in white and the brick pad is labelled in purple. Not to scale.

The two internal rooms, therefore, measure roughly 4.5m long (north-south) by 2m wide (east-west) for the easternmost room, and 4.5m long (north-south) by 1.75m wide (east-west) for the westernmost room, although this room also jutted out an additional 0.9m to the west to include fireplace 16605. The westernmost room contained the large squarish fireplace or chimney structure (16605) and a smaller brick pad or platform (16604) in the northwest corner of the space. There are no internal structural elements or any indication of how the easternmost room was used.

The sandstock brick pad or platform 16604 abutted the west and north walls of Structure 6, and was set 275mm away from the fireplace (Figure 8.5, Figure 8.6). It measured 1m east-west by 0.93m north-south and appears to have survived intact, although it was originally thought to have been cut by the large service trench that cut straight through the centre of Structure 5 and 6. The pad was two courses deep, built with more or less in even rows of stretcher laid bricks, edged with a row of bricks laid head-to-head (BM Sample #50). About 80% of the bricks were full, while 20% were half or quarter fragments, with dimensions of between 210-229 x 107-112 x 73-78mm. The upper course of bricks had thick patches of pale yellow-brown sandy lime mortar (up to 30mm), but other bricks had visible white paint or limewash. The large variation in the brick dimensions and survival of paint or limewash makes it likely that the bricks were salvaged from another structure and reused to make the pad. It is not known what the pad or platform was used for, but the two-course thickness would have supported a substantial weight; similar pads or bases were recorded in the laundries of other houses in the 3PS study area where they are interpreted as supporting coppers for boiling laundry. In Structure 6, the platform probably supported a copper (i.e. Structure 6 was a laundry), but could also have acted as an offset hob to keep food warm (i.e. Structure 6 was a detached, larger than normal kitchen needed by a boarding house operating at 63 Macquarie Street between 1883-1885 according to both the *Sands Directory* and Council Rates Assessment Books), or that it may have been used for some kind of light industrial purpose (i.e. Structure 6 was a workshop). Whatever the function of Structure 6, it appeared to have a timber floor in association with the large fireplace/chimney.

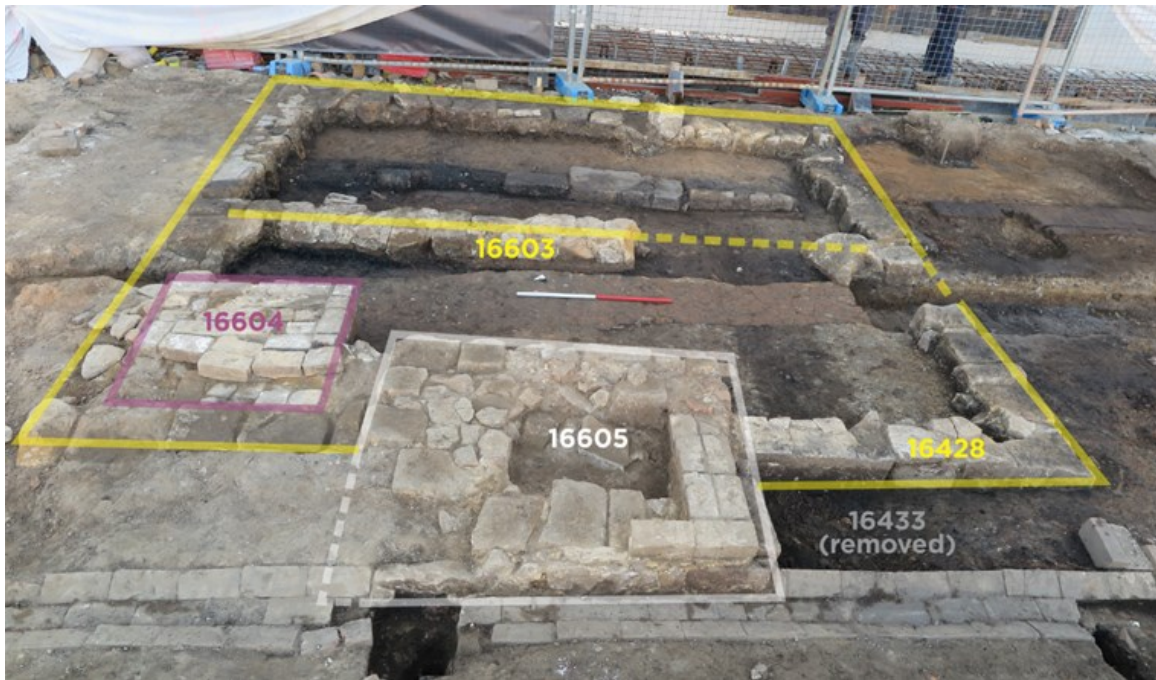
Figure 8.6: Fireplace 16605 and brick pad 16604 in Structure 6. View to east, 1m scale.

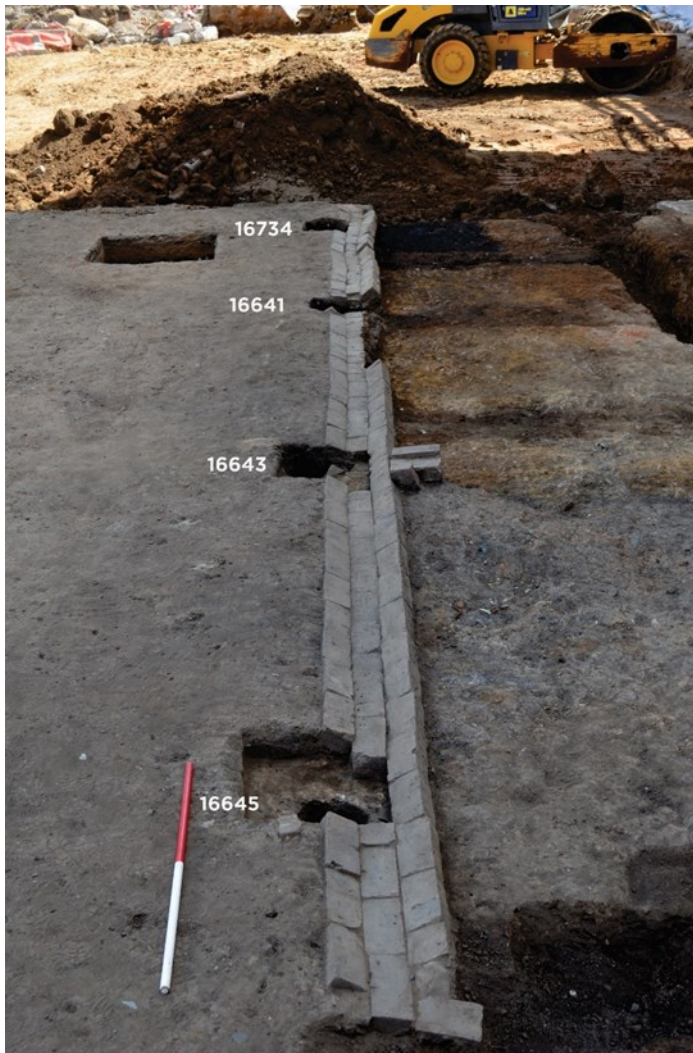
Figure 8.7: Photo showing the four postholes cut through the north-south running brick dish drain 16421. View to north, 1m scale. DSC_9237.

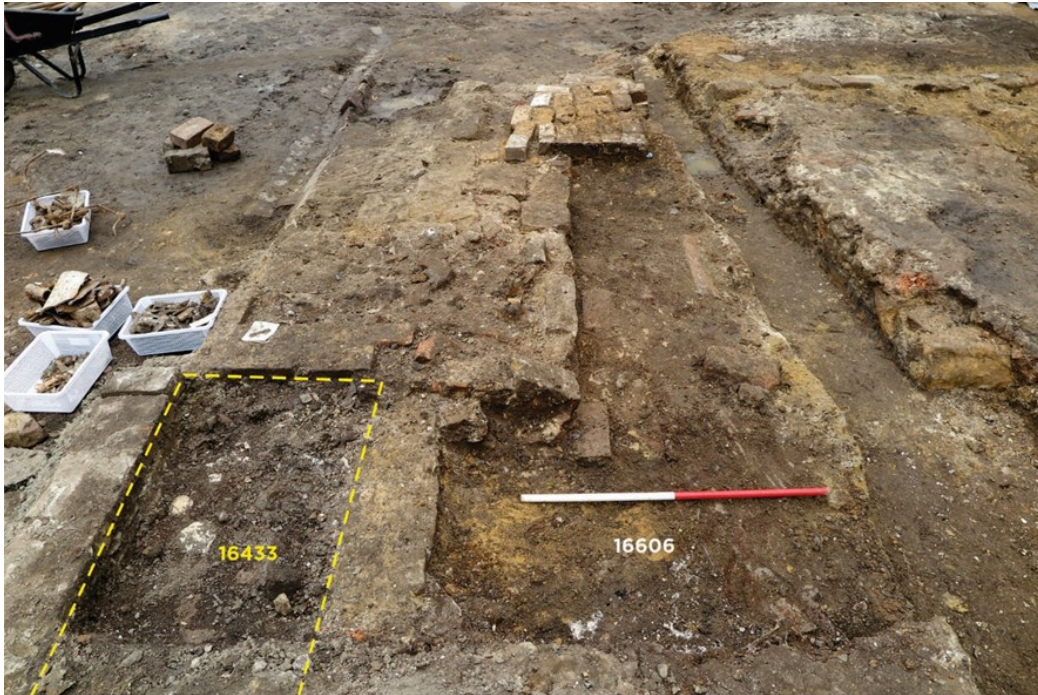
Figure 8.8: Photograph taken mid-excavation of Structure 6 showing bottle dump 16433 (left) and demolition fill 16606 (right). View to north, 1m scale.

The space between the south wall of the chimney, the western wall of the structure and the dish drain was filled with a dark brownish black, organic-rich sand that contained very frequent, large, glass bottle and tan/white stoneware fragments (16433). The stoneware bottle or jar fragments in particular appeared to be from the same kind of vessels, suggesting they were disposed of as part of a single event or dump, rather than gradually accumulating over time. The majority of these were stoneware demijohns made by the Sharpe Brothers with manufacture dates from c.1903 to c.1960s (see Ceramics Report, Vol. 3, Sec. 8.1). The deposit was up to 150mm thick and sat on top of a tightly compacted, dark grey clayey silt with crushed sandstock brick and sandstone fragments (16615) that formed the latest yard surface across the whole southeast corner of the area (equivalent to context 16594 in Area B). The fact that the bottles were dumped on top of the yard surface meant they post-dated the latest yard surfacing event, but may still have been contemporary with the use of Structure 6.

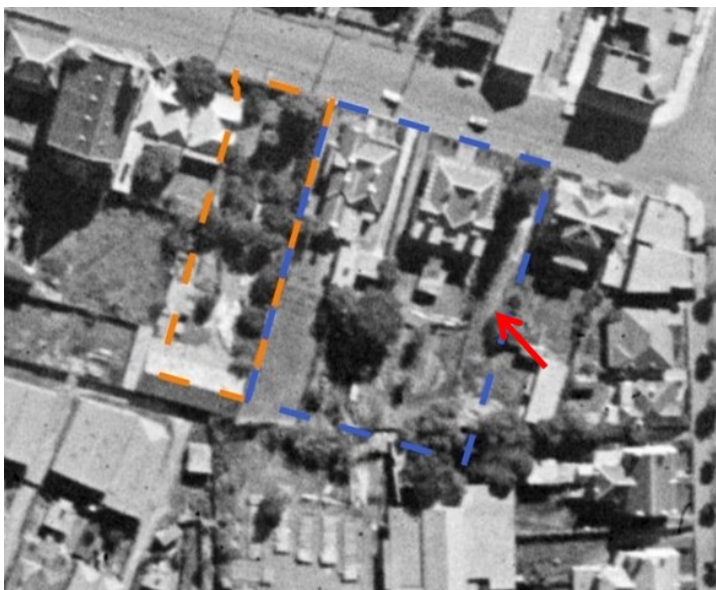
Figure 8.9: 1943 aerial photograph showing that Structure 6 (approximate location arrowed in red) has been demolished by this date. North is at top.

Archaeological evidence associated with the occupation of Lot 32 by the houses fronting Macquarie Street during this phase included a small number of rubbish pits containing artefacts dating from the 20th century and a dump of stoneware bottles or jars against the western wall of Structure 6. By the early 1940s the detached structure on the western boundary of Lot 32 (Structure 6) had been demolished, as it does not appear on the 1943 aerial photograph of Parramatta (Figure 8.9). An extensive demolition deposit was recorded that dates from this period.

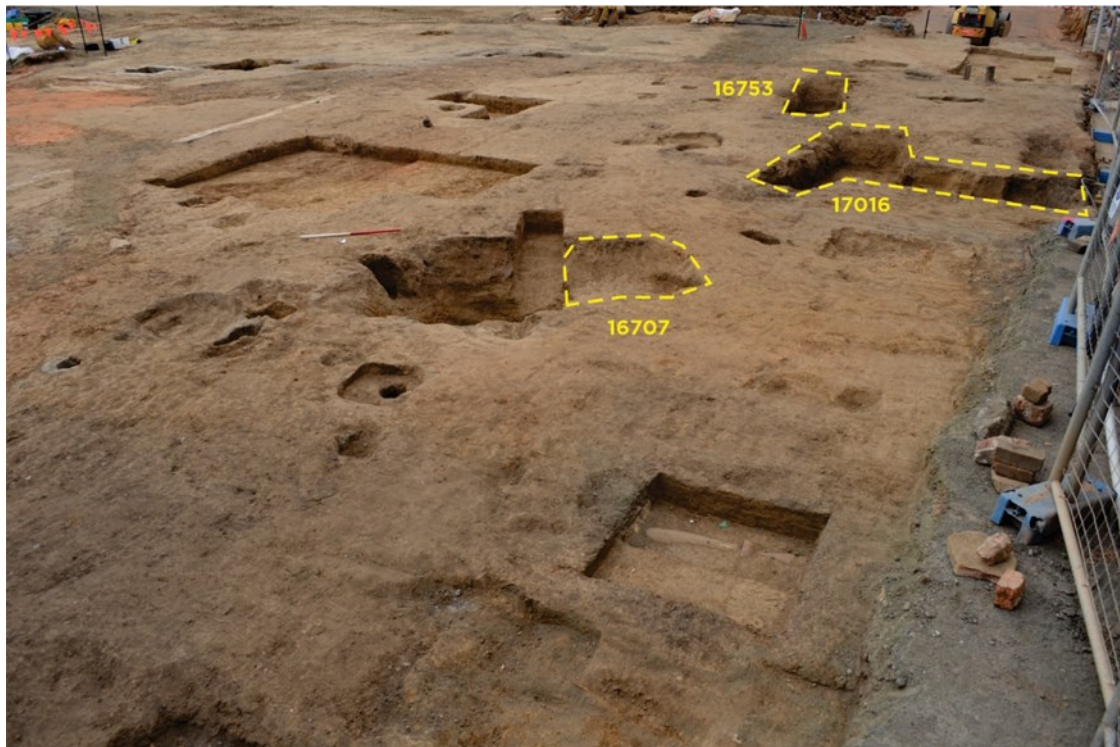
Figure 8.10: Photo of the southeast corner of Area C showing three of the 20th century rubbish pits (dashed yellow). The northern two pits were machine excavated due to asbestos contamination. View to northwest, 1m scale. DSC_9360.

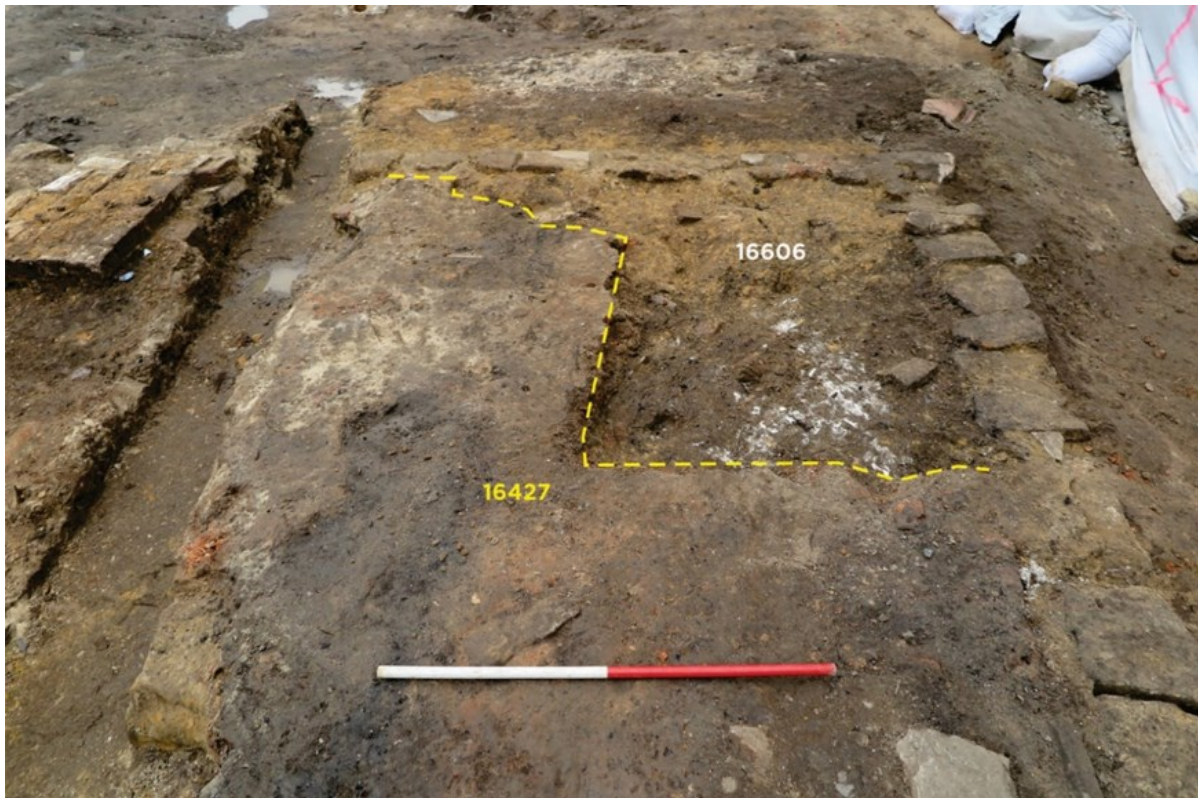
Figure 8.11: Red clay capping 16427 partially removed onto yellow and white demolition material 16606. View to north, 1m scale.

Spread out across the entirety of Structure 6 was a demolition fill composed of loose, white and mustard sand with a moderate amount of iron or metal objects (16606) including small fragments of corrugated iron sheets, lead pipes, and metal brackets (Figure 8.11, Figure 8.12). The demolition fill was spread over an area of roughly 5 x 5m and was up to 150mm thick. There were also fragments of broken cement slab in this deposit, possibly from a later concrete floor within Structure 6 to replace the timber floorboards. The white and mustard colour and sandy matrix is due to decayed sandstone fragments; there were also fragments of broken dry-pressed and sandstock bricks in the demolition fill. This indicates that at least the footings of this structure, and perhaps the superstructure as well, were built from both sandstone and brick, consistent with the mix of building materials recorded in the fireplace or chimney structure 16605. The presence of both dry-pressed and sandstock bricks could be due to a mix of new or reused materials in the original construction, which would be consistent with a post-1878 construction date implied by the listing of the area as 'Enclosed Land' in the 1878 Rate Assessment book. Alternatively, the presence of two different types of bricks may be due to the original construction using

The demolition fill 16606 was sealed with a thick layer of orange and pink plastic clay (16427). The clay was moderately compacted and covered an area of roughly 5 x 5m. It was substantially thicker towards the western side where it had a maximum thickness of 400mm (Figure 8.11). Up to half of the deposit was comprised of brick rubble, with a high frequency of large, corrugated iron sheets assumed to be from the roof of Structure 6. It appears that the roof was one of the last things to be demolished and the iron sheets were left sitting over the building, which was then covered by the clay. A pocket of mid to dark brown sandy silt with a moderate number of artefacts was found (16434) within the plastic clay (16606). This material was given a separate number as it was such a different consistency and was originally suspected to be an underfloor or occupation related deposit. Careful hand excavation of the material and the size of the artefacts, however, showed that this was just a small area of different fill localised along the southern side of the brick pad 16604, perhaps associated with the demolition of the pad structure (laundry copper or kitchen hob) and was still part of the general demolition of Structure 6.

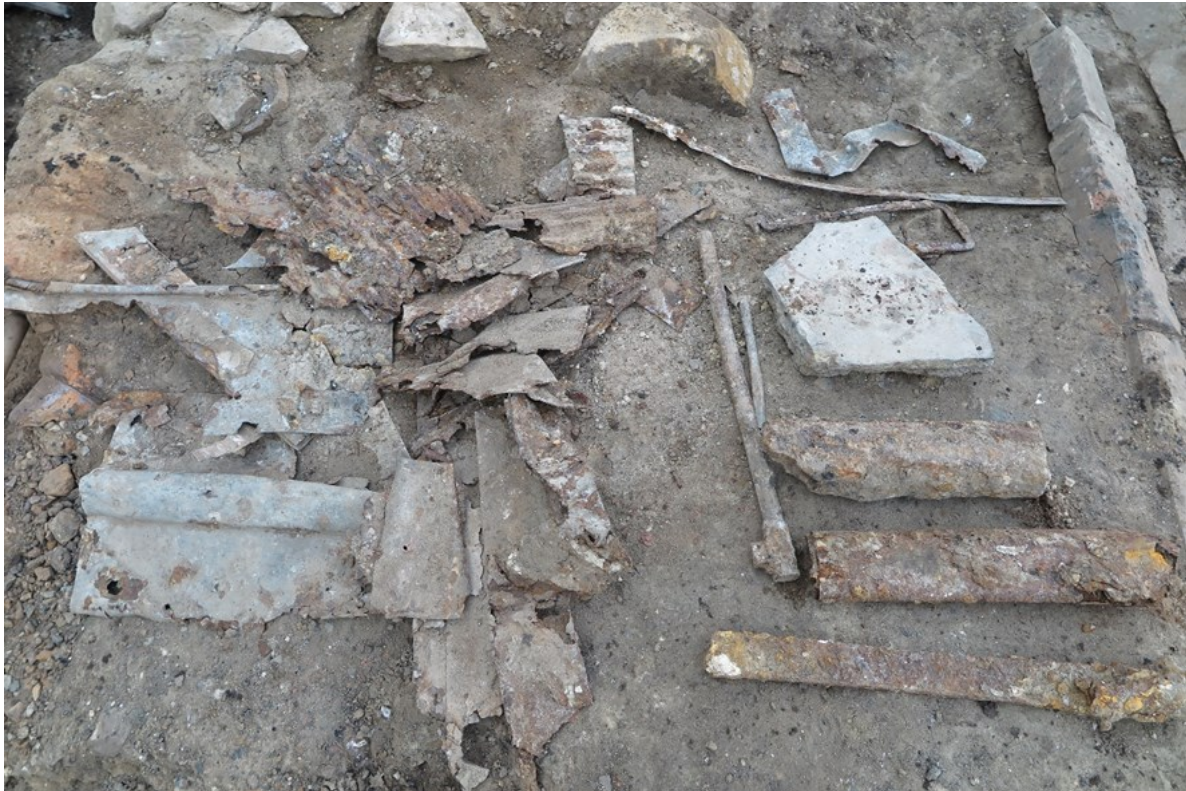
Figure 8.12: Metal objects, including a large number of corrugated iron sheet fragments (top centre) recovered from demolition material 16427 and discarded. No scale.

A large number of corrugated iron fragments were recovered from demolition material 16427 from within the building (Figure 8.12, discussed below) which strongly suggests that this structure had an iron roof. A number of marble fragments were sampled from the demolition material (BM Sample #26), perhaps from the surround of the fireplace, or another decorative architectural feature inside the structure. The large number of iron and metal artefacts recovered from the demolition material hints at a use as a domestic or light-industrial workshop, but there were no *in situ* occupation deposits or artefacts that could be unequivocally associated with the structure.
