3PS – 153 MACQUARIE STREET, PARRAMATTA

TRENCH REPORT – AREA D

JANUARY 2018

VOLUME 2, SECTION 7.4

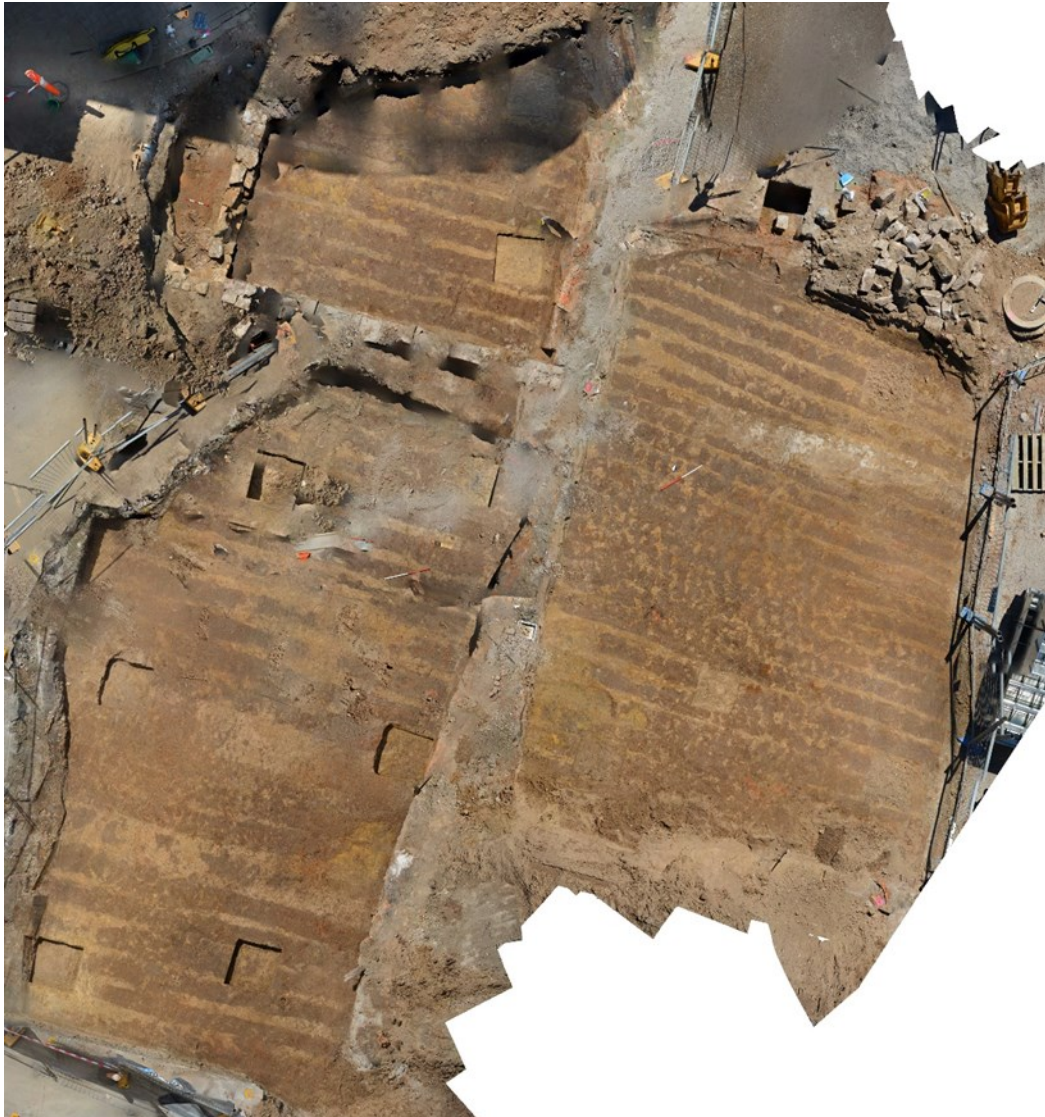
Composite orthophoto of early agricultural plough lines exposed in Area D. G. Hazell (Arcsurv) 2016.

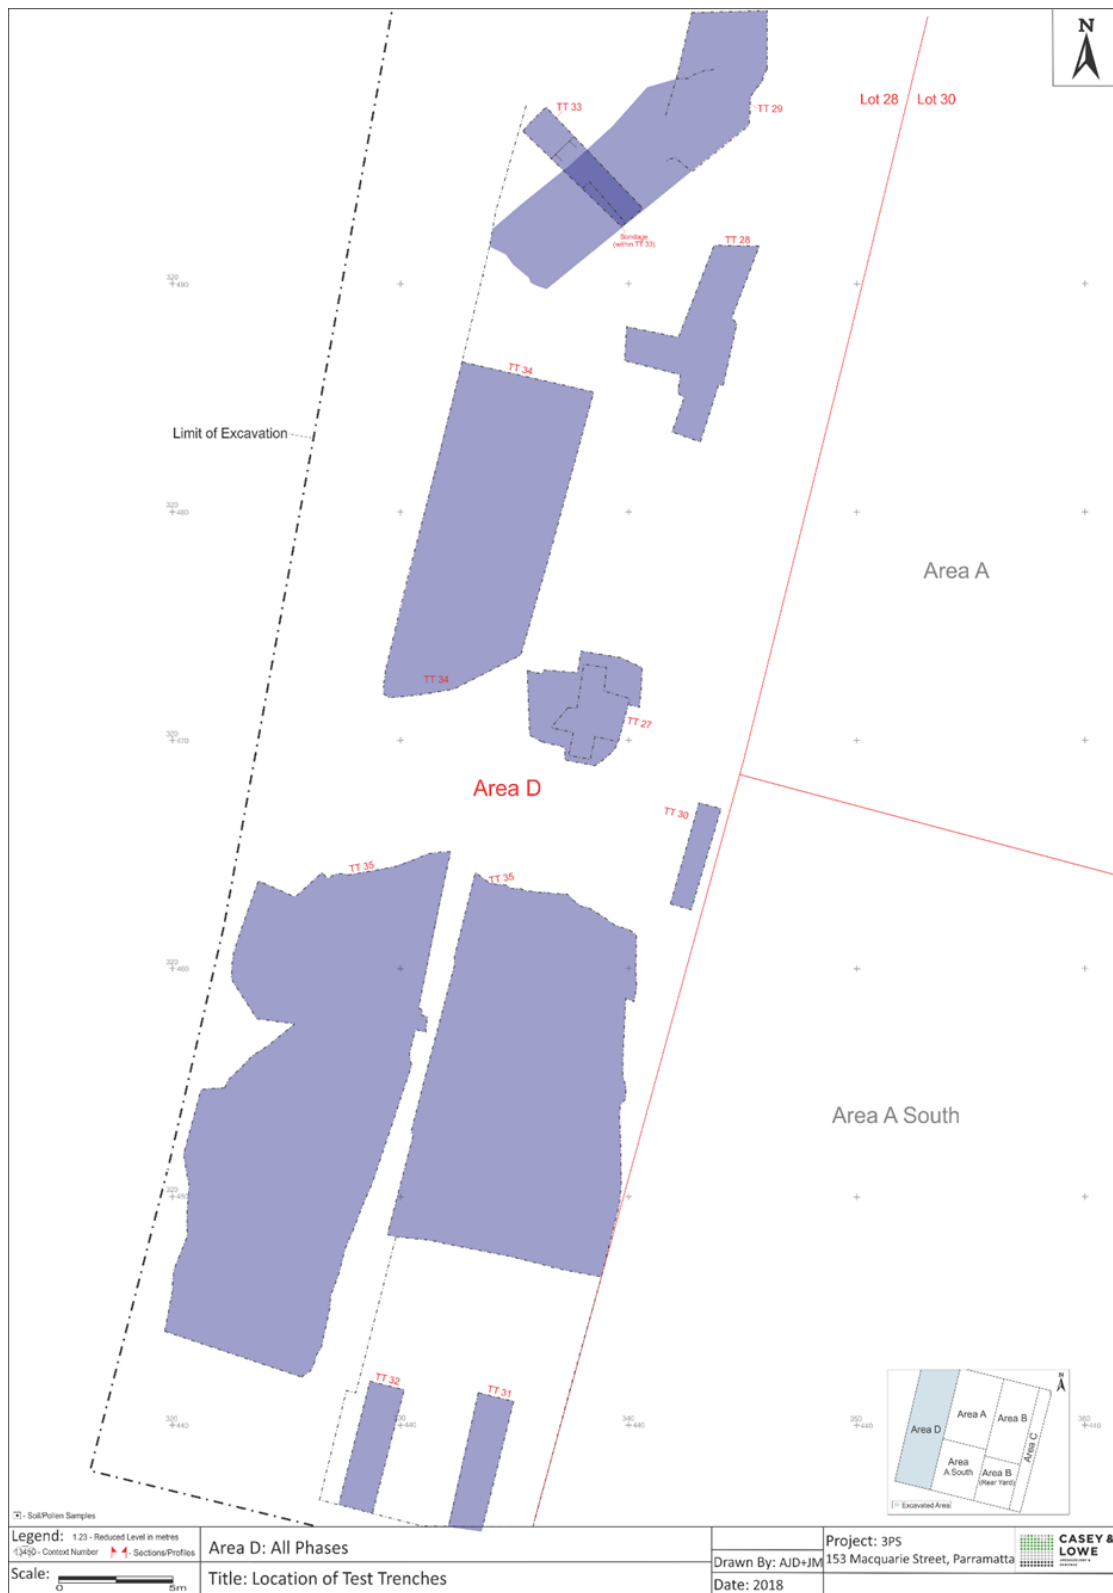
Figure 3.1: Plan showing the location of the various test trenches excavated by machine and then manually across Area D (shaded). The trenches to the north were generally deeper than those to the south, except for the machine excavated trenches through the pond TT31 and TT32. The western edge of the site to the north was under the footpath full of services so it was not investigated.

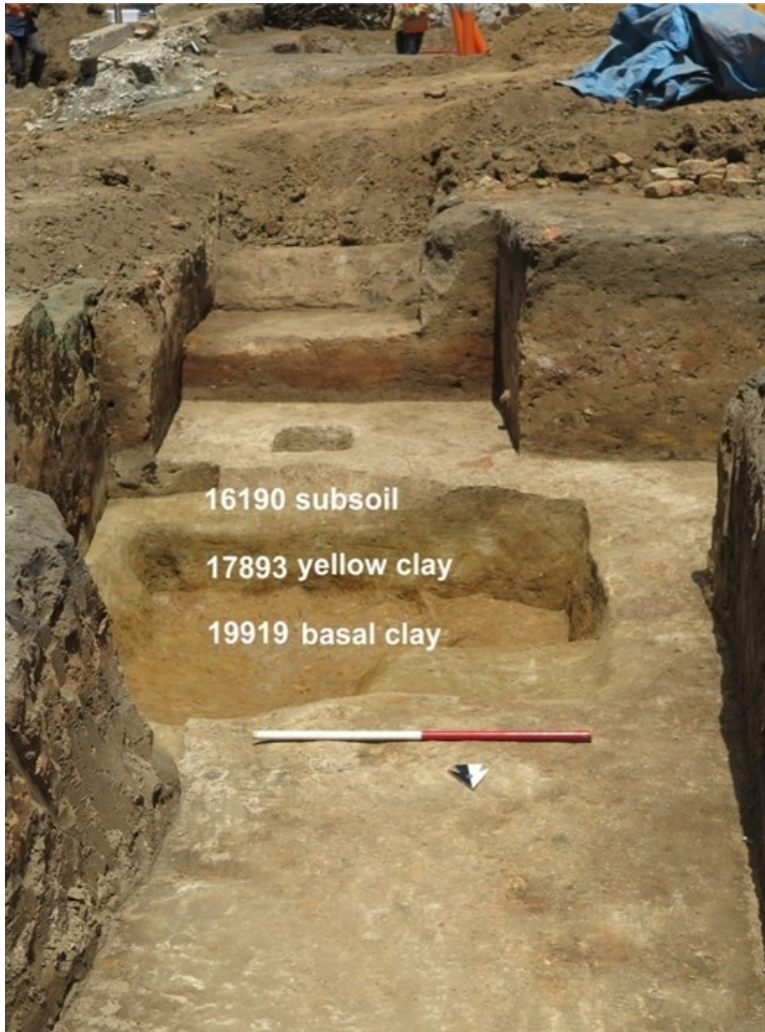
Figure 3.3: View of natural soil profile at the base of TT28. View to the south, Scale 1m. IMG_5463.

clayey silt, context 17893. This was only identified in TT31 and TT32, at the base of a large storage pit in TT28 (Figure 3.3) and either side of the drainage channel/drain in TT33 (Figure 3.4). The subsoil, context 16190, was relatively intact across the site with most archaeological features cutting into it. The subsoil was found to slope from RL11.00m in the south-east corner down to RL 8.45 in the north-west corner as shown in Figure 3.2. The remnant topsoil was heavily modified and mixed with historical inclusions and artefacts, it was also mottled with the upper margins of the subsoil. In the southern half of Area D, within Lot 1, the modified historic topsoil had been ploughed in rows cutting into the subsoil.

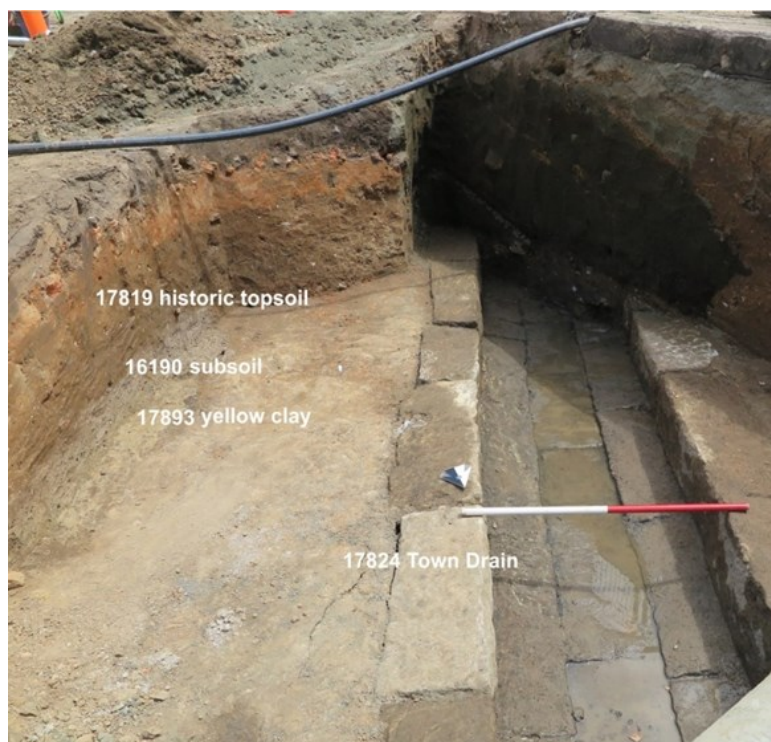
Figure 3.4: Natural soil profile emerging to the east of the edge of the cut for the drain. View to the south, scale 1m. IMG_5516.

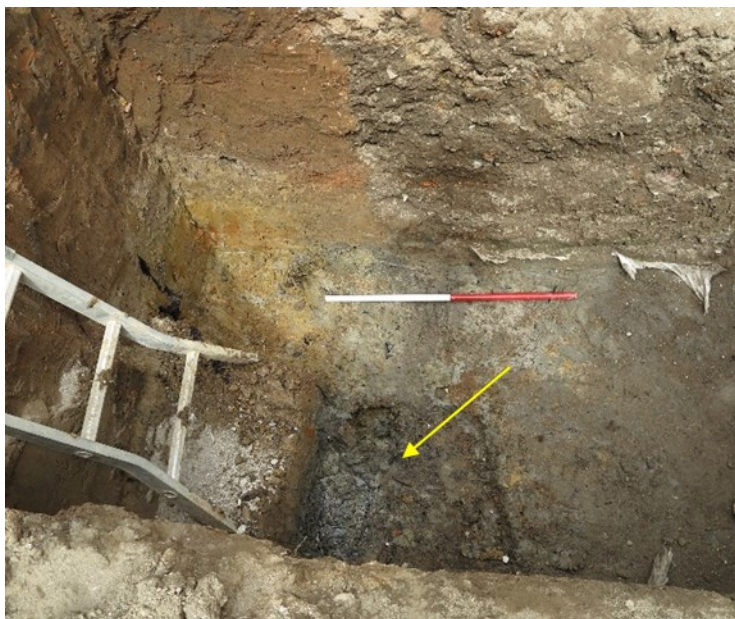
Figure 3.5: The top of the creek line clays with reed like vegetation visible arrowed within context 17852. View to the south, 1m scale. IMG_5846.

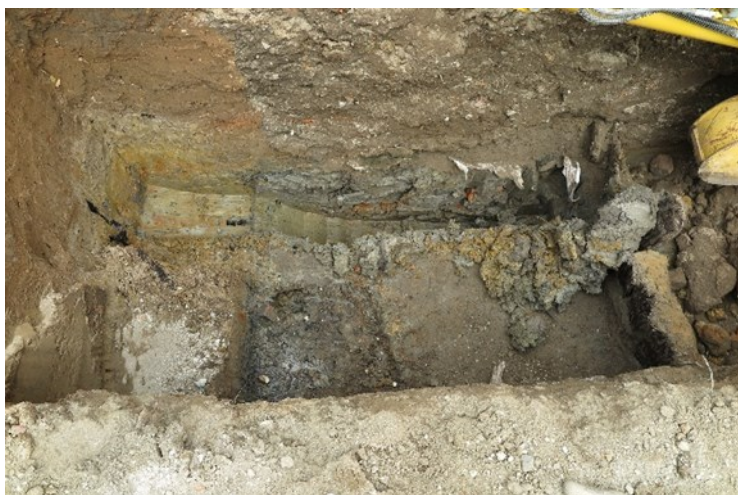
Figure 3.6: Grey creek line clays 17852 with sandstock brick fragment inclusions sitting above a mottled yellow 'natural' clay. A narrow trench was dug through the grey clay to expose the underlying yellow clay (17893) of the natural soil profile. View to the south, IMG_5856.

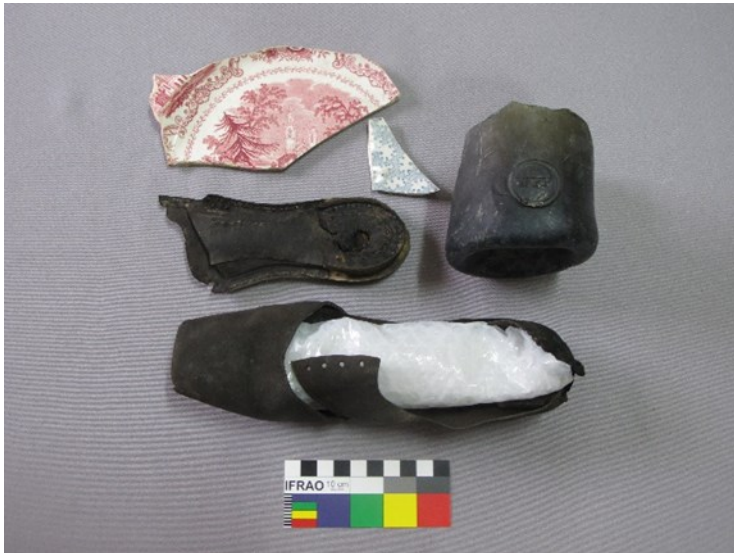
Figure 3.7: Leather duck-bill toed shoe, ceramics and a bottle stamped with the letters WPP found within the grey clay of the creek line, below the Town Drain. 100mm scale, IMG_4899.

Artefacts collected from within the grey silty clay (17852), were securely sealed below the drain. These artefacts included sandstock brick fragments, ceramics, glass and a partial leather shoe (Figure 3.7). The shoe was a hand-stitched square duckbill-toed lace-up shoe, a style which generally dates to between 1820 to c.1860.⁶⁰ The shoe was rather worn suggesting that it had been deliberately discarded. The ceramics recovered were red and grey transfer printed table-wares (dating from the 1830s onwards). The base of a dark green beer/wine bottle included a stamped seal on the lower body; with the letters 'WPP' embossed. The bottle was free-blown with a slightly sagging base which is generally dated to pre-1820 before mould blown glass technologies were adopted.

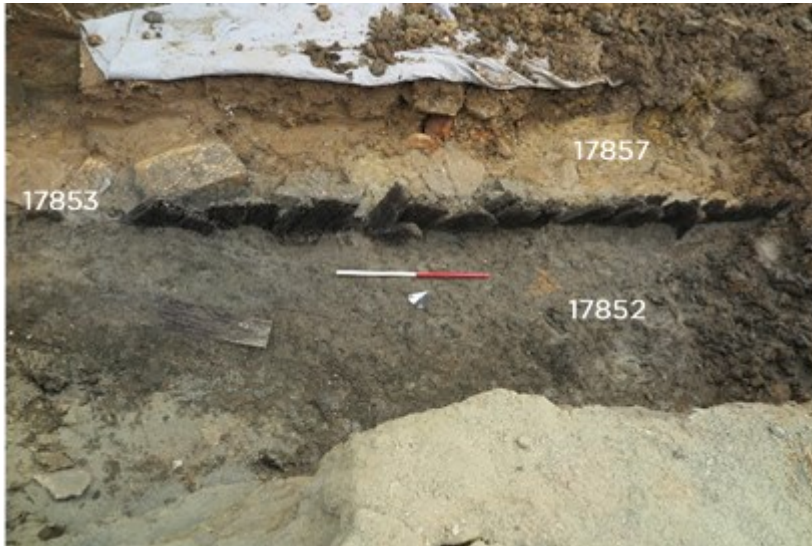
Figure 3.8: Timber shoring (17853) in the creek line with sandstone rubble behind (17857) and the grey estuarine clay (17852) in the foreground. View to the west, 1m scale. IMG_5808.

The grey deposit (context 17852), including remnant reeds and early 19th-century artefacts was found within a channel cut into the subsoil. The channel was at the base of a larger cut (context 17831), identified as the cut for the construction of the Town Drain, to be discussed in Phase 4 below. This channel could have been created through natural processes, whereby the course of running water draining down slope had carved out the underlying subsoil and the flowing water had deposited the grey silt within. However, it is more likely that the cut for the channel represents the formalization of the creek line, where the channel was dug deliberately to direct the flow of draining water. Either way, the base of the channel was filled with the water-logged silty clay creek line sediment (context 17852) and a sandstone packing fill, context 17857, into which a series of upright timbers, context 17853, were embedded (Figure 3.8). The upright timbers formed a barrier or shoring which was somehow connected with the formalisation of the drainage channel. A deep deposit of the grey silty clay had built up within the channel on the eastern side of the barrier, whereas there was a thick layer of sandstone rubble mixed with yellow sandy clay, context 17857, packed up against the western side. Therefore, the barrier had been reinforced on its western side perhaps protecting the edge of the creek from erosion while the creek sediment built up against it within the channel. There was no evidence for any form of timber barrier on the eastern side of the channel and no timbers on the base of the channel.

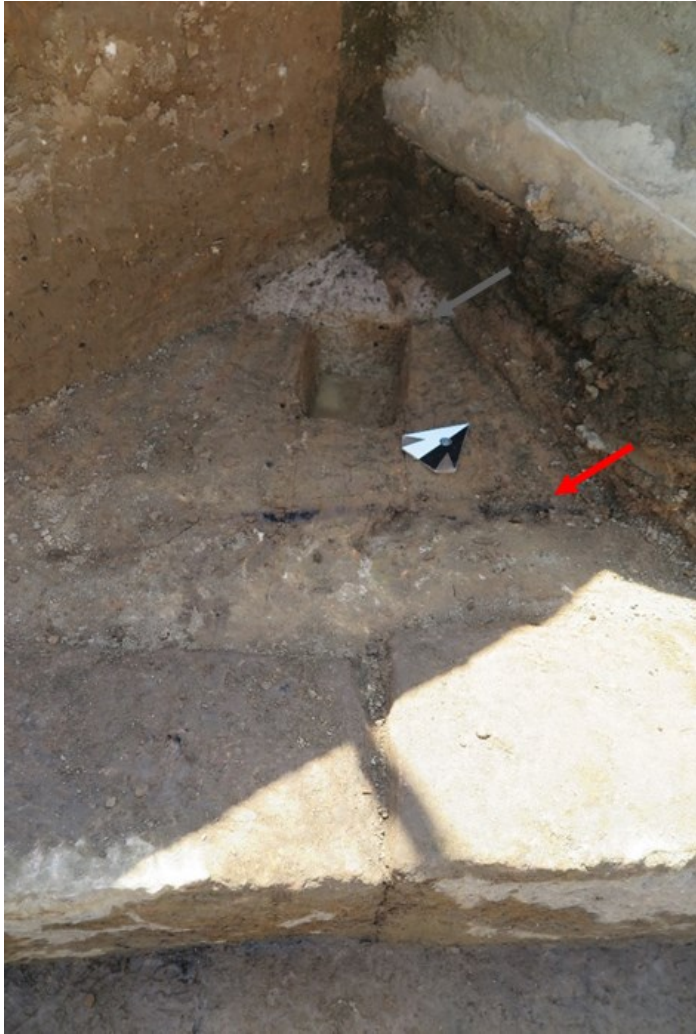
Figure 3.9: The first sign of the timber feature 17853 is shown here arrowed in red. The cut in the subsoil for the channel/drain is arrowed in orange, the western sandstone wall of the Town Drain is in the foreground. View to the west. IMG_5540.

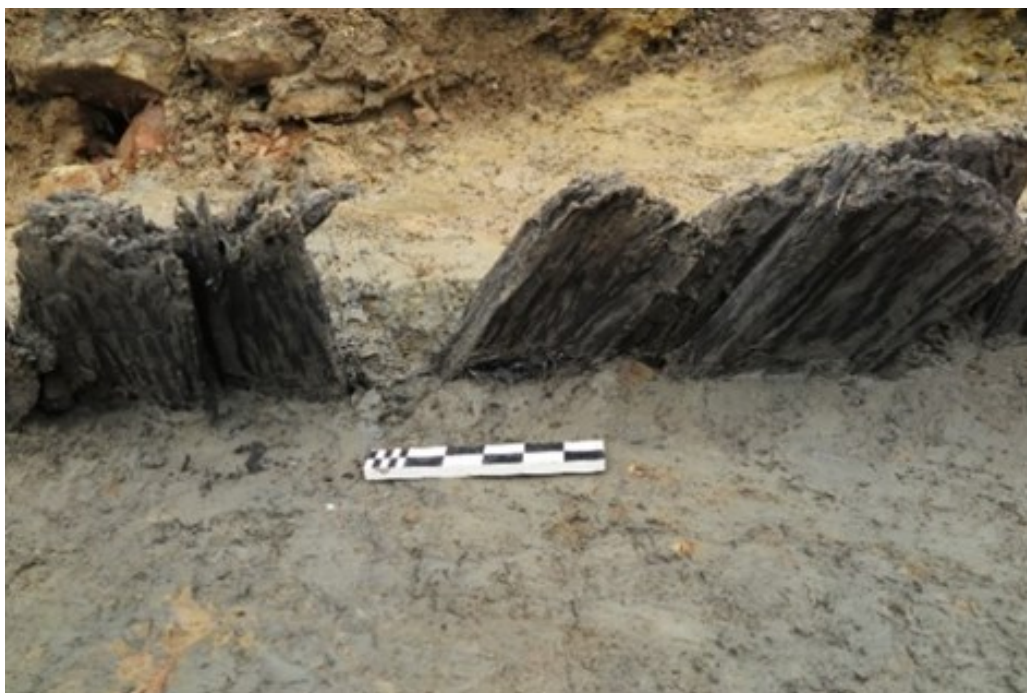
Figure 3.11: Detail of the timber shoring 17853 found beside the Town Drain within the creek line. View to the west, 300mm scale. IMG_5817.

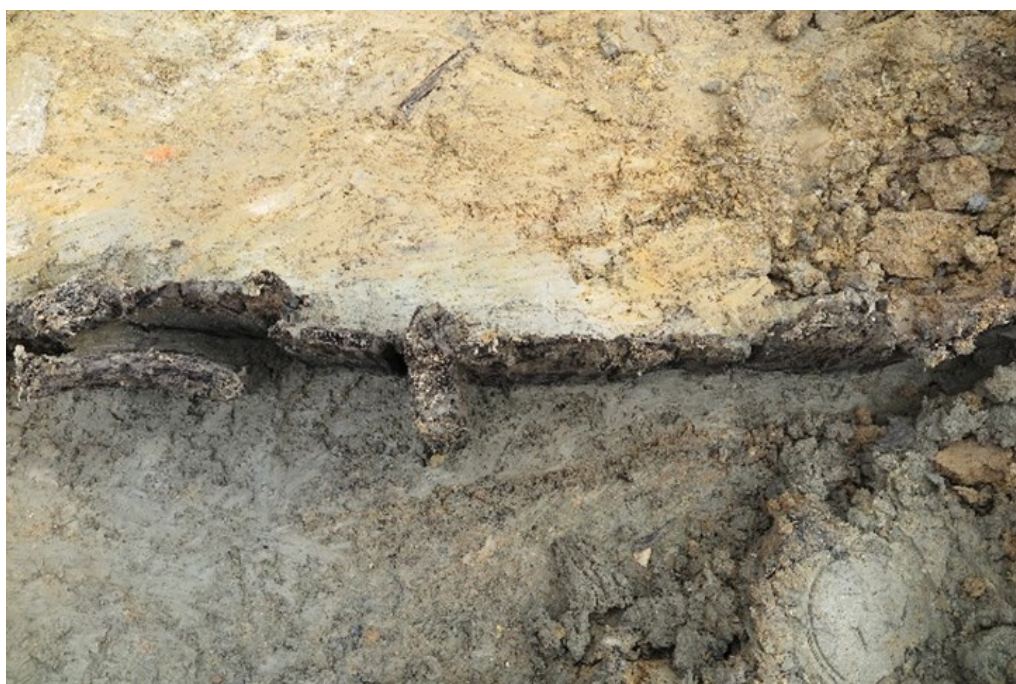
Figure 3.12: Detail of the timber barrier delineating the two deposits, showing an upright post perpendicular to the slabs. View to the west. IMG_5820.

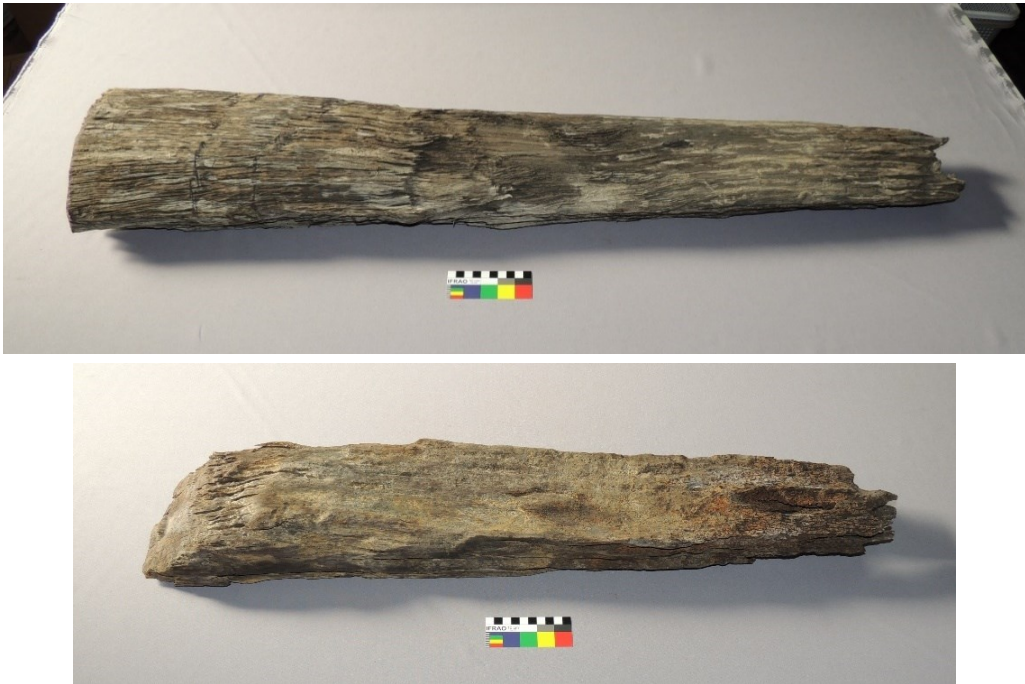
Figure 3.13: Two timbers from the timber shoring 17853 showing the chamfered wedge-shaped base. Narrow-leaved Red Iron Bark (*Eucalyptus* ?2 crebra). DSCN3713, DSCNS3727 scale 100mm.

The linear timber shoring or barrier embedded in the grey silty channel bed formalised the western edge of the creek/drainage channel. During excavation the shoring was first identified as a line of decaying timber beside the second course of sandstone blocks of the Town Drain at the northern end (Figure 3.9). This timber shoring may have been a precursor to the stone Town Drain or have been part of the construction process for that drain. Perhaps delineating the edge of the creek creating a barrier to further erosion or directing the water whilst the drain was under construction. The feature ran parallel to the sandstone drain at a fairly uniform distance of 300mm from the western wall. This uniformity may support the idea that it was part of the construction process for the drain. The extent of the timber feature was exposed to a length of 1.5m in the eastern part of the trench and 7.5m in the western section (Figure 3.10). It was composed of large flat timber palings or slabs positioned side by side forming a barrier, with large squarish posts up to 1.06m high, perpendicular to the slabs at intervals of 2.3–2.7m (Figure 3.11, Figure 3.12, Figure 3.13). The large paling slabs ranged from 260–340mm wide at the base, tapering towards the top, the longest was 870mm. Several had a curved outer edge showing that they had been split or sawn from a large tree trunk. The bases of several palings were chamfered to form a wedge which would have facilitated driving them into the clay. One post was considerably wider at the base suggesting that it had been dug into the clay, however there was no evidence for a trench or posthole cut associated with any of the timbers. It is more likely that the base of the timbers were driven into the clay (context 17852) then the sandstone rubble (context 17857) was packed in behind them, to the west. The upright palings were closely fitted together without gaps between, which suggests that they were put in place to form a potentially watertight barrier on the western edge of the channel (Figure 3.14). No timbers were found on the eastern side of the channel (Figure 3.15).

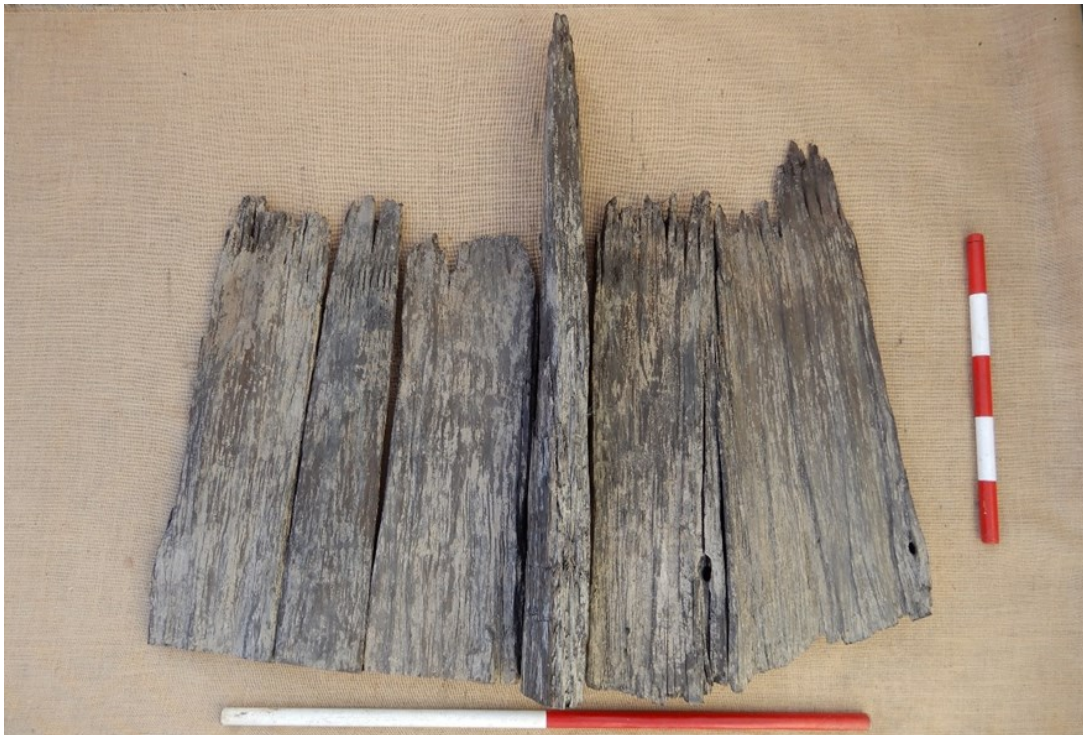
Figure 3.14: A segment of the timber shoring 17853 (removed and retained – here reconstructed) showing how well fitted they were; forming a well-constructed potentially water-resistant barrier. 1m and 500mm scale. DSCN0062.

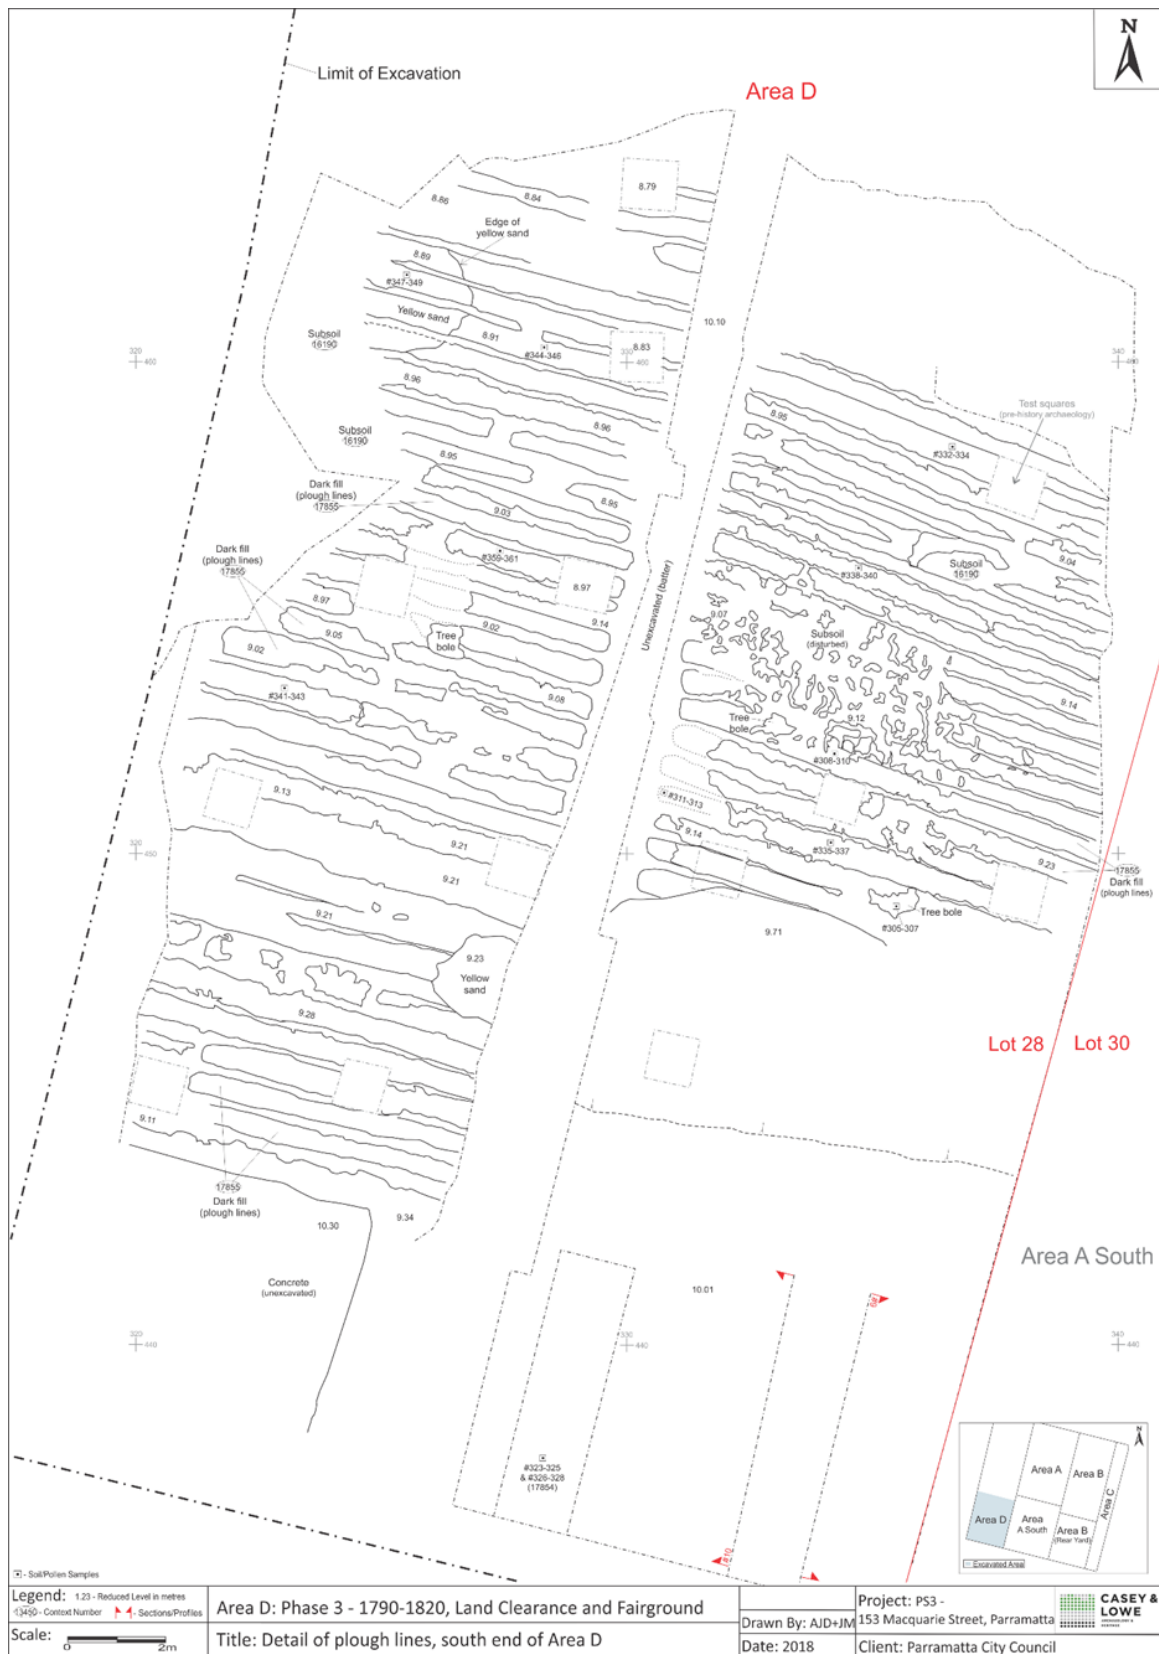
Figure 3.16: Detail plan of the plough lines in Area D. Post-excavation analysis of the artefacts within the plough lines has resulted in this context being rephased to Phase 4.1 in the Final Excavation Report.

A series of plough lines were revealed within the historic boundary of Lot 1, (aka 181) the allotment leased to Robert Bateman. These plough lines, collectively assigned the context number 17855, were found cutting into the pale-yellow/grey subsoil (context 16190) (Figure 3.16, Figure 3.17, Figure 3.18, Figure 3.19, Figure 3.20, Figure 3.21, Figure 3.22). The plough lines were linear cuts in the subsoil with a sharp break of slope at the top where it was truncated by the machine, and gradual concave sides forming a U-shape in section. The average width of the plough lines was 450mm with depths ranging from 30-100mm and lengths greater than 6m. As the area was only exposed within the test trenches the complete length of the plough lines was not able to be recorded. The fill within the features was a soft mid brown/grey silty clay with some patches of yellow sand and some charcoal fleck inclusions, therefore a mix of modified historic topsoil 17819, subsoil 16190 and context 17827.

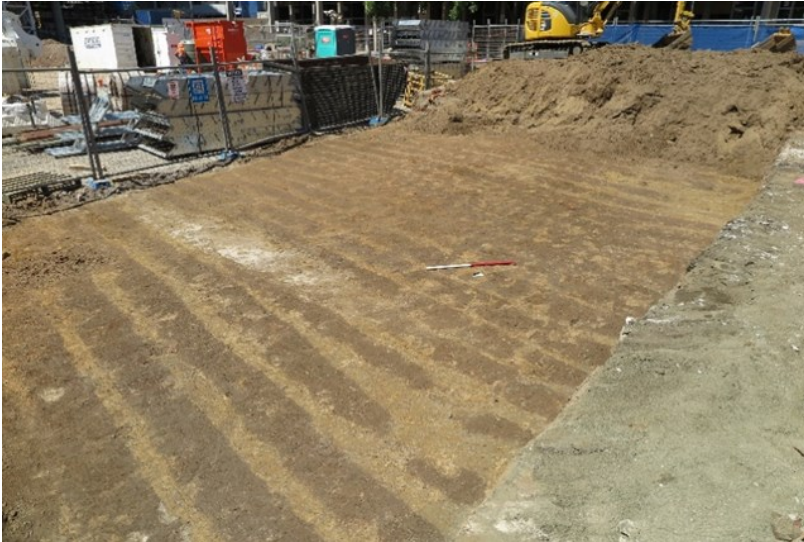
Figure 3.17: Plough lines at the south-east end of Civic Place. View to the south east, 1m scale. IMG_5703.

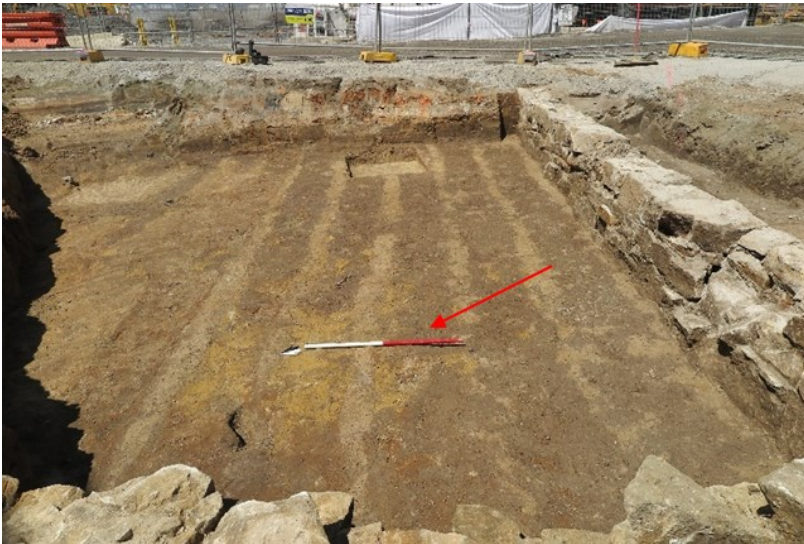
Figure 3.18: Plough lines at the centre of Civic Place. A patch of yellow sandy material 17827 can be seen at the base of the plough lines (arrowed in red). This is similar to deposit 17827 seen in TT28. View to the east, 1m scale. IMG_6031.

A lens of yellow sandy material, context 17827, was found in TT28 where it showed up just above the subsoil as an interface between the modified topsoil and the underlying subsoil (Figure 3.31). In the southern part of Area D, this deposit was found over/associated with the top of plough lines (Figure 3.18, Figure 3.23). Mottled mustard yellow and grey brown, coarse, clayey sand interface between the modified topsoil 17819 and the subsoil. This deposit was only found in patches across the site but was always associated with redeposited topsoil, therefore, must be related to modification of the natural deposits, probably caused by agricultural activity.

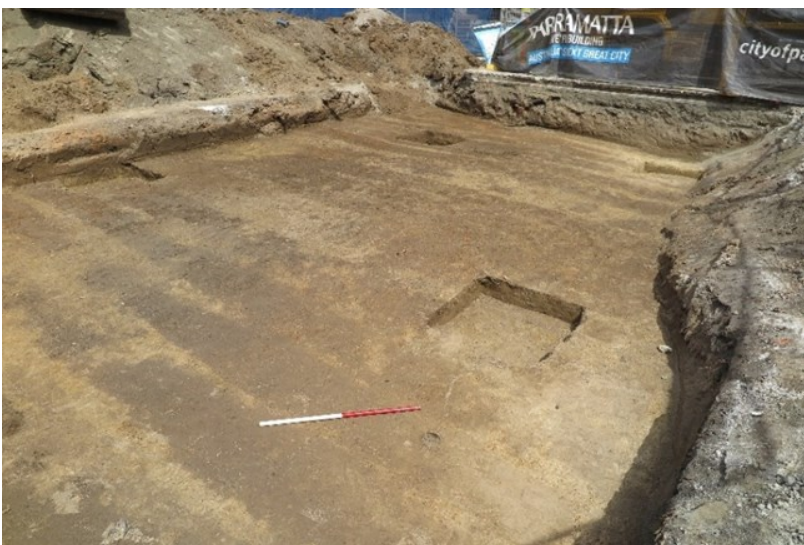
Figure 3.19: Plough lines at southwest end of Civic Place. View to the southeast, 1m scale. IMG_5879.

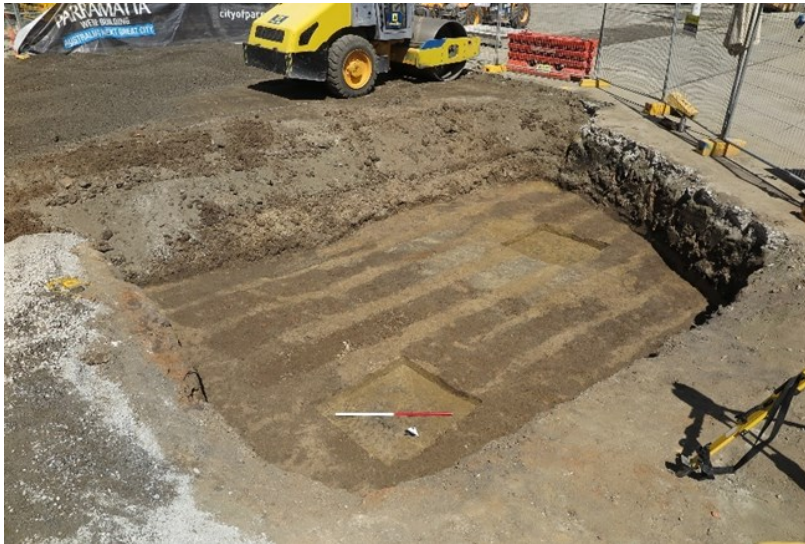
Figure 3.20: Plough lines in the west of Civic Place. All of these furrows were excavated and all material was wet sieved to provide a sample of what may have been in the topsoil at this period. View to the southwest, 1m scale. IMG_5920.

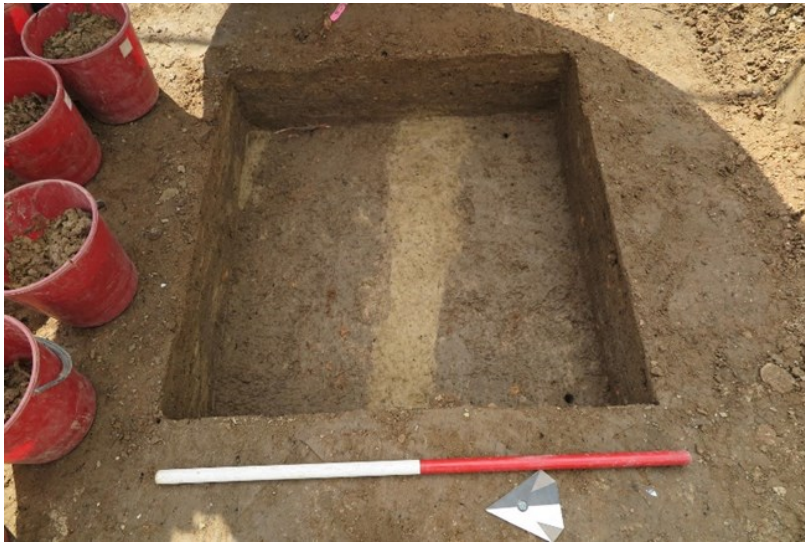
Figure 3.21: The top of linear plough lines visible in an aboriginal test pit. View to the east, 1m scale. IMG_5970.

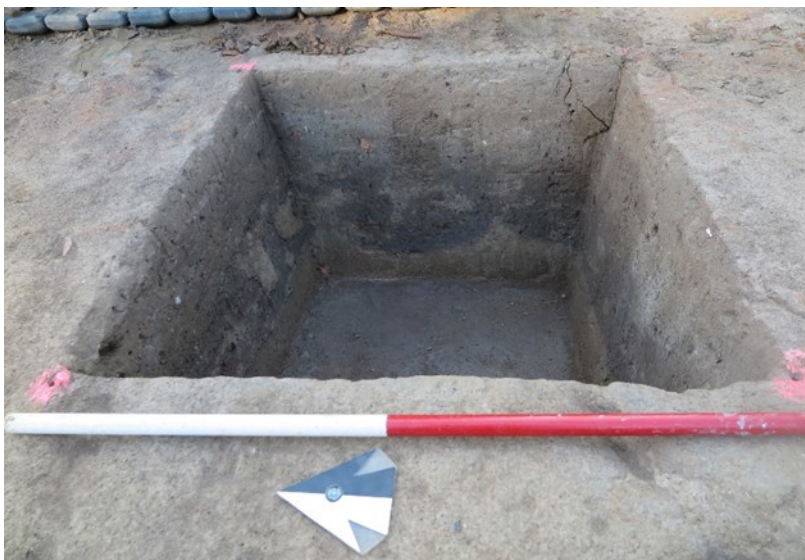
Figure 3.22: Aboriginal test trench showing plough lines visible in the section. The topsoil has been churned or turned over by the action of the plough. View to the east, 1m scale. IMG_5630.

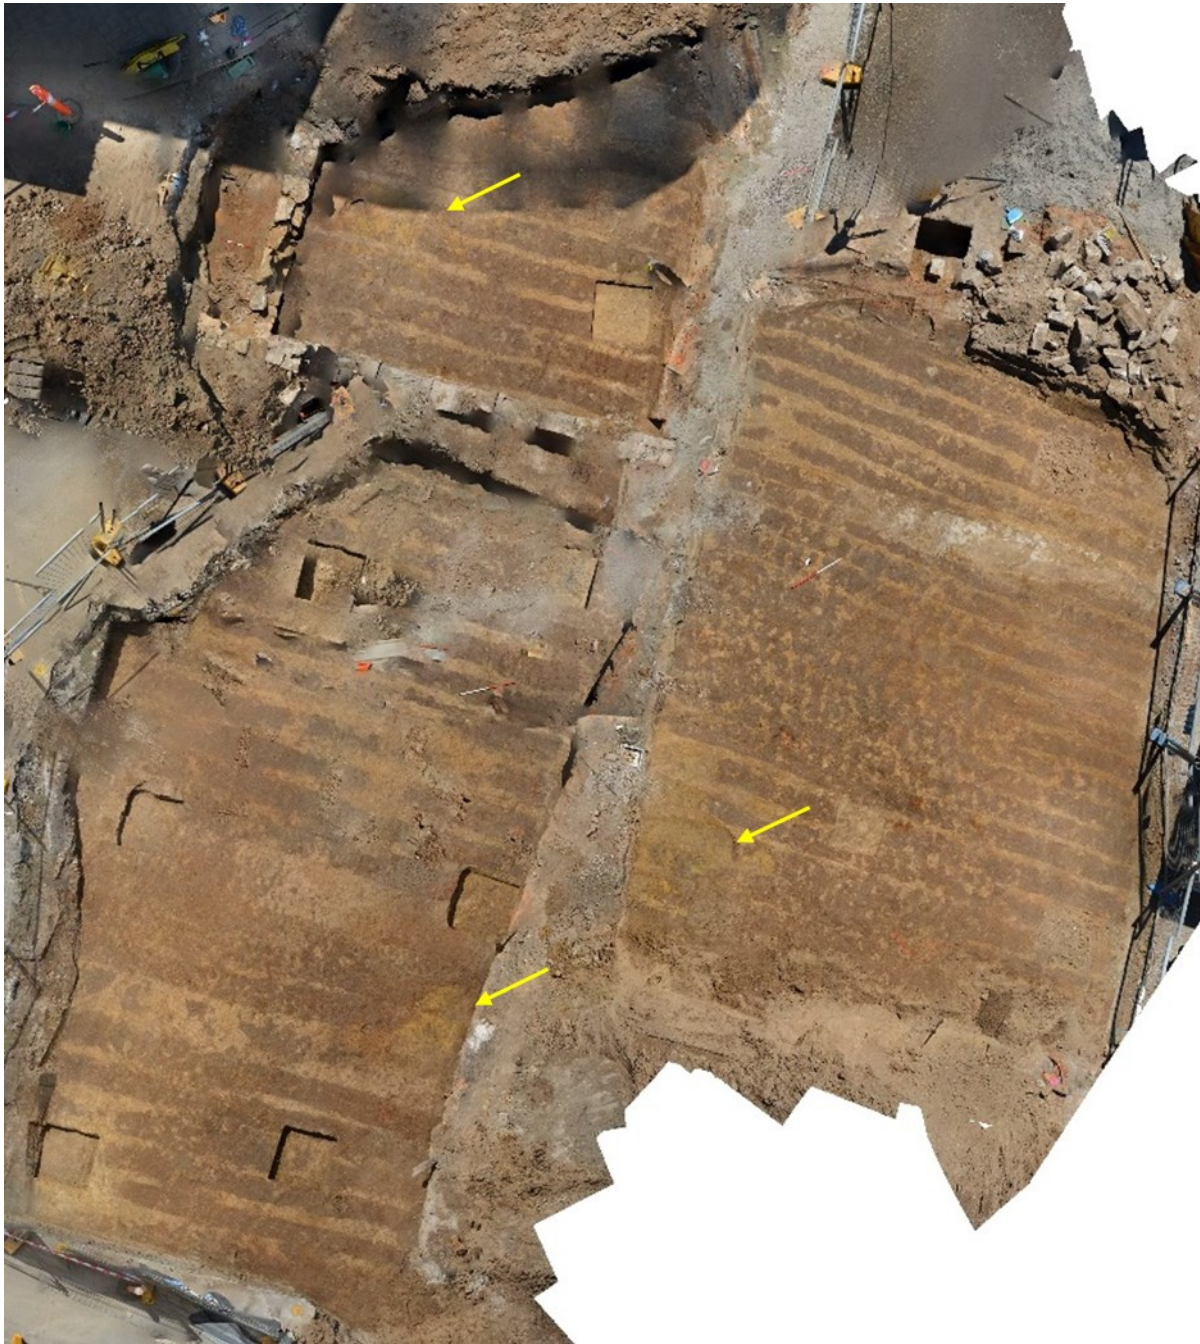
Figure 3.23: Composite orthophoto (Arcsurv 2016) showing the extent of the plough lines (17855), uncovered in Area D. Patches of yellow sand, (17827) can also be seen (arrowed in yellow). A large spoil heap which could not be removed may have concealed a continuation of the plough lines in the southeast of the property.

The lines were distinct and represent a single cultivation activity, where the plough had only been dragged once across the area with no criss-crossing or re-ploughing (Figure 3.23). Therefore, the cultivation marks probably denote a single crop. This act of single ploughing may reflect a practice of permissive occupancy whereby a grant could be secured by showing improvement of the land as required under the grant. As the area of ploughing appears to be largely contained within the boundary of Lot 1, Section 15 it is likely that it was undertaken by Bateman during his occupancy, and therefore should be dated to the 1820s. However, it may rather be part of a larger ploughing event undertaken earlier as part of the cultivation noted on a plan of c.1796, where the study area is marked as 'ground under cultivation'. A few agricultural marks and linear features revealed in the adjacent yard of Lot 30 (Area A) could be part of that event but the evidence there is ephemeral and certainly not conclusive. It is possible that the plough lines continued

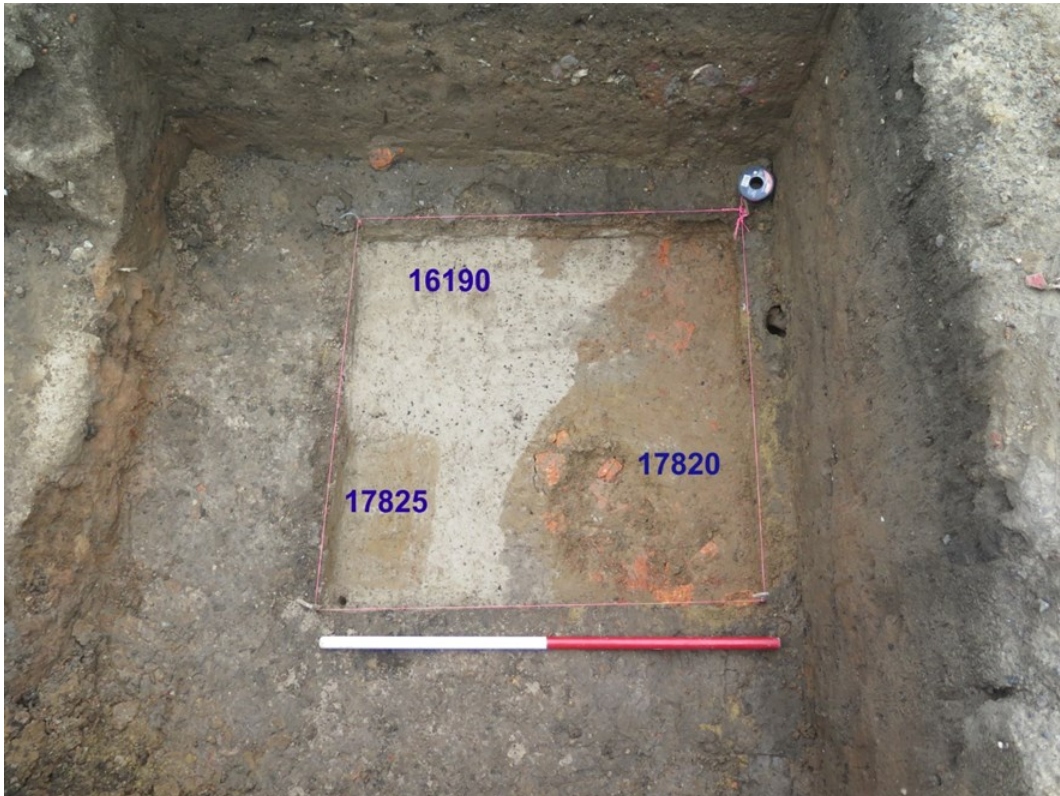
Figure 3.24: Aboriginal test pit BJ16 with features 17820 and 17825 shown cutting through the subsoil. View to the west, 1m scale, IMG_3420.

TT28 was a large T-shaped machine-excavated test trench 20m south of Macquarie Street. The trench was initially opened as an Aboriginal 1 x 1m test pit (square BJ16). Within BJ16, the edges of two historical features were revealed cutting into the natural subsoil, context 16190 (Figure 3.24). The Aboriginal testing was abandoned at this stage as the soil was clearly disturbed and the features historical. The test pit was expanded by machine to investigate these features, ultimately measuring 10m north-south and 1.8m–5.3m east-west and 1.5m deep from the top of the existing concrete surface. The smallest of these features, context 17825, was found to be the base of a truncated posthole whereas the other proved to be the edge of a large brick-filled pit 17820.

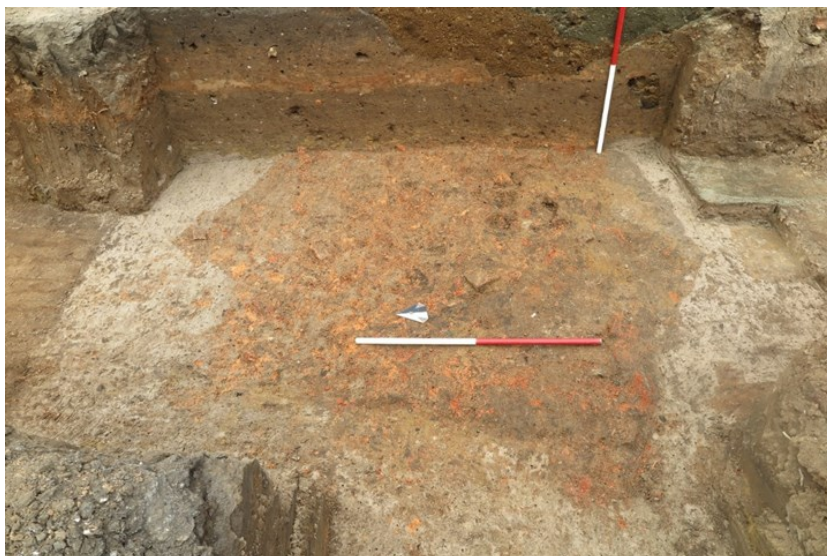
Figure 3.25: Brick fill 17821 sealing pit 17820 and postholes within TT28. View to the east, 1m scale. IMG_5381.

The remains of a probable storage pit, context 17820, was found within TT28 towards the northern end of Area D. The pit was initially identified as an irregular concentration of sandstock brick fragments, context 17821 (Figure 3.25). Excavation of the feature revealed that the bricks were a fill within a large rectangular pit cut into the subsoil, with postholes located in the north east and south east corners. Context 17821, was a series of three fills, the upper 200–300mm was made up of compacted sandstock brick rubble composed of flat orange sandstock fragments, mostly quarter and half brick pieces, within a matrix of redeposited modified historic topsoil 17819 (Figure 3.26). Some dark green glass fragments were found within the brick rubble. Below this was a patchy, firm dark-grey silty clay (redeposited subsoil 16190), up to 100mm thick sitting above a thin band (10–20mm) of

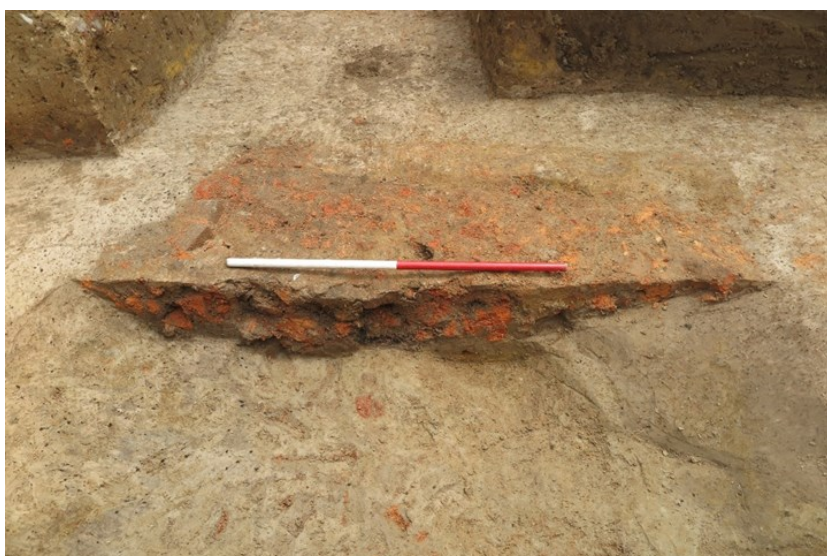
Figure 3.26: Brick fill 17821 of pit 17820, shown half sectioned within TT28. View to the west, 1m scale. IMG_5409.

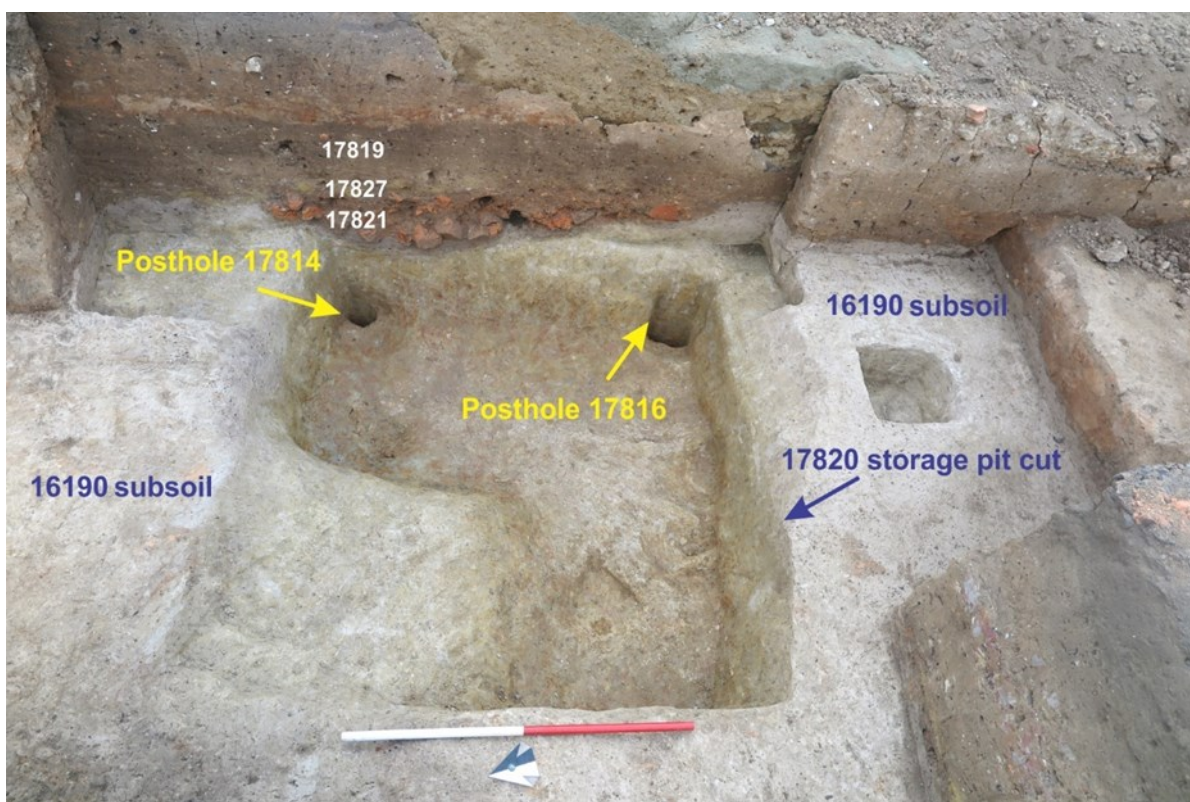
Figure 3.27: Probable storage pit cut into subsoil with two postholes on the eastern side. The pit was filled with sandstock brick fragments, context 17821. View to the east, 1m scale. IMG_5497.

Postholes 17814 and 17816 were located in the north and south-east corners of the pit (Figure 3.27) summarised in Table 3.2. These postholes may have formed part of the superstructure above the pit perhaps supporting a lean-to roof as they were only on one side and none were found on the western end. The postholes were not visible from above and were sealed by the brick fill within the pit. Therefore, the timbers must have been removed when the pit was abandoned and backfilled.
