3PS – 153 MACQUARIE STREET, PARRAMATTA

TRENCH REPORT – AREA D

JANUARY 2018

VOLUME 2, SECTION 7.4

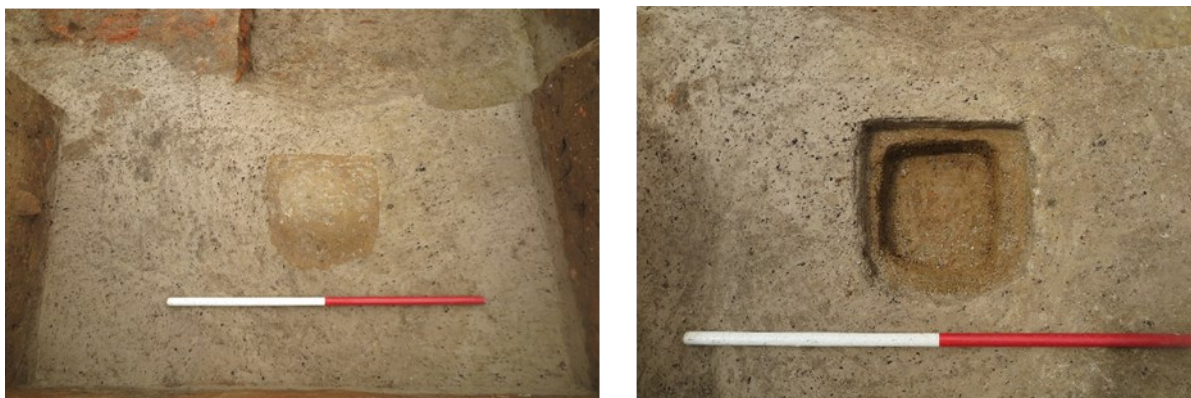
Figure 3.28: Posthole 17825 and fill 17826 pre and post excavation. View to the north, 1m scale. IMG_5403 & IMG_5423.

A single posthole (context 17825) was found immediately (600mm) to the south of the storage pit 17820 (Figure 3.28). This posthole was truncated and although the cut was clear the postpipe was less well defined when excavated. The function of this posthole was not determined however, it was probably contemporary with the storage pit and its associated postholes. Description is given in the table of postholes within TT28 below (Table 3.2).

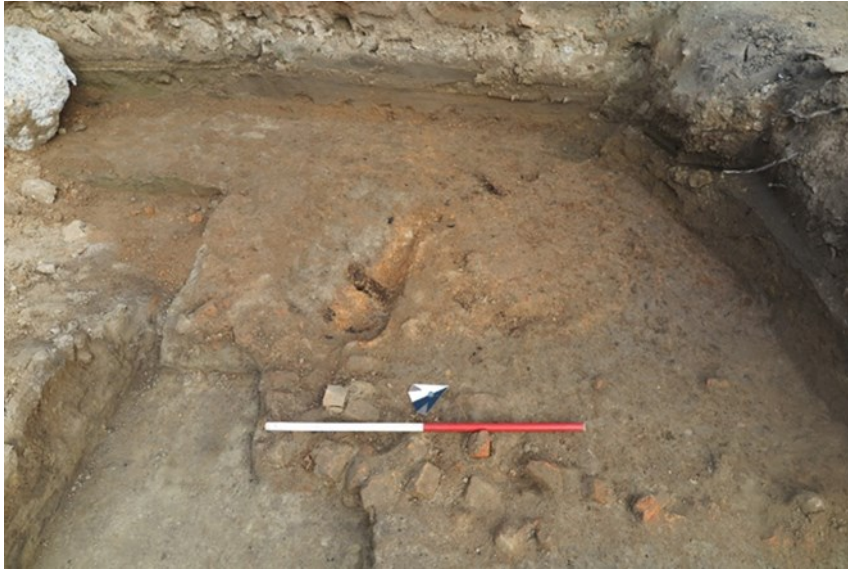
Figure 3.29: Tree bole at the base of TT27 with decayed timber/roots and sandstock brick fragments. View to the west, 1m scale. IMG_5504

TT27 was a cross shaped machine excavated test trench 16m to the south of TT28, 5.2m x 3-4m with a maximum depth of 1.92m. Originally dug to remove overburden to facilitate the Aboriginal test squares, TT27 was extended when a feature was found cut into the subsoil at the base of the modified topsoil and fills. In the base of TT27 a burnt-out tree with fired clay and charred timber had been backfilled with context 17830, a mix of sandstock brick fragments and modified topsoil (Figure 3.29). The burnt-out tree root system was 1.5m north-south, 1.8m east-west and 180mm deep. The brick fragments within 17830 were orange flat (unfrogged) ¼ and ½ bricks in a redeposited modified topsoil matrix. A similar pit was found in TT34, 3m to the north west of TT27.

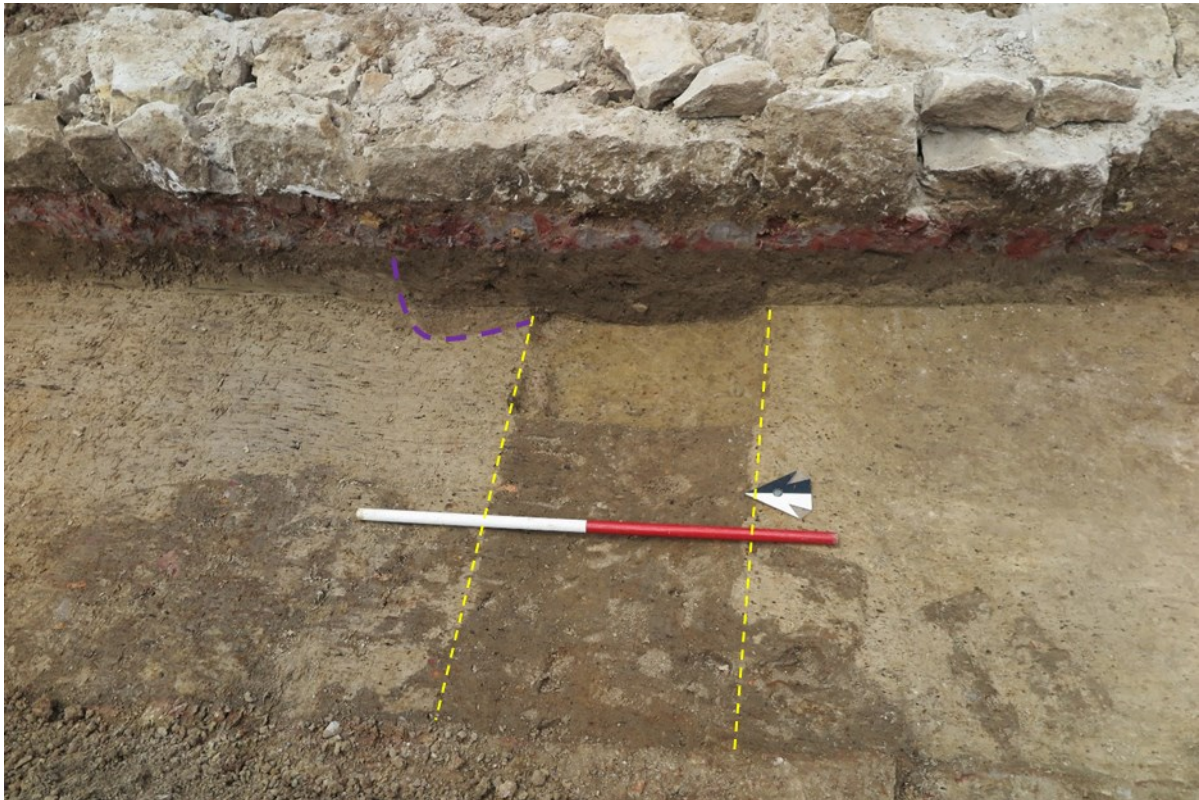
Figure 3.30: Linear feature 17828 (dashed in yellow) below north-south aligned sandstone fence 17275 on the boundary of Lot 30 and Lot 28 and a possible posthole dashed in purple. Also showing the pink and grey clay levelling fill 17895 beneath the fence. View to the east, 1m scale. IMG_5450.

TT30 was a machine excavated north-south oriented trench dug beside the boundary fence 17275 between Lot 28 and Lot 30. The test trench was 4.40m long x 1.5m wide x 620mm deep. A shallow linear feature 17828 found in TT30 may represent a drainage channel running east west (Figure 3.30). The channel was filled with context 17829, a fine-grained grey/brown sandy silt with frequent charcoal flecks, occasional iron stone nodules and small <20mm sandstock brick fragments. The feature was cut into the subsoil 16190. The channel fill was topped with modified historic topsoil 17819 which was sealed by a mottled pink and grey redeposited clay (17895) used as a levelling fill under the sandstone boundary fence 17275. To the east of the linear feature was a square cut that may represent a posthole - perhaps associated with a former timber fence as it is positioned directly below the later sandstone fence. This drainage channel is probably associated with the occupation of the 1820s cottage 4 in Area A - Lot 30 immediately to the east (see Area A 3PS Trench Report).

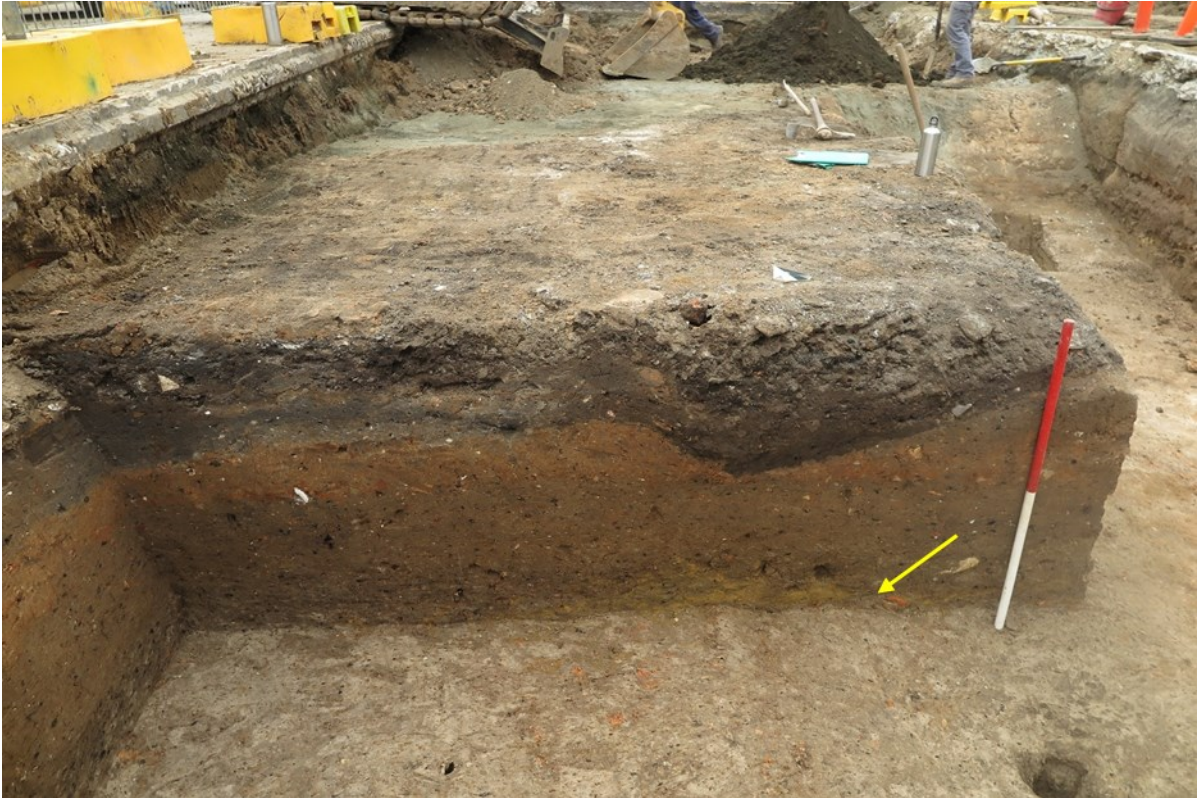
Figure 3.31: Lens of yellow sandy material 17827 above disturbed subsoil and below modified topsoil 17819 in TT28, arrowed; also found in patches above plough lines. View to north, 1m scale. IMG_5419.

A lens of yellow sandy material, context 17827, was found in TT28 where it showed up just above the subsoil as an interface between the modified topsoil and the underlying subsoil (Figure 3.31). In the southern part of Area D, this deposit was found over/associated with the top of plough lines (Figure 3.18, Figure 3.23). Mottled mustard yellow and grey brown, coarse, clayey sand interface between the modified topsoil 17819 and the subsoil. This deposit was only found in patches across the site but was always associated with redeposited topsoil, therefore, must be related to modification of the natural deposits, probably caused by agricultural activity.

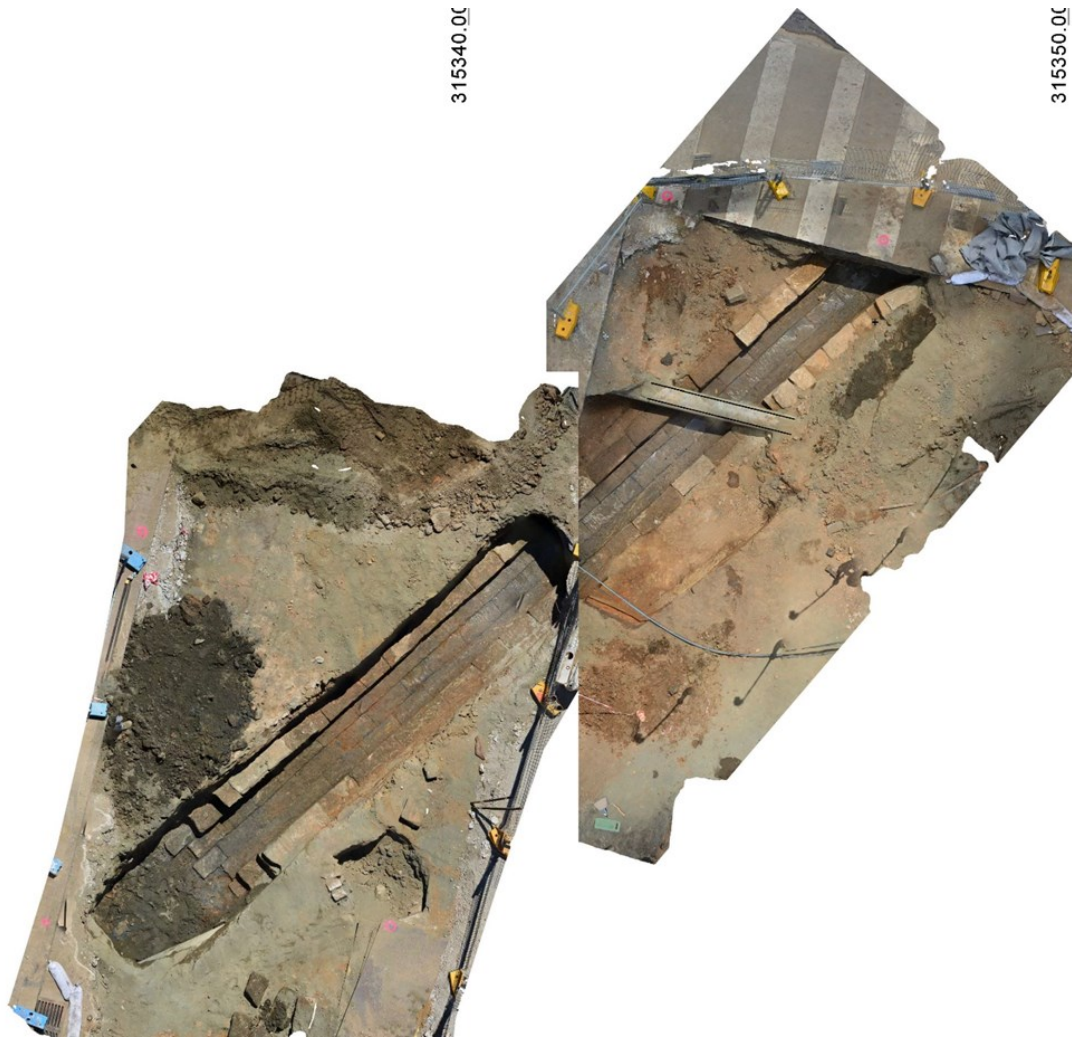
Figure 3.32: Composite orthophoto of the Town Drain extending diagonally across Civic Place. (Hazell 2016).

The Parramatta Town Drain, (context 17824) constructed in sandstone at its southwestern end, and sandstock brick elsewhere, passes diagonally across Lot 28/Civic Place (Figure 3.32). The portion of the drain uncovered during the excavation in Area D was constructed in stone in the 1840s. The 15.50m segment of the Town Drain was excavated within the roadway (Leigh Place) in two stages due to access issues (Figure 3.33, Figure 3.34). When the drain was removed it was found to have been built within an existing creek line or channel with a row of upright timbers embedded in the western side forming a barrier or shoring (17853) with a fill of sandstone rubble (17857) packed behind the timbers. This indicates that the creek line was being manipulated or formalised before the drain was

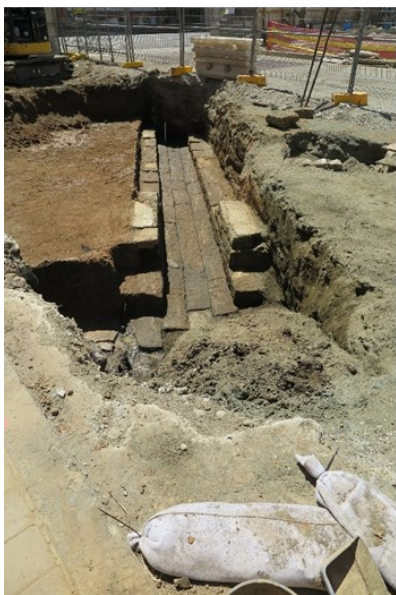
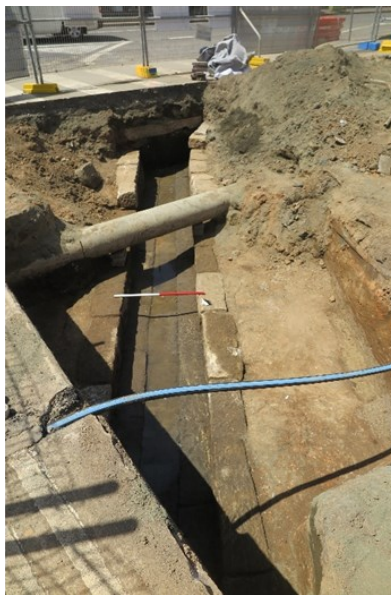
Figure 3.33: Southwestern end of sandstone Town Drain (left). View to the north. IMG_5755. Northeastern end of drain going under Macquarie Street (right). View to the north, 1m scale. IMG_5522.

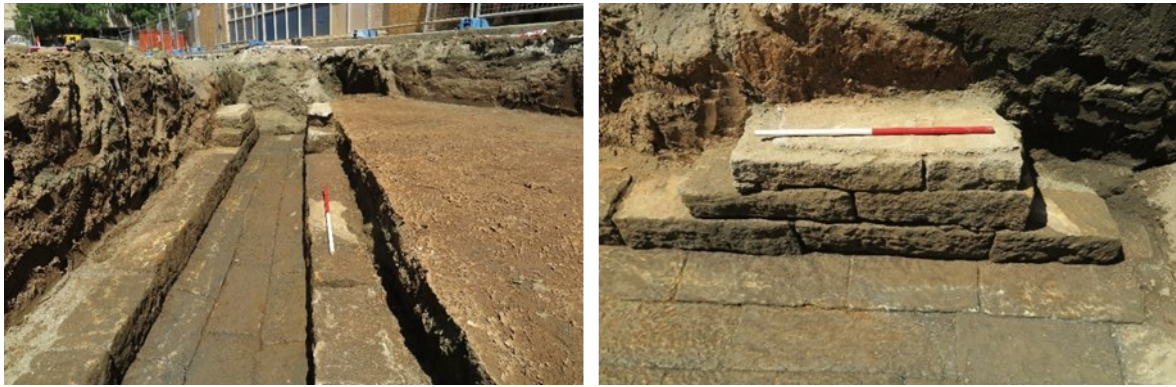
Figure 3.34: View of the southwestern end of the drain. View to the south west (left). IMG_5745. Detail of coursing of the western wall of the drain (right). View to the west, 1 m scale. IMG_5742.

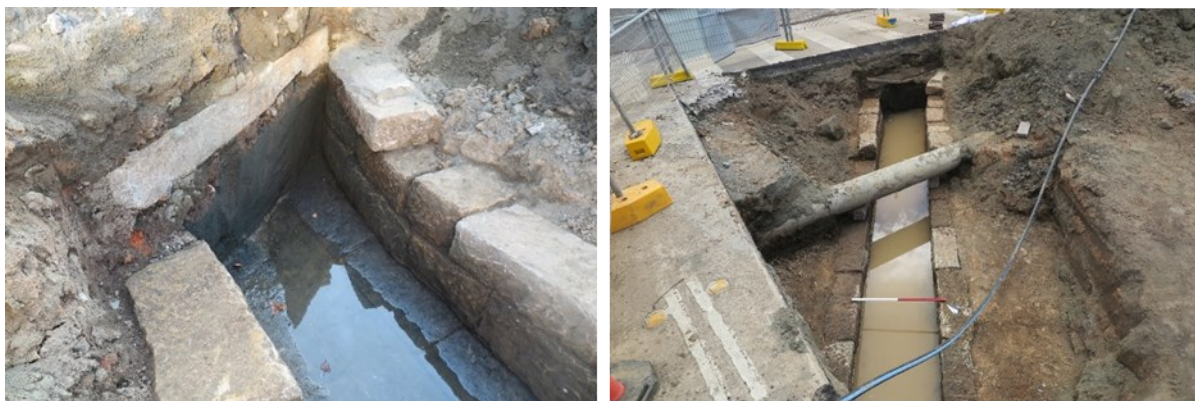
Figure 3.35: Detail of curved eastern wall of Town Drain heading under the pavement of Macquarie Street. View to the north east. IMG_5545 (left). The drain as an effective water receptacle after heavy rain. View to the north east, 1m scale. IMG_5443 (right).

The eastern wall of the drain appeared to curve at the north eastern Macquarie Street end, veering to the east under the pavement with a concrete slab on top (Figure 3.35). The southwestern end of the drain was truncated by a cement storm-water pipe which had replaced the drain in the 1960s. The whole of the sandstone drain under the road was filled with stabilised sand and road base.

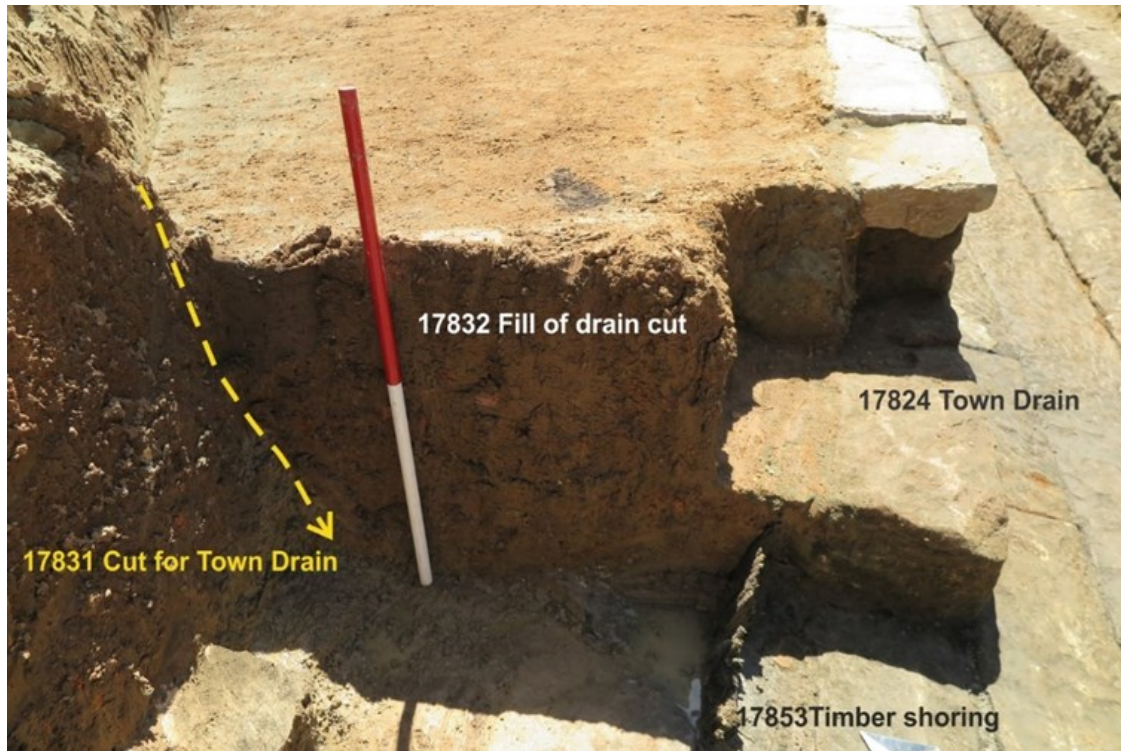
Figure 3.36: Western side of the Town Drain showing the cut and fill for the drain. View to the north, 1m scale. IMG_5739.

The western cut for the drain was clearly identified for a length of 10.5m whereas the eastern side was only found for a length of 3.5m due to the presence of a c.1950s storm water service. The cut was a wide U-shape approximately 3.30m wide and at least 1.2m deep. The cut had gently sloping slightly curving sides and a concave base. The cut was excavated deliberately to allow the sandstone blocks to be installed, perhaps widening the original channel.

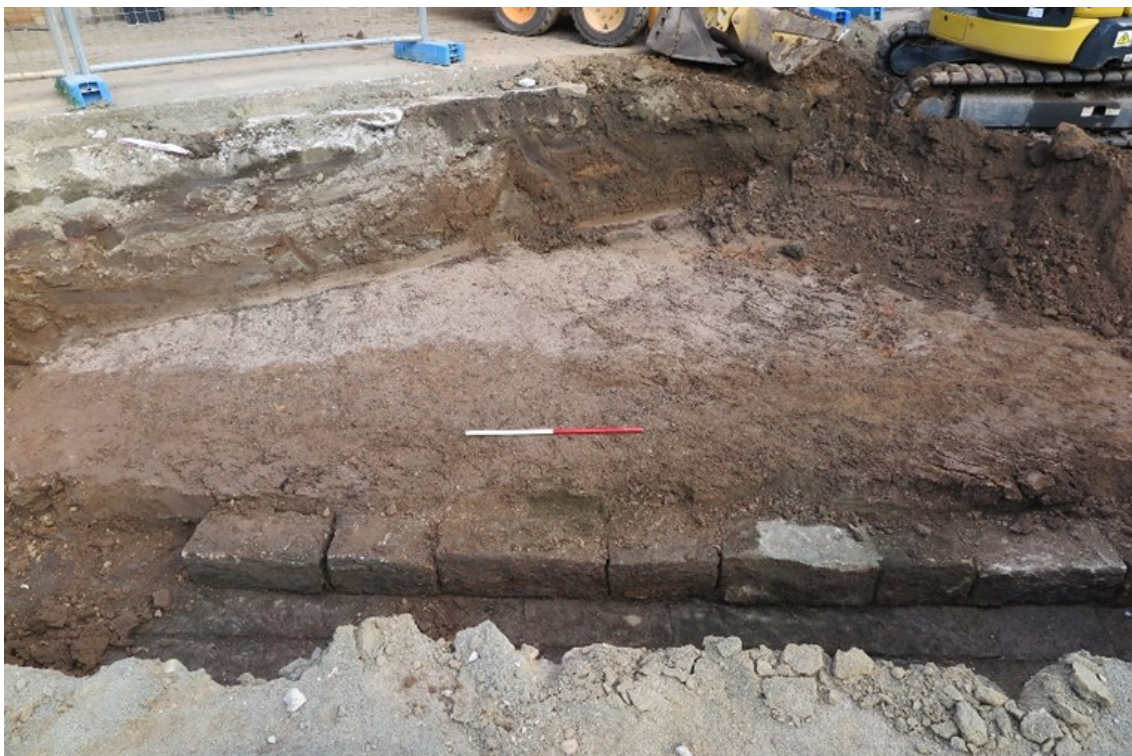
Figure 3.37: Cut 17831 visible cutting into the pale subsoil on the north western side of the drain. View to northwest, 1m scale. IMG_5793.

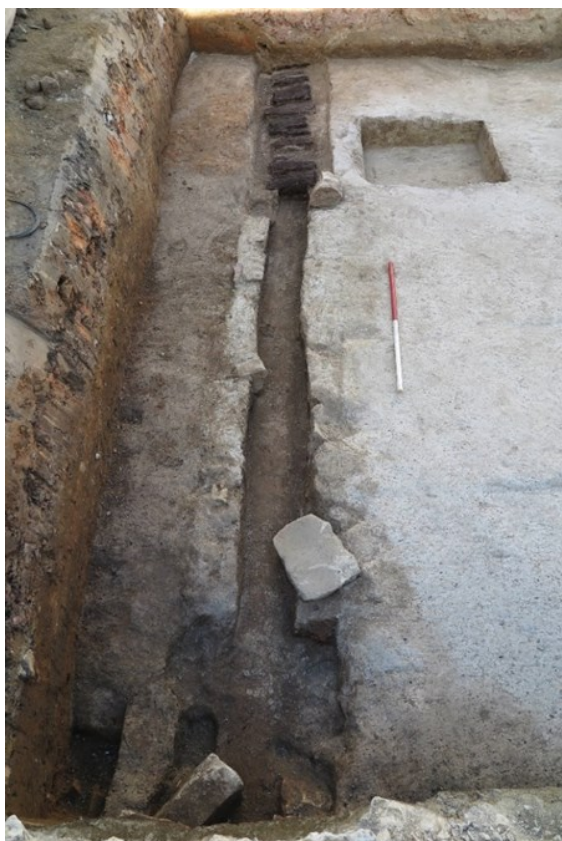
Figure 3.39: Timber capped drain leading from the sump/cess pit from Lot 30 in Area D to the Town Drain. View to the east, 1m scale. IMG_6093.

The extant drain was constructed from timber pieces (ranging from 300–420mm long, 100–250mm wide and 30–60mm thick) cut to fit in the channel at the eastern end for 2.2m and occasional sandstone blocks lining the sides of the drain at the western end for 3.7m. Building materials sample BM 113 was taken of the timber capping. In the western trench edge, east facing section, where the drain disappeared under the footpath, the drain was a more formal structure with sandstone sides and capping (Figure 3.40). This suggests that in the western section of the drain, the sandstone blocks had been robbed out and the few blocks left in place were the remains of that structure.

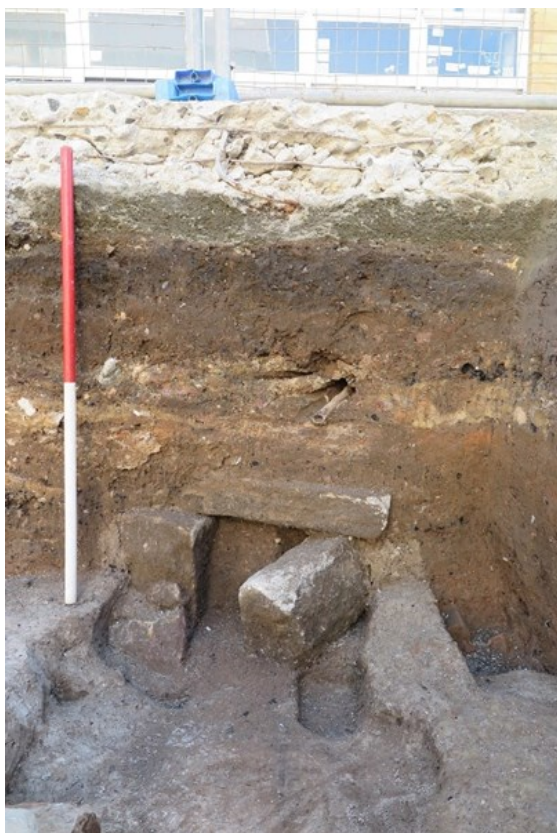
Figure 3.40: Sandstone end of the drain leading into the Town Drain. View to the west, 1m scale. IMG_6088.

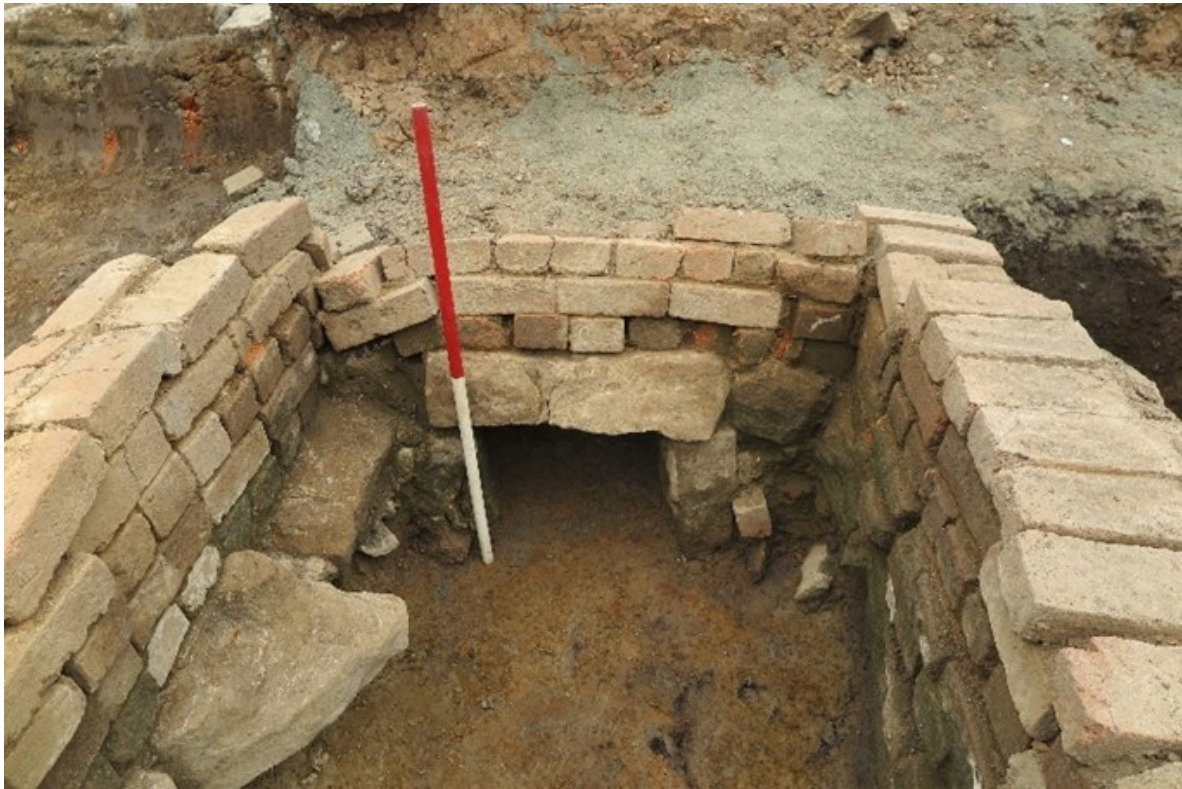
Figure 3.41: Sump or cesspit on Lot 30 found in Area A associated with the 1820s cottage and shown on the Railway Resumptions plan of 1858. The channel of the drain continued as the timber capped drain on Lot 28 in Area B. View to the west, 1m scale. IMG_4680.

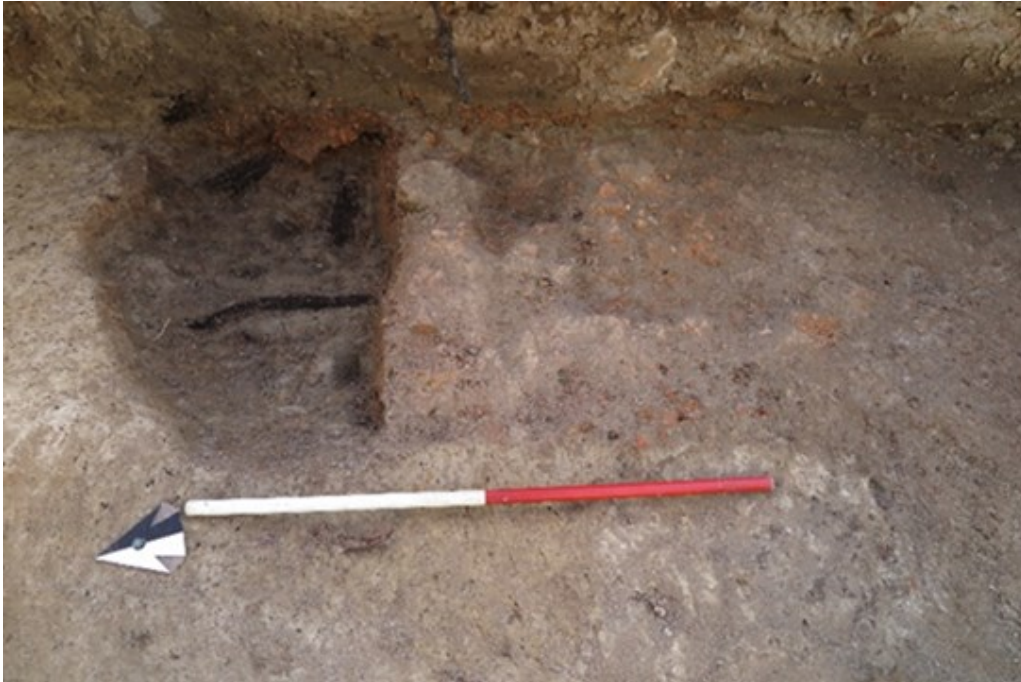
Figure 3.43: Brick filled pit 17882, partially sectioned with brick rubble in place to the south and decayed timber at the base. View to the east, 1m scale. IMG_6067.

base of the fill, this timber may be part of a general demolition fill along with the discarded brick pieces or may be tree roots. The pit was similar to a brick and decayed wood-filled pit within TT27, 3m to the southeast.

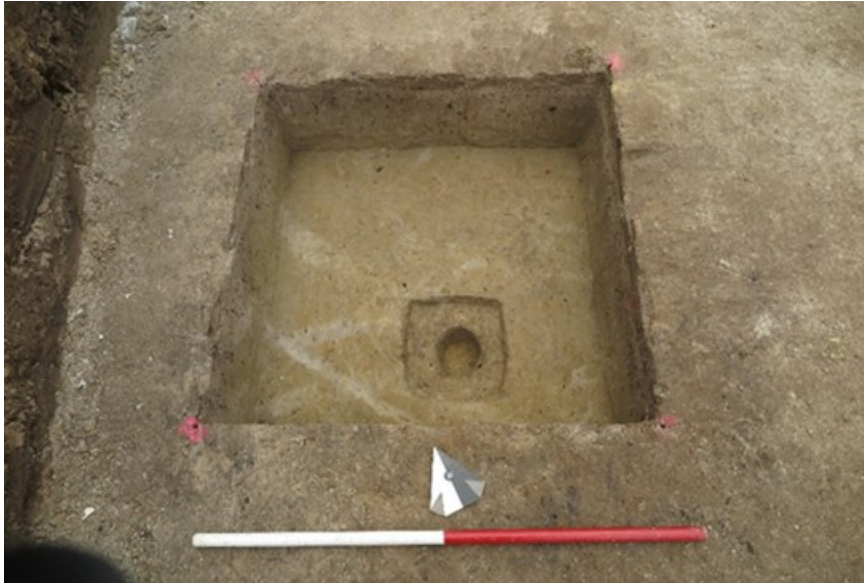
Figure 3.44: Posthole 17861 identified within Aboriginal Test Pit BT21. View to the north west, 1m scale. IMG_5838.

In TT34 a series of post holes were identified to the south of the timber-capped drain 17888. Two postholes (contexts 17861 and 17869) were found within Aboriginal test pits; BT21 and BQ20, close to the drain, these were excavated during the Aboriginal testing (Figure 3.44, Figure 3.45). Posthole 17869 contained a piece of remnant timber post. The other postholes, 17878 and 17884, were further from the drain (Figure 3.46). The postholes were only visible cutting into the subsoil 16190 and were obscured by the modified topsoil. Each of the four postholes was different and they did not seem related to one another. They did not appear to form an identifiable structure. These postholes are probably related to the use of the area during the early occupation of the cottage on Lot 30 and the installation of the timber-capped drain. However, it is not clear what function they may have had. The following Table 3.3 is a summary of these postholes.

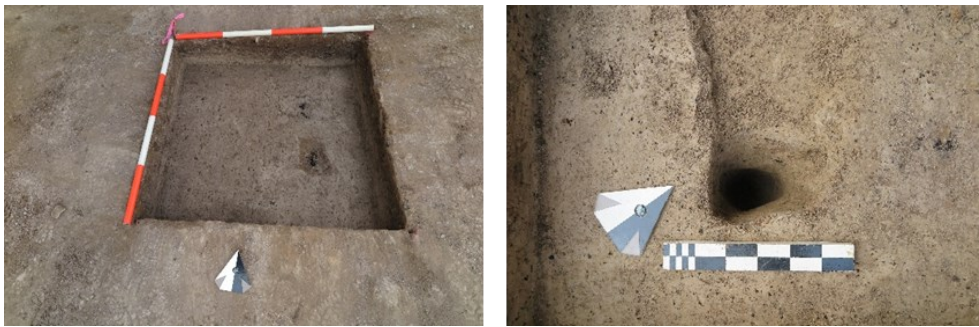
Figure 3.45: Posthole 17869 (left) found within Aboriginal test pit BQ20. View to the north, 1m scale. IMG_5873. Post ex posthole 17869 (right). View to the north west, 300mm scale. IMG_5877.

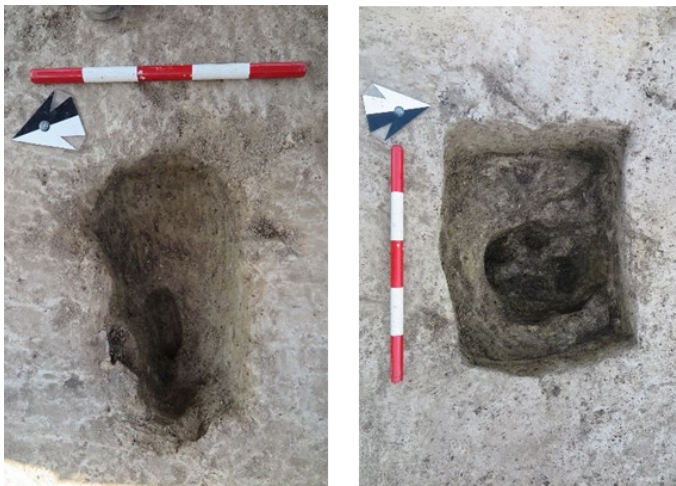
Figure 3.46: Post ex of posthole 17884 (left). View to the east, 500mm scale. IMG_6072. Post ex of posthole 17878 (right). View to the west, 500mm scale. IMG_6059.

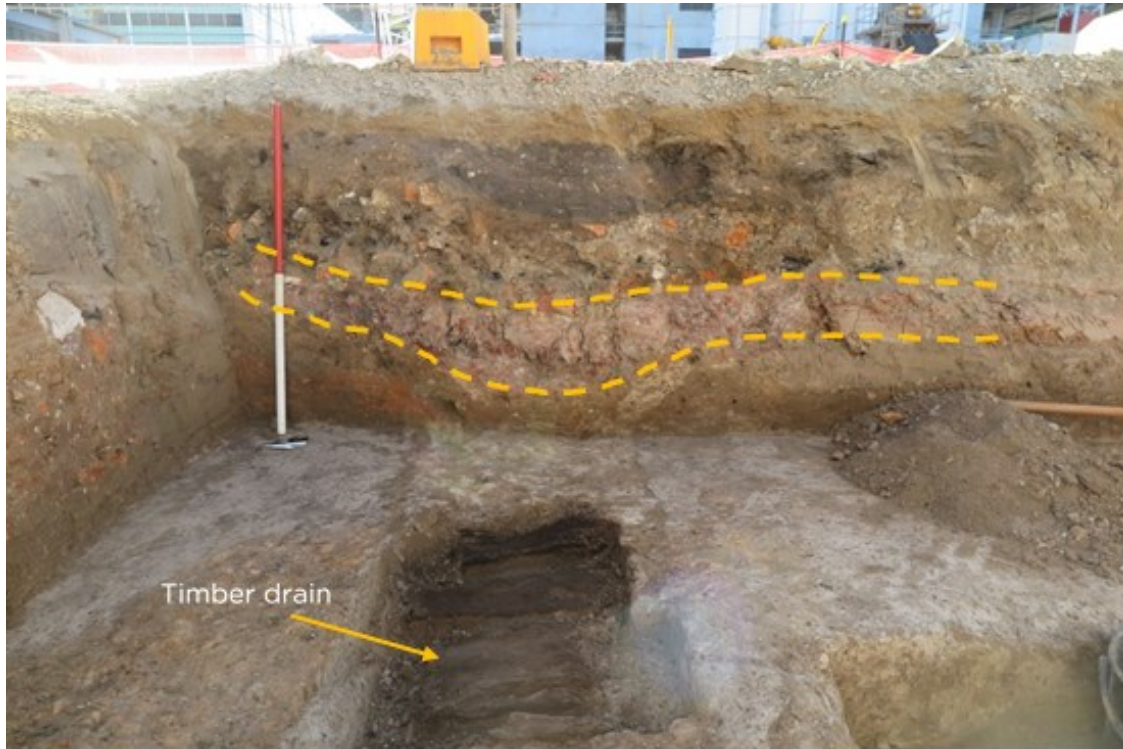
Figure 3.47: View of timber drain 17888 with pink and grey clay levelling fill 17895 above dashed in yellow. View to the east, 1m scale. IMG_6062.

A dense mottled-pink and grey clay levelling fill, context 17895, was found capping the timber-capped drain 17888 (Figure 3.47). This levelling fill was also found directly below the north-south aligned fence, context 17275, on the boundary between Lot 30 and Lot 28 (Figure 3.48).

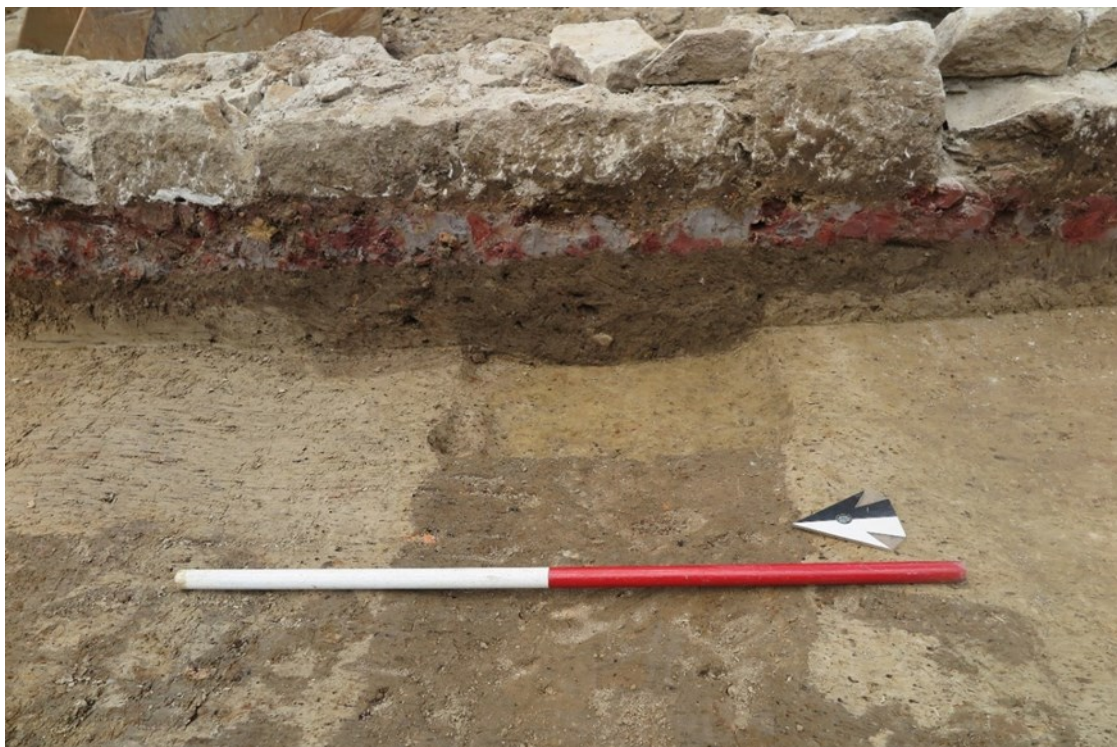
Figure 3.48: Pink and grey clay levelling fill directly beneath sandstone wall 17275 on the boundary of Lot 28 and Lot 30 within TT30. View to the east, 1m scale. IMG_5451.

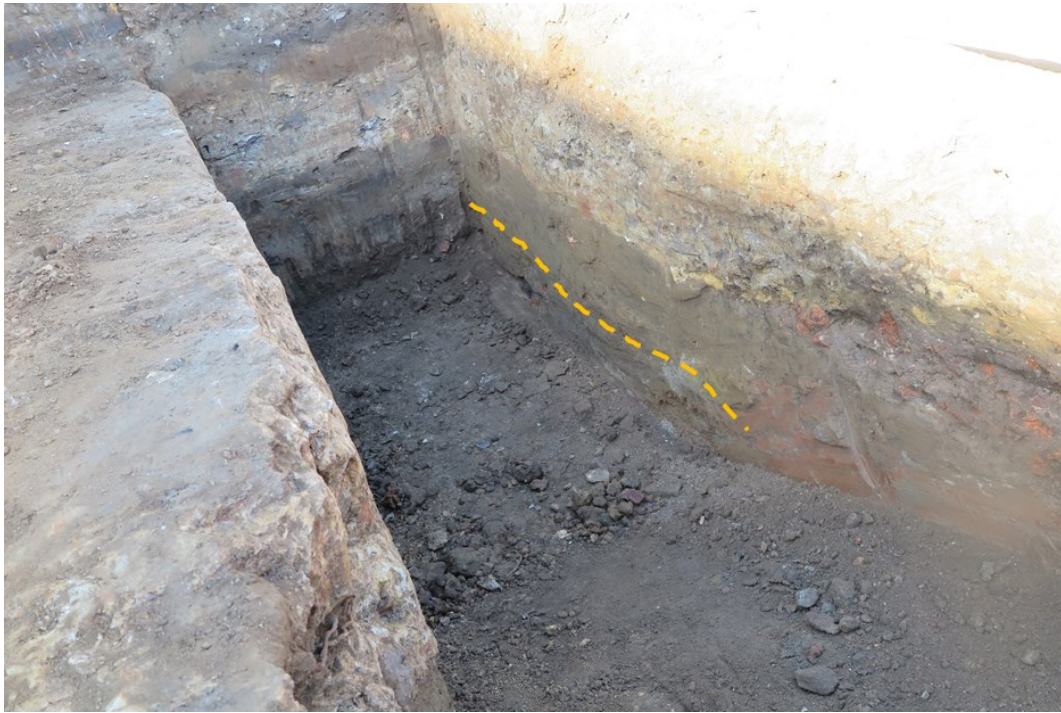
Figure 3.49: East facing section of TT31 showing the fills within the pond. The pink/orange basal clays (19919) can be seen at the right with the lowest deposit of grey silty clay (17854) seen below the dashed yellow line. View to the south-east. IMG_5689.

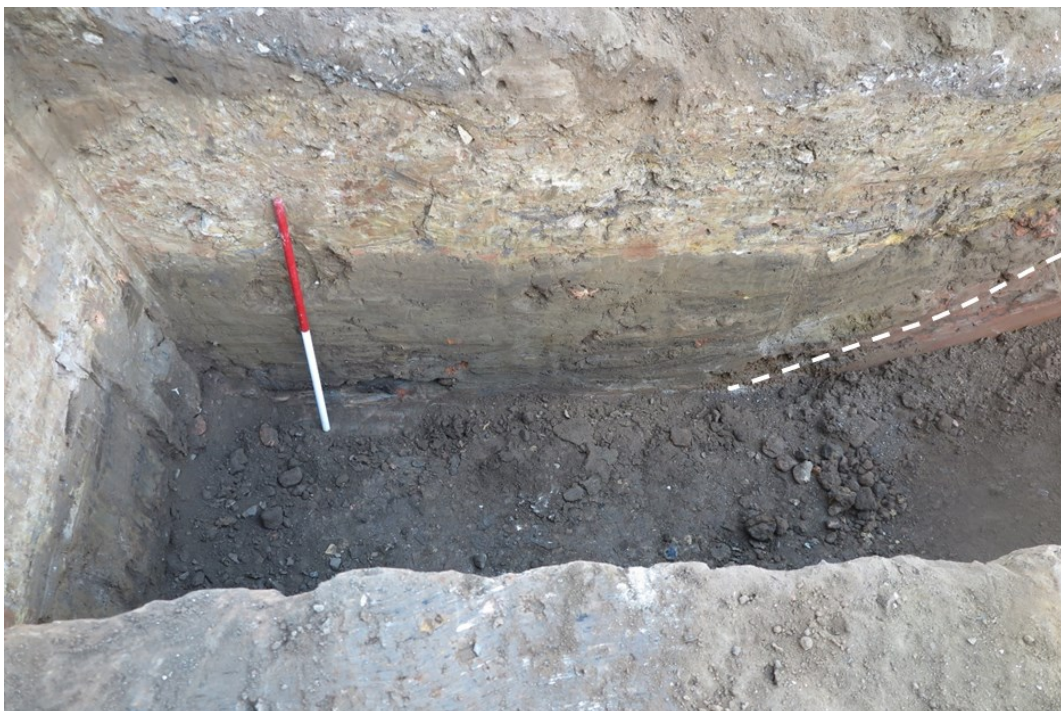
Figure 3.50: East facing section of TT31 showing pond fills including the grey silty clay at the base (17854) with timber and sandstock brick fragments within. The grey clay sits directly on the basal pink/orange clays 19919. The cut for the pond is visible to the right (dashed). View to the west, 1m scale. IMG_5684.

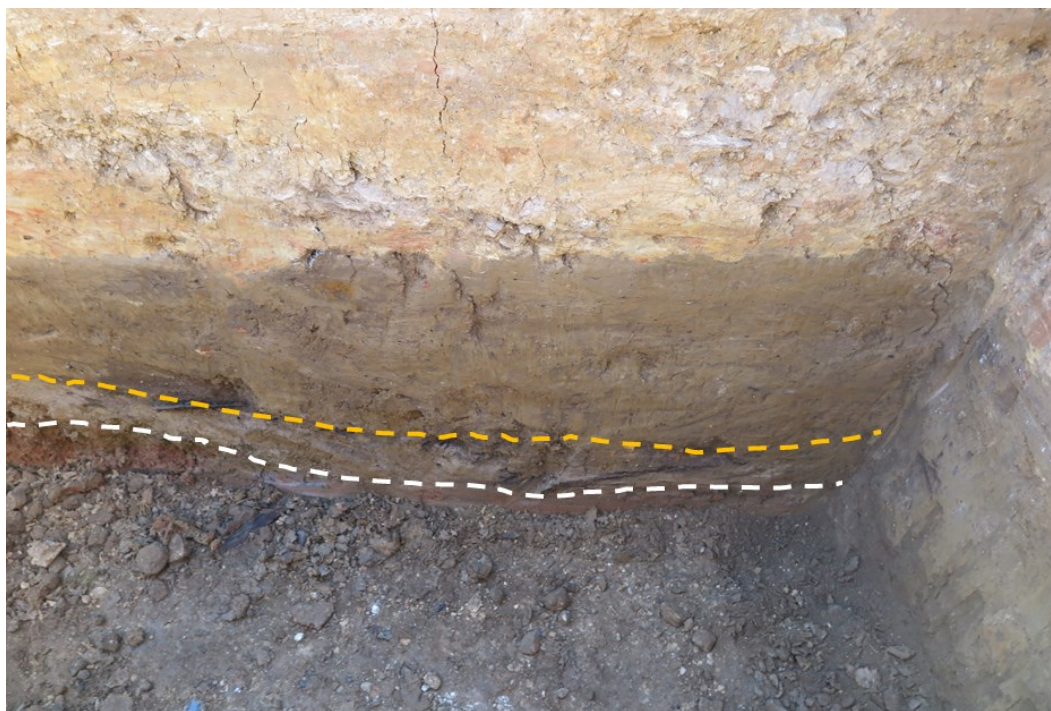
Figure 3.51: West facing section of TT31 showing the pond fills. Below the white dashed line is the mottled pink/orange clay 19919 with the grey silty clay 17854 resting above. Several pieces of semi-decayed timber were found within this deposit having sunk to the bottom of the pond. Clays tipped into the pond as backfill can be seen above the yellow dashed line. View to the east. IMG_5691.

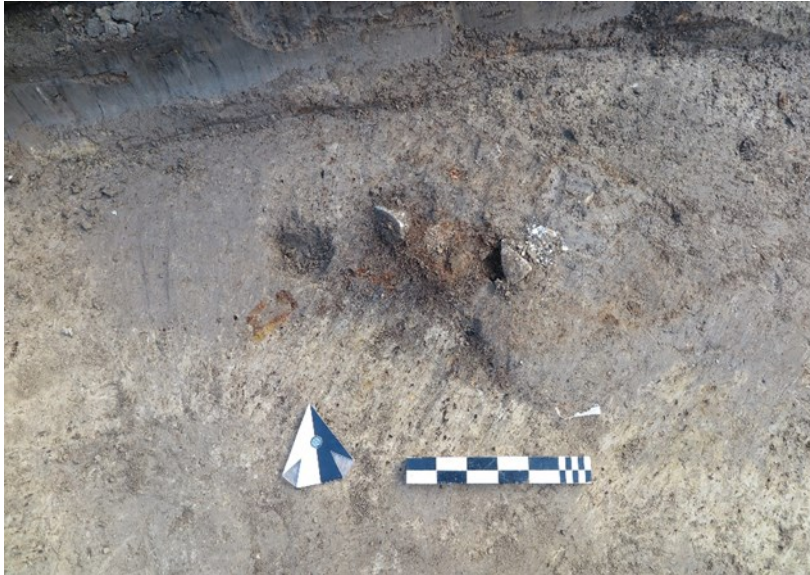
Figure 3.52: Pit 17873 before excavation. Found within plough-line. View to the north 300mm scale. IMG_5915.

A shallow irregular pit (context 17873), loosely oval in plan was found cutting into the fill of a plough line (Figure 3.52). The pit was shallow with vertical sides to the north and a gently sloping edge to the south. The pit was 700 x 500mm with a maximum depth of 70mm. As the pit was quite shallow it is probable that it had been dug from higher up in the modified topsoil overlying the plough line and only the truncated base was preserved. The pit fill (17874) was a mid-brown sandy silt with some iron staining, which contained a high concentration of artefacts. These included animal bones, ceramics, glass and metal. The pit was identified as purposely dug for depositing rubbish after the plough lines had been covered by topsoil.

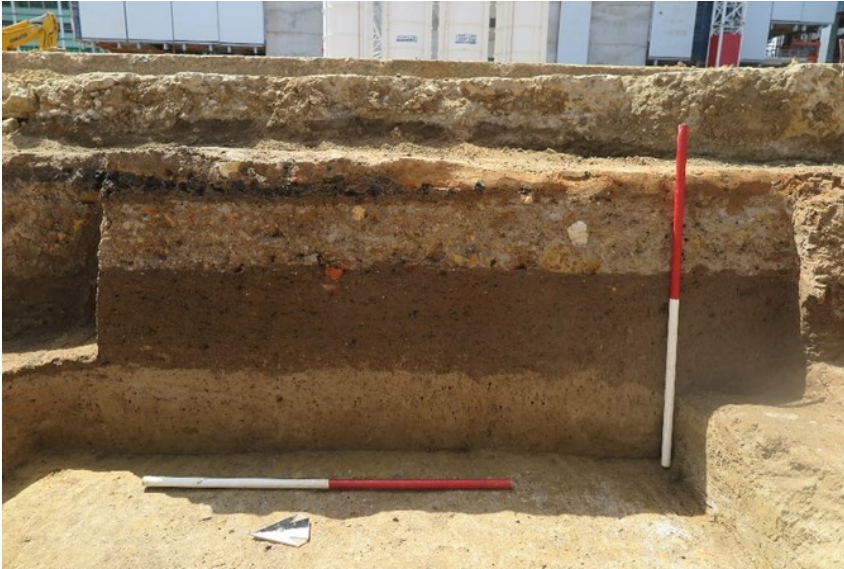
Figure 3.53: Modified historic topsoil 17819 shown sitting above subsoil 16190 and below a series of 20th-century levelling fills 17822 within TT28 western extension. View to the south, 1m scale. IMG_5433.

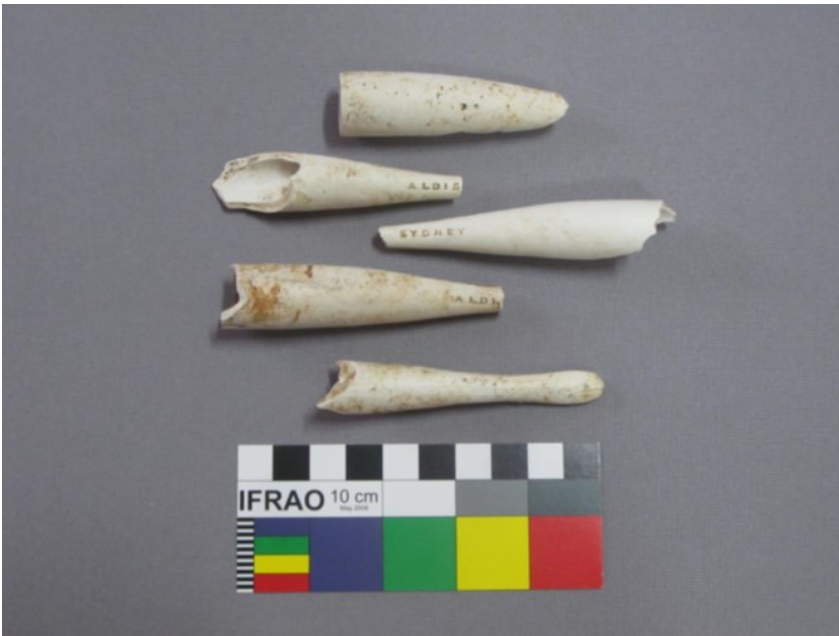
Figure 3.54: Examples of pipes or cigarette holders found in the topsoil of Lot 28, Civic Place, 'Aldis/ Sydney'. 100mm scale. (Casey & Lowe 2016).

An extensive deposit above the natural soil profiles was identified as a modified historic topsoil. In Area D, this was numbered 17819 and was equivalent to 16120 in Area A, Lot 30 to the east. There was no definitively intact original topsoil in Area D, whereas some had been found beneath levelling fills under Cottage 4 in Area A (see Area A Trench Report). In Area D, the modified topsoil had been redeposited and overturned during the initial period of land clearance and land-use. Some modification was clearly agricultural in nature such as ploughing, where the furrows were filled with the churned, redeposited topsoil. The thick layer of modified topsoil, was found extending across the northern half of Area D. It was identified within test trenches TT27, TT28, TT29, TT33 and TT34, up to 300-350mm thick (Figure 3.53). In the southern half of the area, it was not as thick and was less well defined, as it was mixed with the underlying subsoil through ploughing activities. The deposit was a moderately loose, fine grained grey-brown loam with frequent charcoal flecks and fragments 2-7mm, occasional sandstock brick fragments <25mm and rare sandstone fragments <20mm. The lower margins of this deposit (100-150mm) were slightly more clayey than above. The deposit was found directly overlying the pale grey subsoil 16190 where it was less disturbed and the margins between the two layers were clear. It was also found overlying the yellow sandy lenses 17827, where the it had been redeposited in areas of greater disturbance such as pits and furrows. The deposit was also found above and sealing the storage pit 17820 in TT28. The presence of building materials and other inclusions in this topsoil indicates that it had been exposed, worked and modified during the 19th century. The deposit was sealed by layers of levelling fills in the late-19th to early-20th century. Artefacts found in the modified topsoil included ceramics, glass and a large quantity of kaolin smoking pipe fragments or cigarette holders (Figure 3.54).

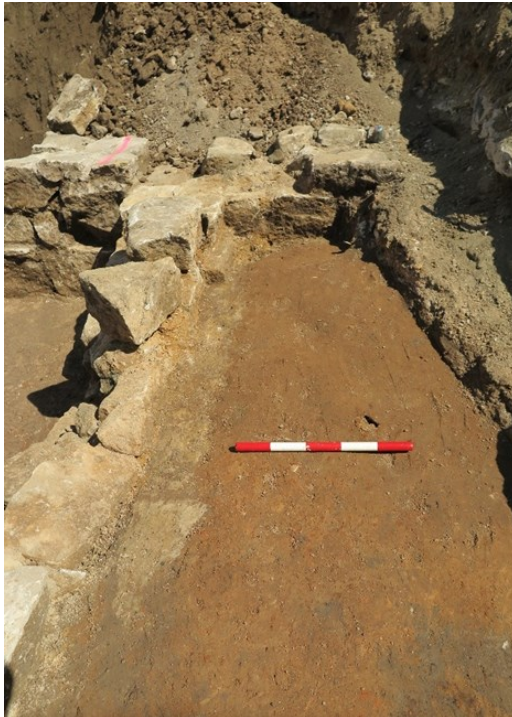
Figure 3.56: Sandstone wall footing 17896 with levelling fill 17850 inside. The southern wall stub of the building can be seen extending to the east under the limit of excavation. View to the south, 500mm scale. IMG_6049.

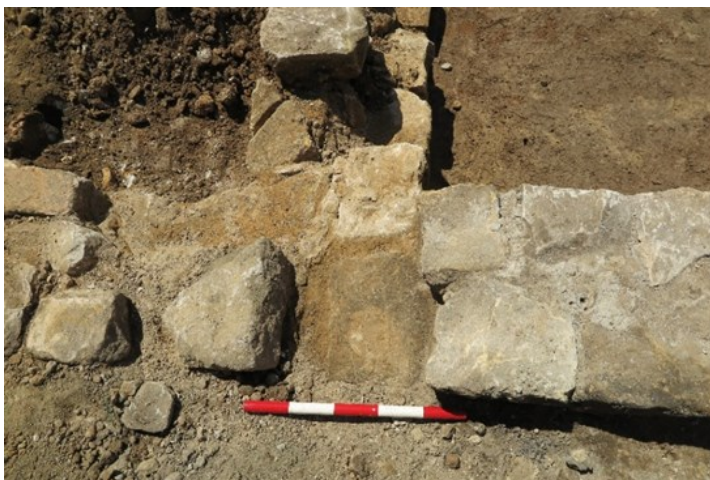
Figure 3.57: Detail of bonding between the east-west sandstone fence 17875 and the outbuilding structure 17896 showing that the fence is abutting the building. View to the north, 500mm scale. IMG_6033.

irregular undressed-sandstone blocks, standing to a maximum height of 690mm with an overall width of 400–450mm. The block sizes ranged from 100 x 120 x 130mm to 450 x 280 x 200mm. The north-south extent of the wall was 4.25m in length and the east-west wall was excavated to a length of 1.3m but did continue further to the west beyond the limit of excavation. Only small sections of each wall were found, however subsequent excavations to the west in the area of the Pound, outside the 3PS limit of excavation, undertaken by Wendy Thorp on behalf of Biosis Pty Ltd in 2016, uncovered the remains of the western wall and a continuation of the southern wall of the building. The northern wall of the structure had been completely removed by a large service trench. Abutting the north-south wall of the structure was another similar wall footing (context 17875) which was interpreted as part of the fence shown on the historic plans as discussed below (Figure 3.57).

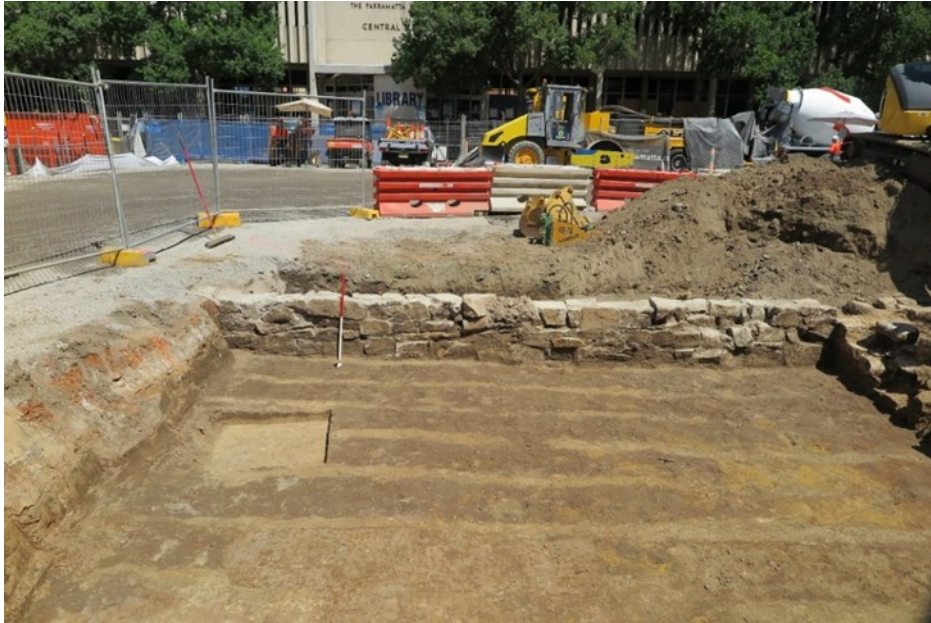
Figure 3.58: East-west fence 17875 associated with wall footings 17896. Plough lines can be seen in the foreground that pre-date the wall. View to the south, 1m scale. IMG_6036.

To the east of the outbuilding, on the same alignment as the southern wall footing, a second sandstone feature, context 17875, extended to the east towards the boundary with Lot 30 (Figure 3.58, Figure 3.59). This feature or footing was interpreted as a sandstone fence line running perpendicular to a north-south sandstone fence (context 17275) between Lot 28 and 30 as shown on the plan of 1895 rather than as a wall footing for a structure. The fence was two to four courses high, made of irregular sandstone pieces ranging in size from 100 x 120 x 130mm to 200 x 280 x 450mm. The larger stones were more rectangular and appeared to be more deliberately shaped. The width of the wall was 480-500mm with a height of 600-900mm. Bonded with a firm pale grey sand mortar with occasional flecks of burnt shell. Building materials sample BM #111 was taken of the mortar bonding of this wall. A foundation trench for the wall was identified to the north of the wall in the eastern side of TT35 and either side of the wall in the western side TT35. The cut (17876) was 90-110mm wide on either side of the wall with a total width of 600mm, with vertical sides and a maximum depth of 390mm. The foundation trench was filled with context 17877, a moderately loose mid-brown silt with occasional charcoal pieces (2-5mm) and small sandstone fragments 20-40mm (Figure 3.60).
