3PS – 153 MACQUARIE STREET, PARRAMATTA

TRENCH REPORT – AREA D

JANUARY 2018

VOLUME 2, SECTION 7.4

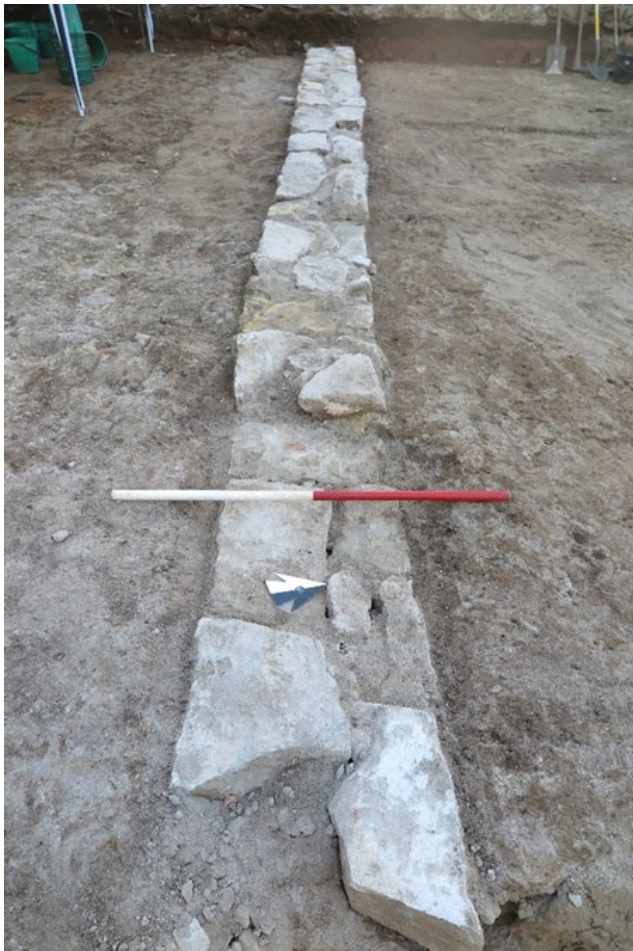
Figure 3.59: Eastern end of east-west aligned fence/wall 17875. View to the east, 1m scale. IMG_5584.

To the east of the outbuilding, on the same alignment as the southern wall footing, a second sandstone feature, context 17875, extended to the east towards the boundary with Lot 30 (Figure 3.58, Figure 3.59). This feature or footing was interpreted as a sandstone fence line running perpendicular to a north-south sandstone fence (context 17275) between Lot 28 and 30 as shown on the plan of 1895 rather than as a wall footing for a structure. The fence was two to four courses high, made of irregular sandstone pieces ranging in size from 100 x 120 x 130mm to 200 x 280 x 450mm. The larger stones were more rectangular and appeared to be more deliberately shaped. The width of the wall was 480-500mm with a height of 600-900mm. Bonded with a firm pale grey sand mortar with occasional flecks of burnt shell. Building materials sample BM #111 was taken of the mortar bonding of this wall. A foundation trench for the wall was identified to the north of the wall in the eastern side of TT35 and either side of the wall in the western side TT35. The cut (17876) was 90-110mm wide on either side of the wall with a total width of 600mm, with vertical sides and a maximum depth of 390mm. The foundation trench was filled with context 17877, a moderately loose mid-brown silt with occasional charcoal pieces (2-5mm) and small sandstone fragments 20-40mm (Figure 3.60).

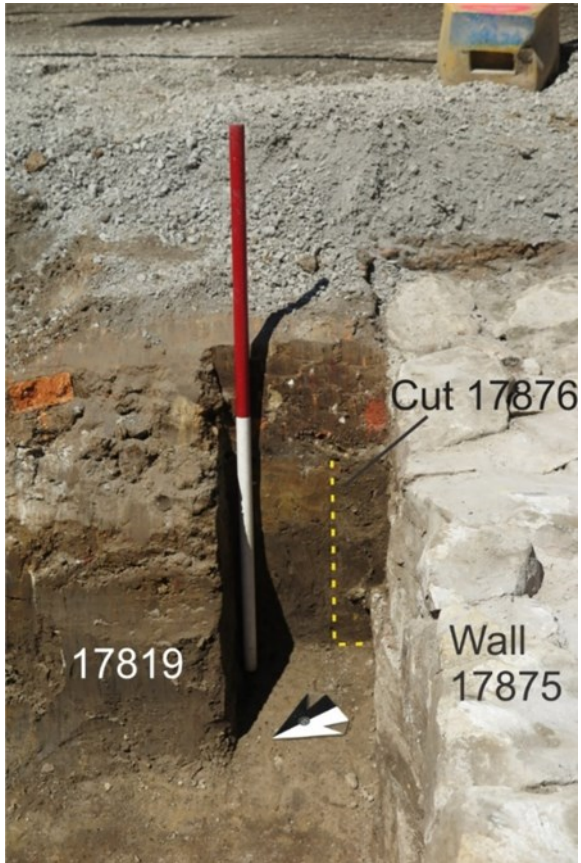
Figure 3.60: Sandstone fence 17875 with foundation trench 17876 and fill 17877 seen in the west facing section cutting through the modified historic topsoil 17819. View to the east, 1m scale. IMG_6039.

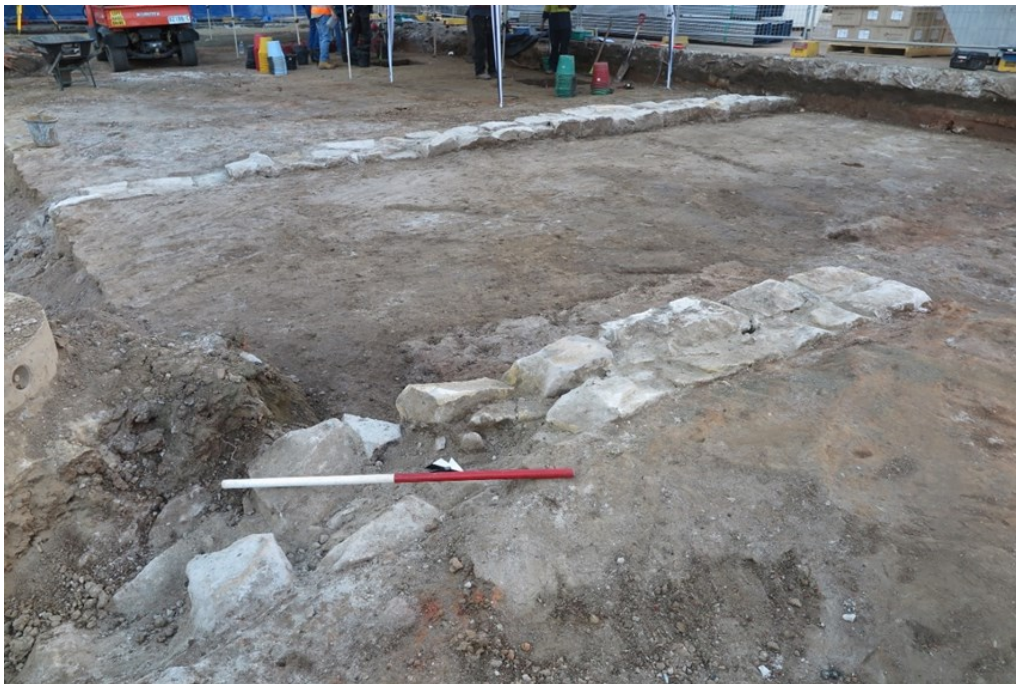
Figure 3.61: East-west aligned fence 17833 with fence 17875 in the background. View to the south west, 1m scale. IMG_5595.

A third sandstone wall-footing or fence was also uncovered in the western side of TT35. This section of walling (context 17833) was located parallel with and 4.10m to the north of fence/wall 17875 (Figure 3.61). The wall extended 3.70m to the west from the eastern edge of TT35 with a width of 450mm. The stones of the wall were similar in size and shape to those from the other sandstone fences 17875 and 17275. All of these sandstone wall footings and fences were of similar construction and it is probable that they were contemporary with each other.

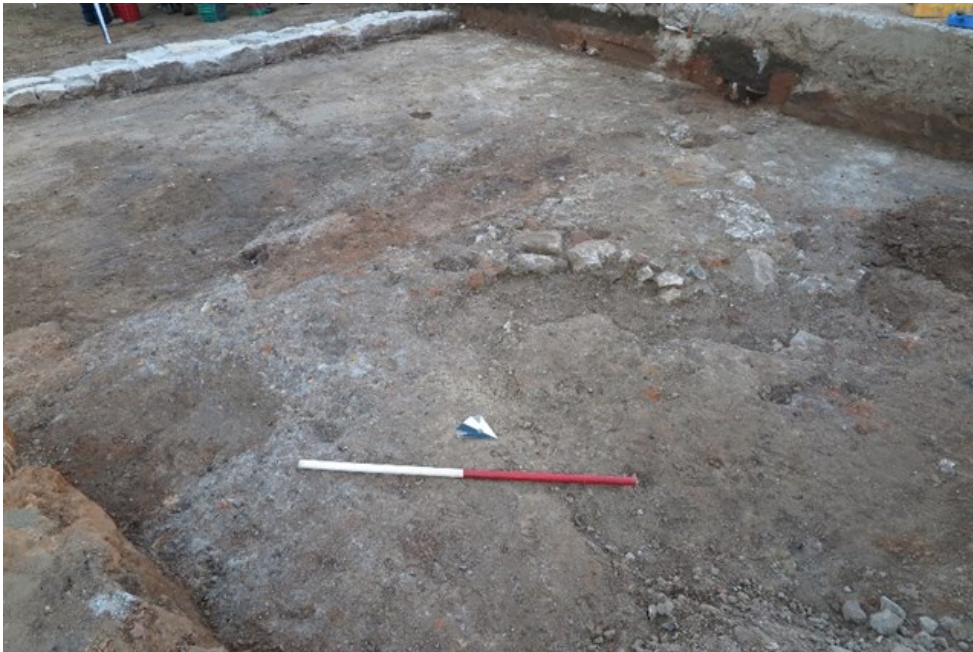
Figure 3.62: Surfaces 17851 in the northern end of TT35. View to the southwest, 1m scale. IMG_5598.

In the northern end of TT35, a series of yard surfaces were found associated with the sandstone walls or fences 17275 and 17833, identified as extending 8m east-west and c.5m north-south (Figure 3.62). The upper layer included a patch of compact cement-like surfacing adjacent to an almost paved area made of irregular sandstone rubble fragments laid together in a random pattern. Part of the surface was a patch of crushed light grey sandstone with yellow sandstone fragment inclusions. A lower section of the yard surface was a more uniform, firm fine grey brown silt with occasional sandstone fragments and some small sandstock brick pieces pressed in. Several 20th-century features, including postholes and pits, were cut into the surfaces. The surfaces were sealed by the rusty orange levelling fill 17850.

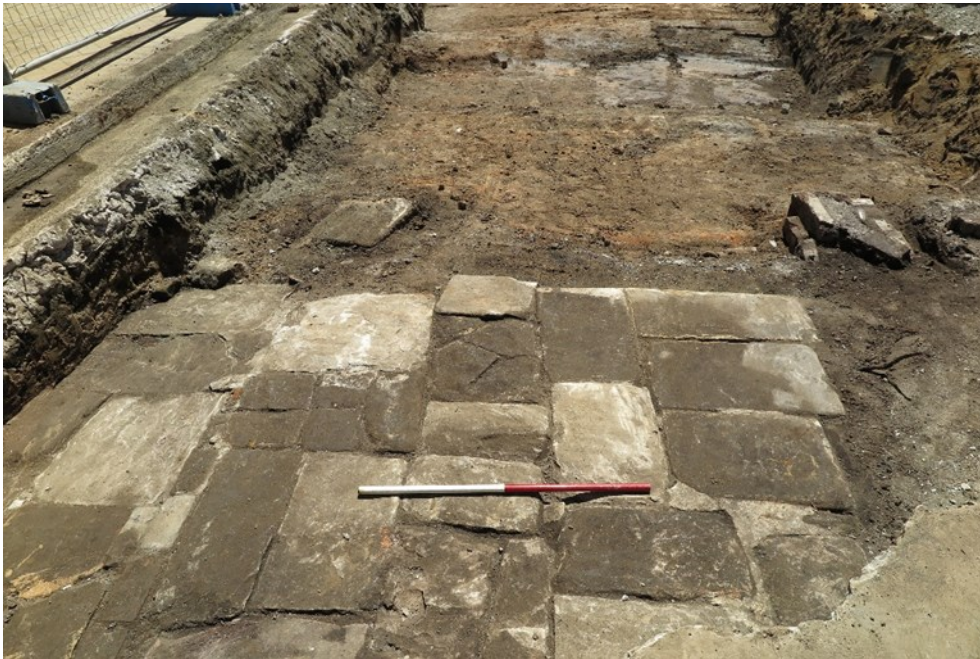
Figure 3.63: Sandstone paving and brick sump 17856. View to the north, 1m scale. IMG_5762.

An area of sandstone paving, was found at the southern limit of excavation with drainage and an associated sump, collectively numbered context 17856 (Figure 3.63). The sandstone paving was an external feature, probably part of a pathway or driveway adjacent to the eastern side of the house. The pavers were mainly rectangular with a mix of medium to large flat stones forming an area 3.5m x 2.5m. The stones ranged in size from 250 x 500mm to 300 x 750mm with a thickness of 80-100mm, laid in fairly regular rows. A single line of

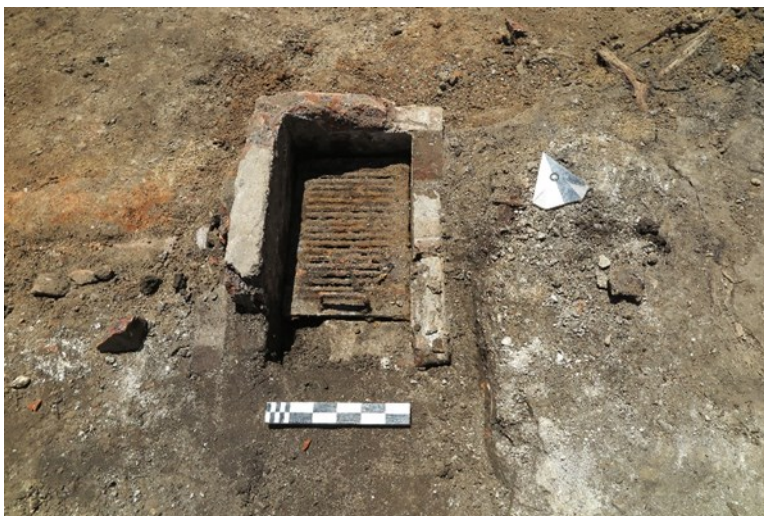
Figure 3.64: Detail of brick sump 17856. View to the north, 300mm scale. IMG_5785.

bricks running north-south through the pavers seemed to form a spacer between two rows of stone. The pavers extended to the west under the Leigh Place footpath beyond the limit of excavation. To the northeast of the main area of paving was a sandstock brick sump (Figure 3.64). The sump was 480mm x 680mm, internally four courses high with cement render lining on the internal walls and base. The sump was covered with a rusted iron grate resting half way down inside it. The sump was constructed with hard-fired sandstock bricks with heart shaped frogs and a hard lime mortar. It is to be noted that similar heart shaped frogged bricks were found in the 1880s residence 'Cranbrook' on Lot 30 in the neighbouring property. A ceramic salt glazed pipe led into the sump on its western side, with the pipe extending further west towards the Leigh Place footpath and drain 17860 which is where the east side of Wyverne would have been.

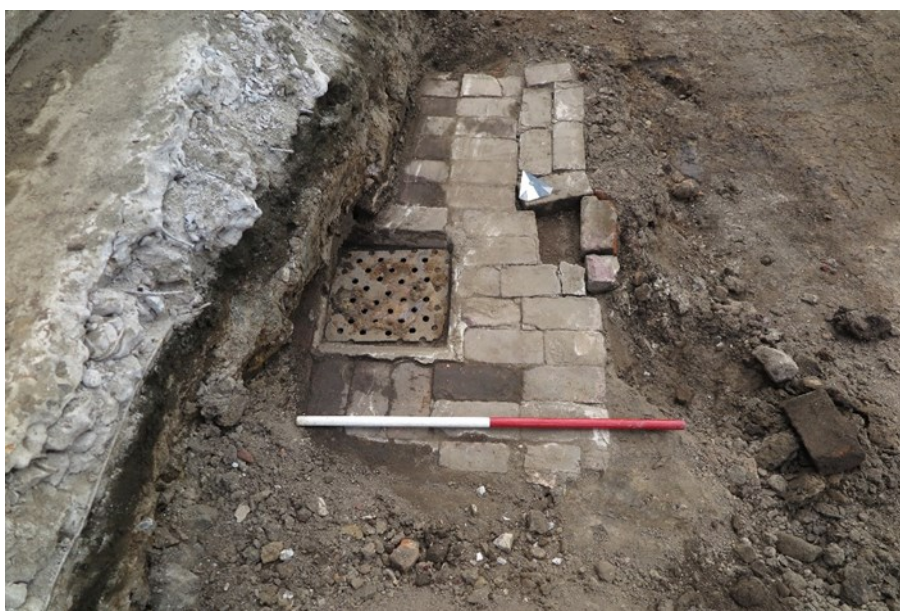
Figure 3.65: Brick pavers and drain west side of Leigh Place (17860). View to the north, 1m scale. IMG_5828.

Below the sandstone paving of 17856 a cement and brick drain and brick paving, context 17860, were found when the sandstone paving was removed (Figure 3.65). The area of paving was immediately below the sandstone layer adjacent to the western limit of excavation of TT34. The brick paving was a mix of dry-pressed bricks and re-used sandstock bricks, the brick dimensions were, (dry-pressed – 230 x 110 x 75mm, sandstock – 230 x 100 x 70mm), with an overall maximum length of 1.65m and minimum width of 900mm. The drain was covered with a thin grate of perforated rusted iron. The inner dimensions of the rectangular drain box were 260mm x 220mm with a depth of 320mm. The head of the drain and the interior was lined with a hard lime cement with two salt-glazed pipes running into the east and west walls, the west pipe with a collar diameter of 190mm and the east pipe with a pipe shaft diameter of 140mm running towards sump 17856. The pipes were encased in the same hard cement. The drain and pipes were part of the drainage system for Wyverne and probably put in place in the late-19th or early-20th century; it is to be noted that this area of Parramatta was connected to the sewer in 1907.

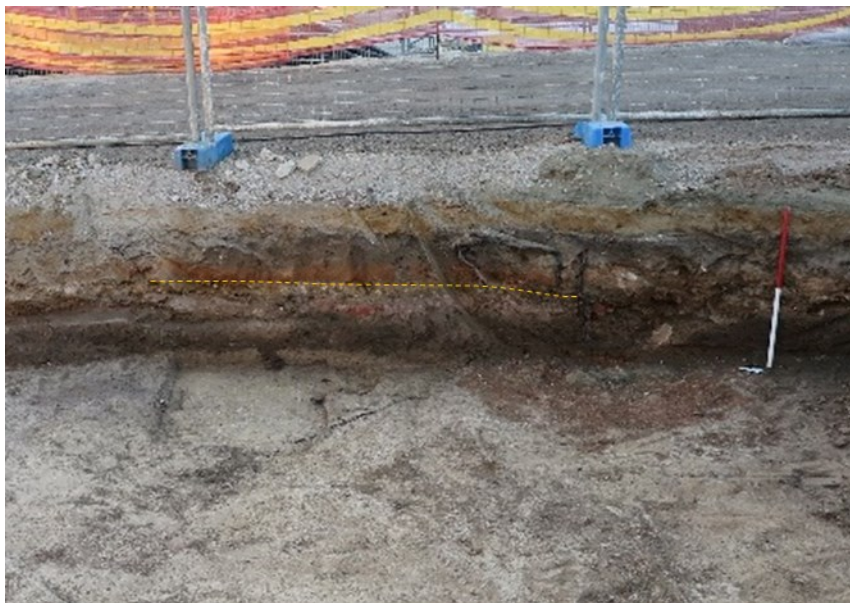
Figure 3.66: West facing section of TT34 showing the rusty orange sand levelling fill 17850 above the dashed yellow line and the pink clay fill 17895 below sitting above the modified topsoil 17819. View to the east, 1m scale. IMG_6004.

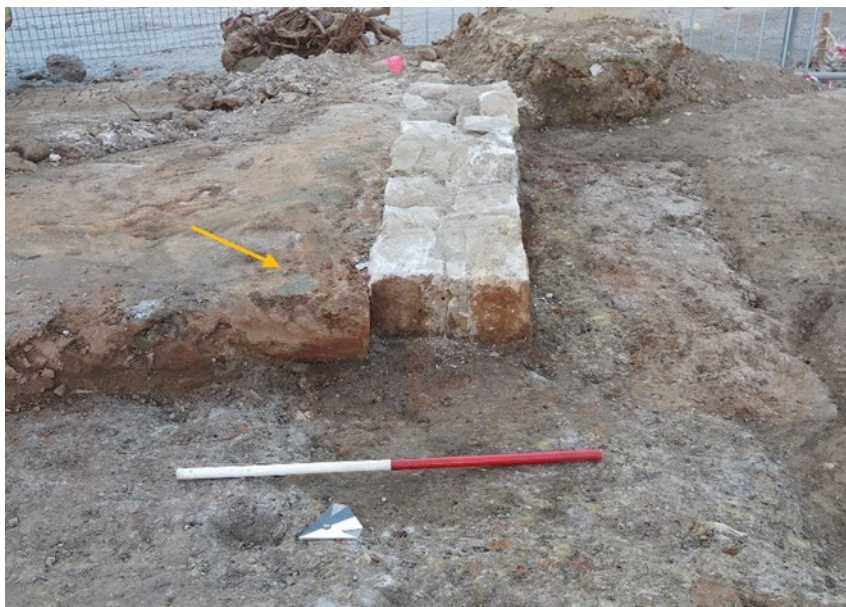
Figure 3.67: Bulk levelling fill 17850 (yellow arrow) abutting fence 17833 with yard surface 17851 in the foreground. View to the east, 1m scale. IMG_5587.

An extensive imported levelling fill was laid across Area D raising the level and sealing the 19th-century deposits below (Figure 3.66). This fill, context 17850, was a fine-grained rusty orange, firm clayey sandy silt. The deposit was effectively sterile with no artefacts present, and had been deliberately introduced. The levelling fill was found abutting the late 19th-century sandstone fence-lines 17875, 17833, wall footings 17896 and was above yard surfaces 17851 (Figure 3.67).

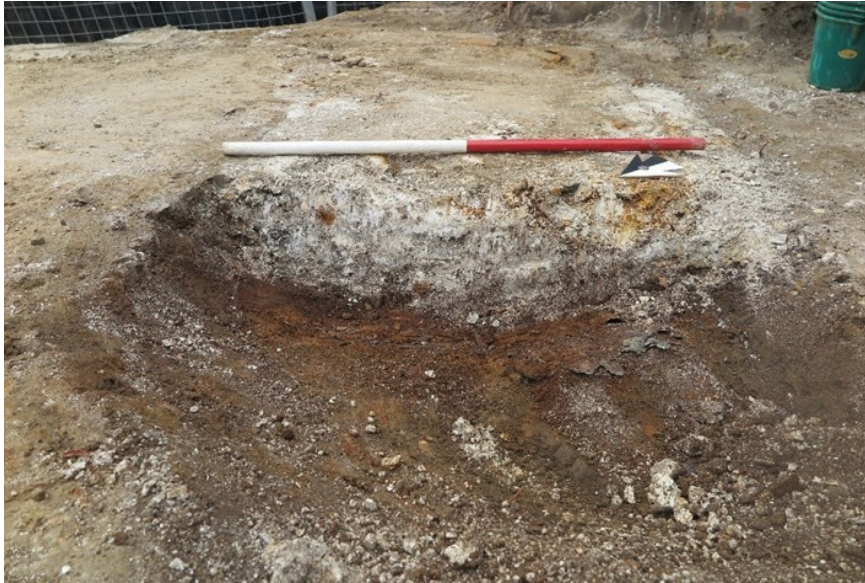
Figure 3.69: Plaster and metal filled pit. View to the east, 1m scale. IMG_5615.

A large plaster filled pit, context 17844, was located north of a mid-20th century tree stump, c.14m from the southern boundary of Lot 1 (Figure 3.69). The pit was irregular in plan with steep sloping sides towards the centre and with a more gradual slope to the side at the western end, 2.3m in length, 1.5m wide with a maximum depth of 750mm. The pit was half sectioned to expose a series of three fills within, collectively numbered (context 17845). The fills included a dense layer of white plaster with frequent rusty iron staining sitting above a lower layer of corroded metal in turn sitting above a thin layer of soft dark brown sandy silt with iron staining. The fill of the pit contained several artefacts including ceramics, glass, metal, window glass and leather shoes.

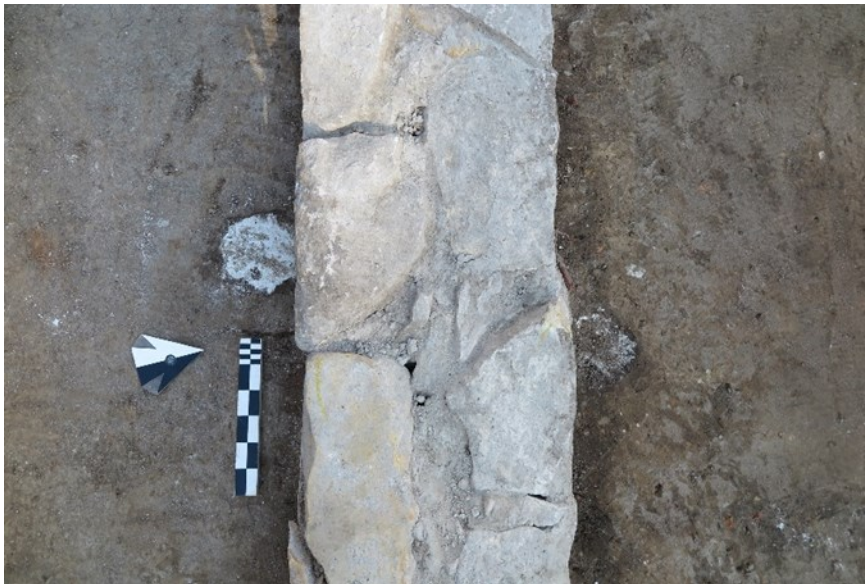
Figure 3.70: Two plaster filled post holes (17840 and 17842) either side of wall 17275 cutting the foundation trench of the wall. View to the west, 300mm scale. IMG_5601.

Three circular post or stake holes were found within the footprint of the plasterworks. They did not have a posthole cut and were all backfilled with plaster. Two were found either side of the east-west aligned sandstone fence/wall 17275 (Figure 3.70), cut through the foundation trench of that wall. These features are probably associated with the plasterworks shed and may represent posts removed when the shed was demolished and residue plaster went into the post pipe backfill. The following table is a summary of these post holes (Table 3.4).

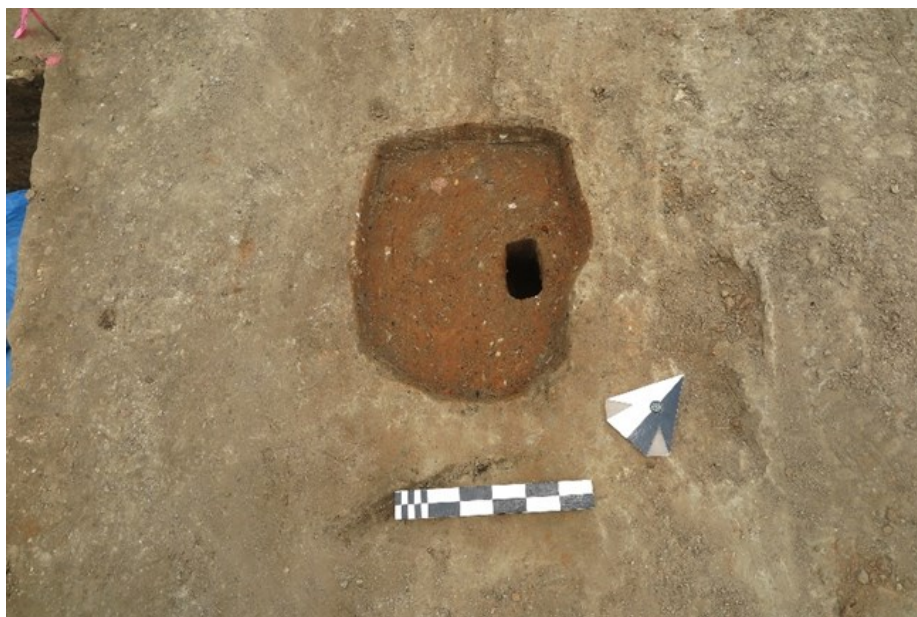
Figure 3.71: Posthole 17834. View to the north east, 300mm scale. IMG_5620.

A fourth posthole, context 17834, (Figure 3.71) was found close to the plaster filled postholes, however it may be a feature that dates to the later use of the site. The posthole cut was sub-rectangular with curved corners, and vertical sides 500 x 380mm oriented east-west. The packing fill, context 17836, was a fine-grained firm red/orange clayey silt with charcoal flecks, small lumps of crushed yellow sandstone. Some glass and ceramics were present in the fill. The postpipe, context 17835, was rectangular with extremely well defined and sharp corners 120 x 70mm, vertical sides and concave base with a depth of 300mm. The pipe fill, context 17837, was a fine grained loose dark grey silt.

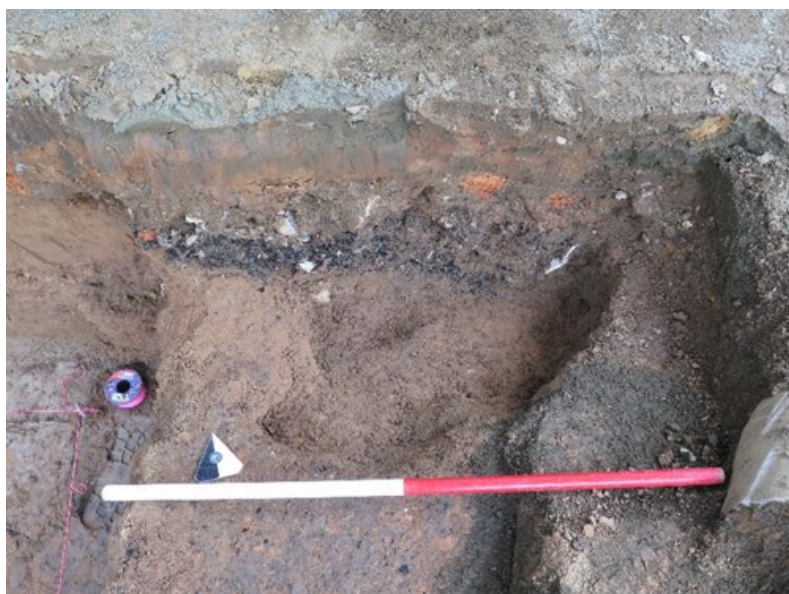
Figure 3.72: Pit 17518 after excavation. View to the north, 1m scale. IMG_3414.

A rubbish pit, context 17518, was found at the northern end of the site adjacent to Macquarie Street. The pit contained late 19th-early 20th-century ceramics and glass artefacts, some bone and sandstock brick fragments and rusty nails. It was an irregular oval in plan with gently sloping base, extending into the northern section of Macquarie Street footpath. Exposed extent 400-500mm wide and 940mm in length, 120-180mm in depth. The upper fill of the pit was truncated by machine excavation but visible in the northern section (Figure 3.72). Fill 17519 was a black and grey soft silty clay with frequent ash and charcoal pieces. Pit fill included: bone, sand stock brick fragments, ceramics, glass, nails shell and sandstone fragments. The pit was cut into the rusty red bulk levelling fill 17850.

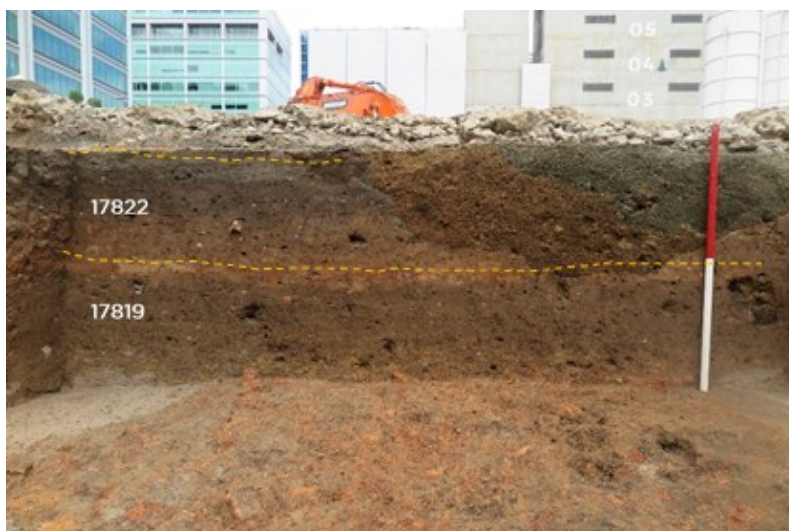
Figure 3.73: West facing section of TT28 showing levelling fills 17822 below the roadway of Civic Place and above the bulk modified topsoil 17819. View to the east, 1m scale. IMG_5384.

A series of levelling fills seen in TT28 below the stabilized sand underneath the road of Leigh Place and above the historic topsoil 17819, were collectively assigned the context number 17822 (Figure 3.73). This levelling or raising event was composed of layers of silty sand fills up to 310–410mm in thickness. The upper fill was a compact dark brown grey sand with frequent charcoal flecks and pieces (5–52mm) and occasional sandstock brick fragments (<20mm), 200–250mm thick. The second of the fills was a mid-red brown sandy silt with occasional charcoal flecks, rare sandstone and sandstock brick fragments <20mm and rare lumps of blue grey/red clay; this layer was up to 140mm in thickness. The lowest of the fills was a very firm, mottled orange-red/buff clay with occasional charcoal pieces (5–15mm) and rare sandstone and sandstock brick fragments.

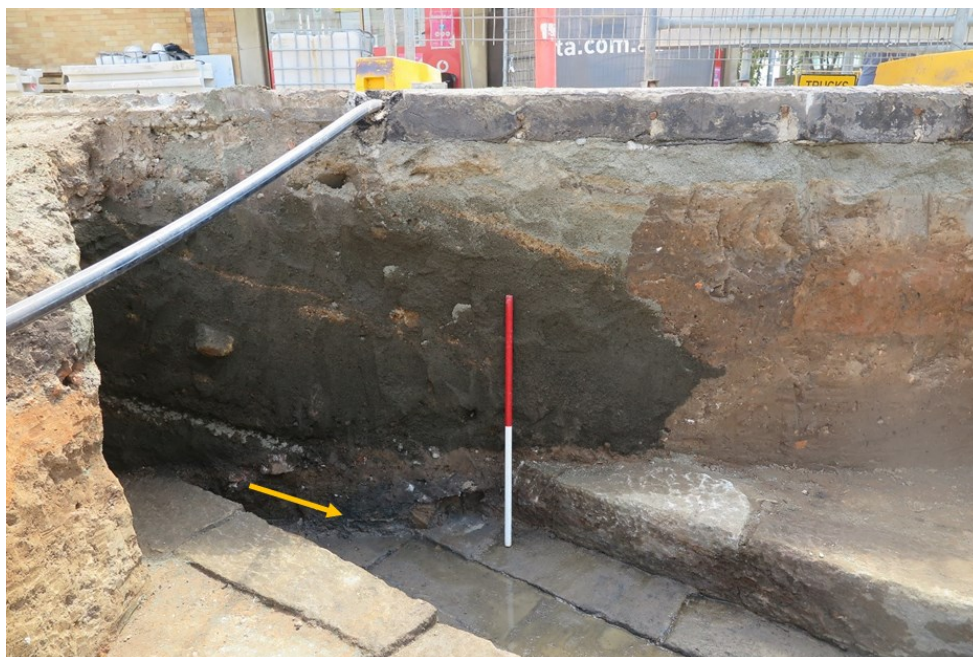
Figure 3.74: Black drain deposit in the base of drain (arrowed) sealed by early 20th-century levelling fills and late 20th-century stabilized sand used as drain backfill under the road. IMG_5524.

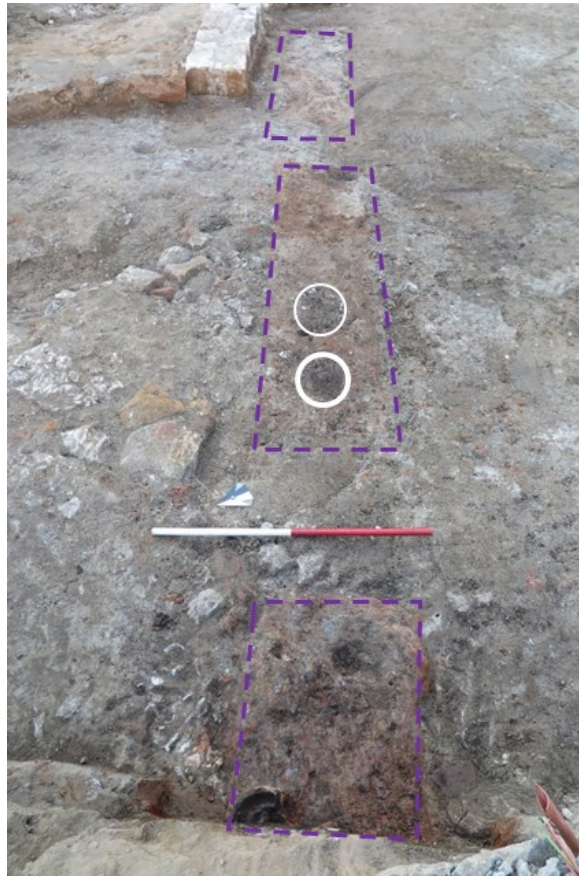
Figure 3.75: Series of late postholes in orange clay filled trenches. View to the east, 1m scale. IMG_5592.

A series of three large rectangular posthole cuts were found immediately to the south of and parallel with sandstone wall 17833, aligned east-west (Figure 3.75). As the cuts, postholes and fills were uniform and clearly associated, they were assigned collective numbers. The cuts, context 17846, were 2.3m in length, 560mm wide, with an unknown depth. Each cut contained large circular post pipes, 300mm in diameter, context 17847. The fill of the posthole trenches, context 17848, was a fine compact/dense mottled orange and brown clay. The fill of the postpipes, context 17849, was a fine dark grey brown silt with frequent charcoal flecks. Some ceramic artefacts and a copper washer were identified in the post pipe fill.

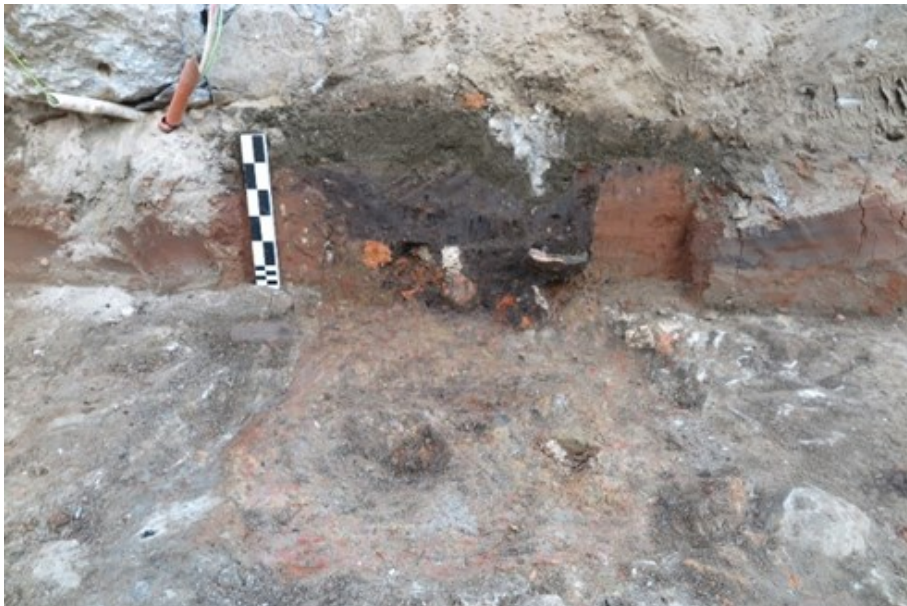
Figure 3.76: Posthole cut 17846 shown cutting through levelling fill 17850. View to the west, 300mm scale. IMG_5589.

These postholes were found cutting through the orange levelling fill 17850 and pre-date the 1960s roadway, as can be seen in Figure 3.76. They are probably the structural remains of a 20th-century building; demolished to make way for Civic Place.

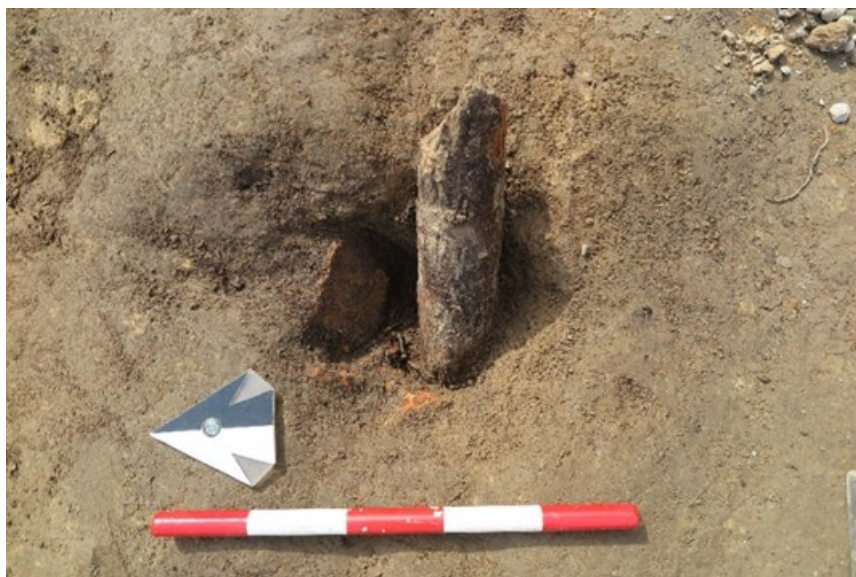
Figure 3.77: Post hole 17865. View to the east, 500mm scale. IMG_5871.

A row of three postholes were found at the southern end of TT35 aligned east-west, 2.5m apart (Figure 3.77, Figure 3.78). Each of these postholes contained a remnant post. They were collectively numbered as, posthole cut 17865, the posthole packing 17867 and the post 17866, and differentiated as A, B, C. from east to west. The postholes were all part of the same unidentified 20th-century structure and are described in the following table (Table 3.5).

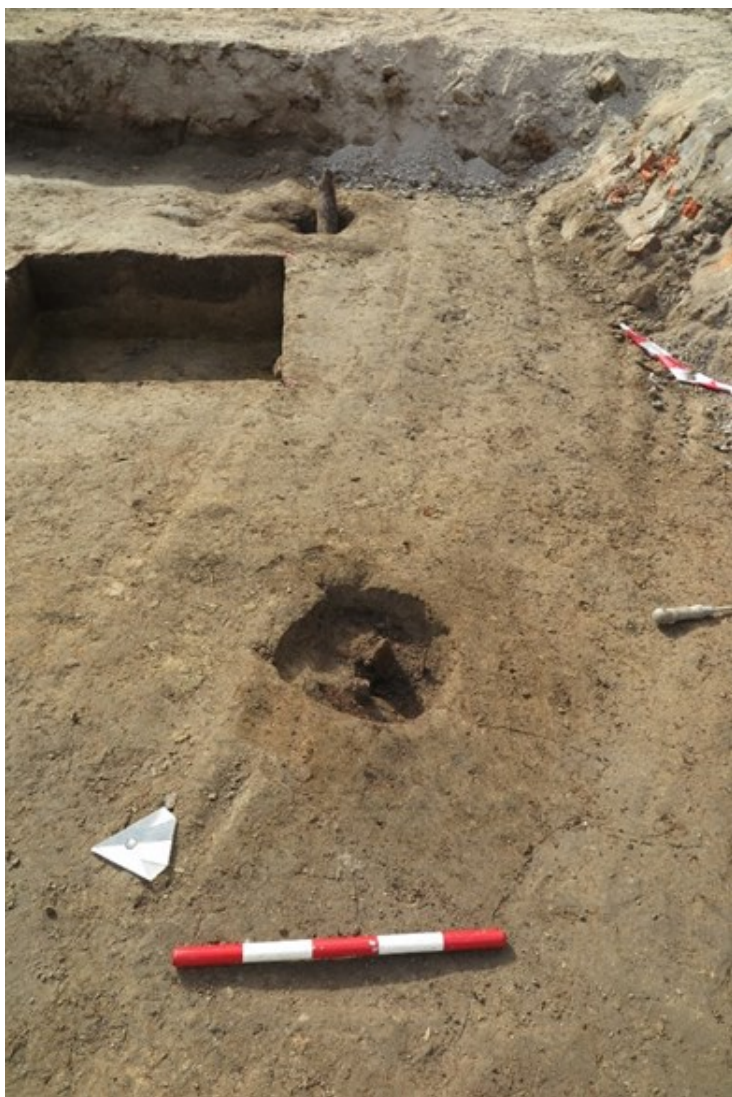
Figure 3.78: Row of postholes 17865 in southern part of Lot 28/1. View to the east, 500mm scale. IMG_5867.

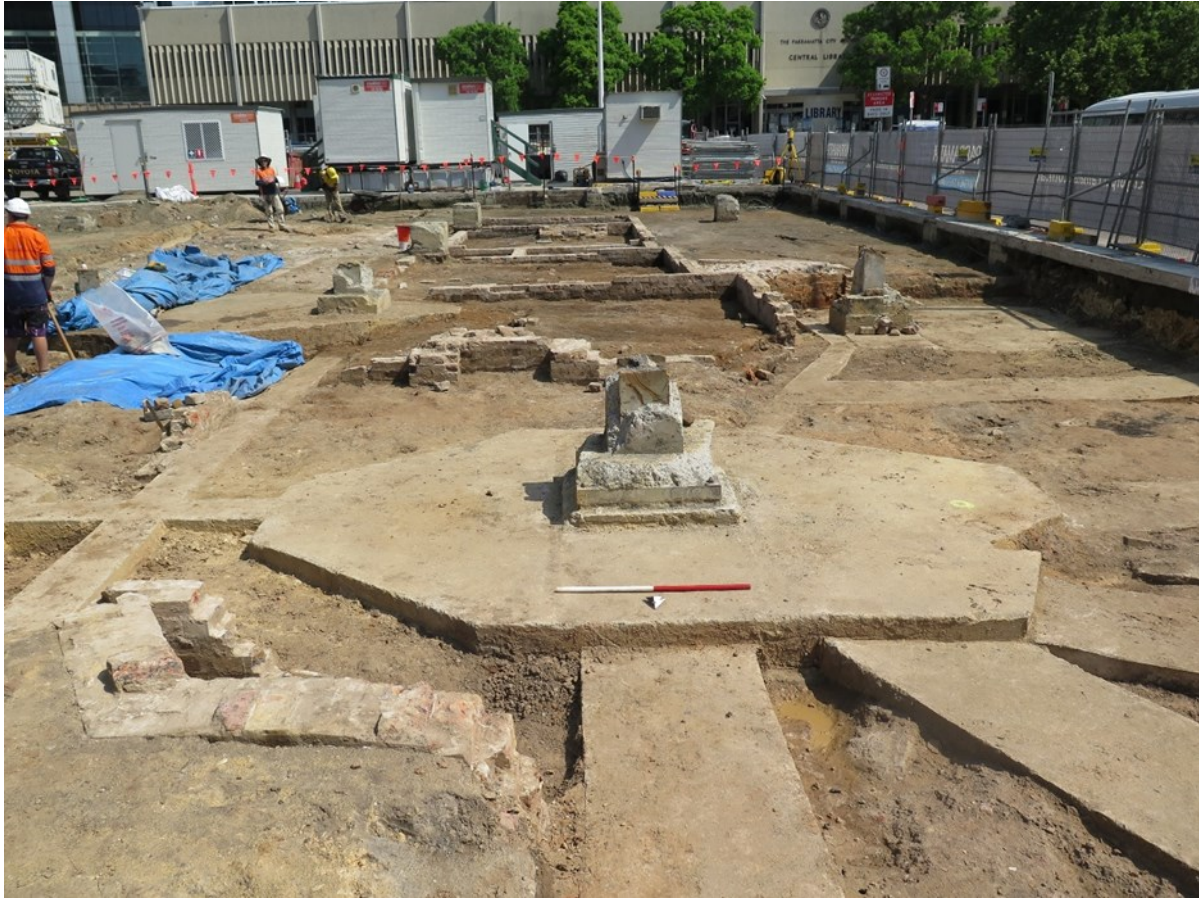
Figure 3.79: Detail of large concrete pads, piers and strip footing beams of the Post Office building in the northern end of the site in Areas A and B. View to the south, 1m scale. IMG_2930.

The post office building was demolished in 2015. The concrete footings, piers and beams were found to be extensive and had impacted much of the archaeology in the northern portion of the site in Areas A and B (Figure 3.79). Although the demolished building was a single-storey structure it is clear by their scale that the foundations were capable of supporting a much larger/taller building, which was proposed but never constructed. A deep lift pit and stairwell had been excavated in the centre north of the site which removed almost all of the front part of the western terrace house Northiam. This lift pit is shown on architects plans for the building from 1965 along with annotation indicating that '7 future floors' were slated for the northern end of the building. The Post Office buildings did not impact Area D, but the introduction of the roadway into Civic Place and access to the Parramatta City Council Library did require that Wyverne and the plaster works be demolished.
