Soil properties at archaeological site, 3 Parramatta Square, 153 Macquarie Street, Parramatta

**Draft Final Report by Dr Roy Lawrie, Soil Scientist, CPSS,
with photographs by Lisa Lawrie and Casey &Lowe P/L,
August 2019.**

Report to Casey & Lowe

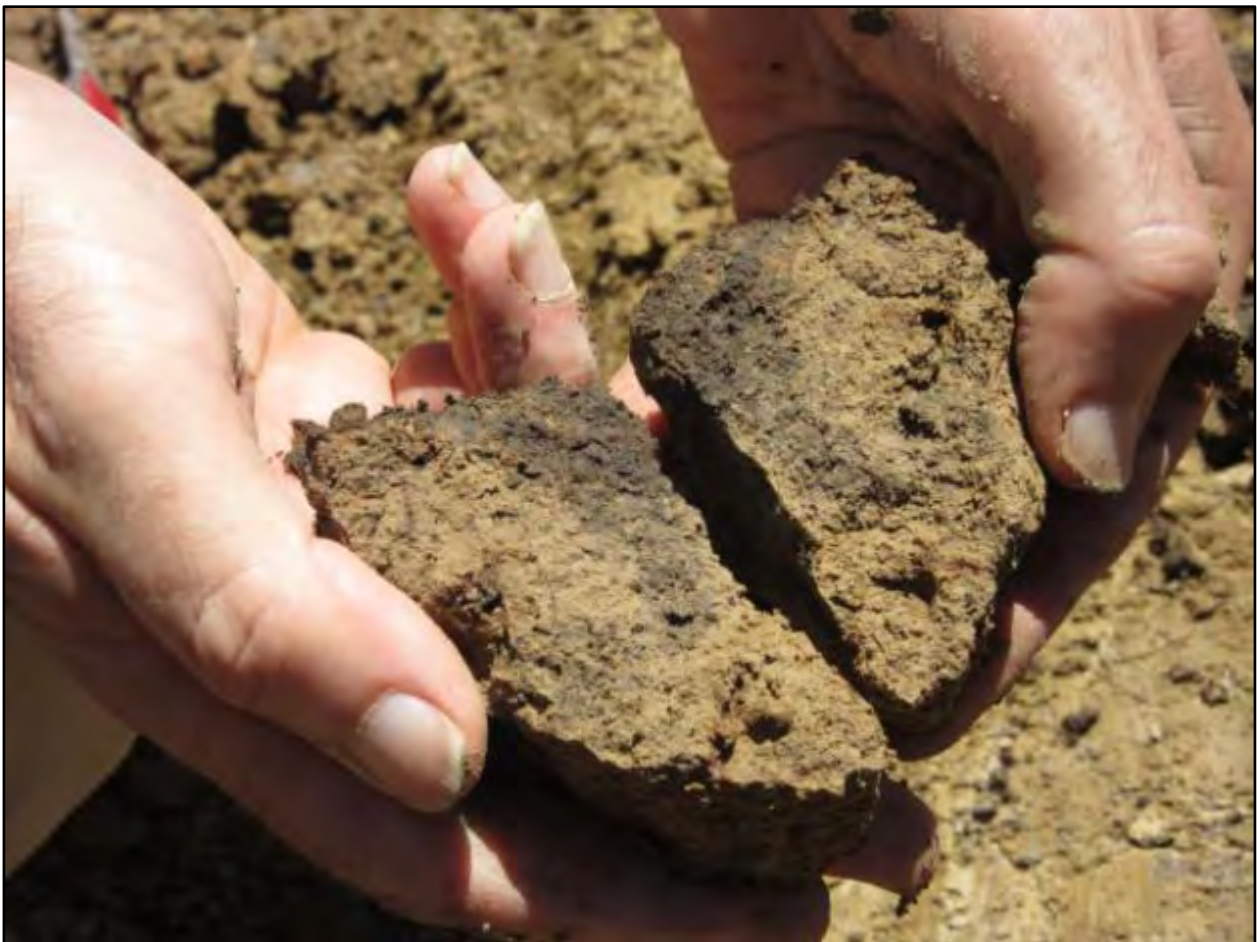
A sign of early cultivation: breaking open a clod to reveal a v-shaped inclusion of the dark historic topsoil, wedged into the pale yellowish grey subsurface. Probably made by a hoe, this feature may have been along a planting line. Some of the original dark topsoil was also found intact, in a low-lying part of the site, preserved by burial under a layer of fill.

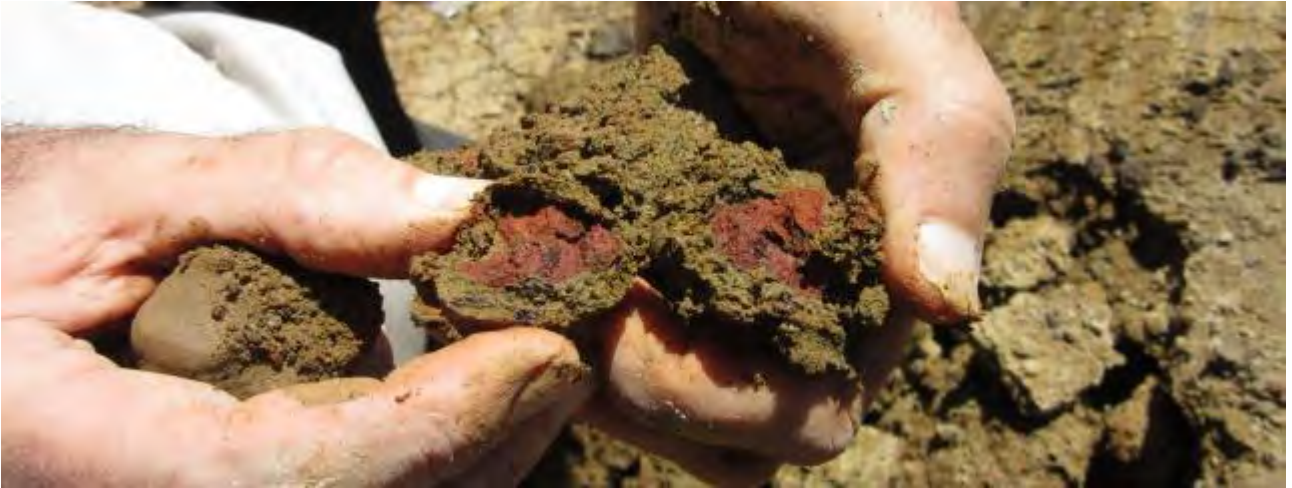
Photo 2: Red brown ironstone gravel is found within a yellowish brown dense clay (IIB horizon) underneath the lighter-textured B horizon of the site 5 profile. Similar gravel was sometimes seen surrounded by red mottles in the underlying possibly Pleistocene clay, the most likely parent material of the IIB horizon.

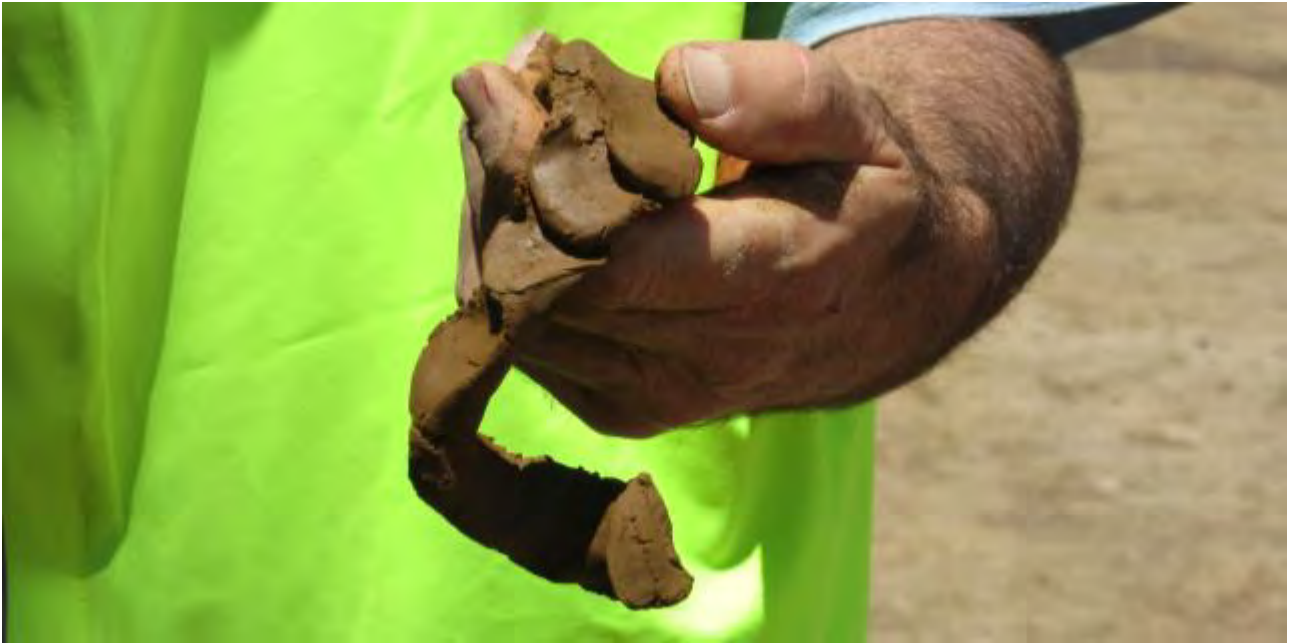
Photo 4: A long ribbon can be moulded from a sample of the IIB horizon (from the site 1 subsoil), demonstrating its high clay content.

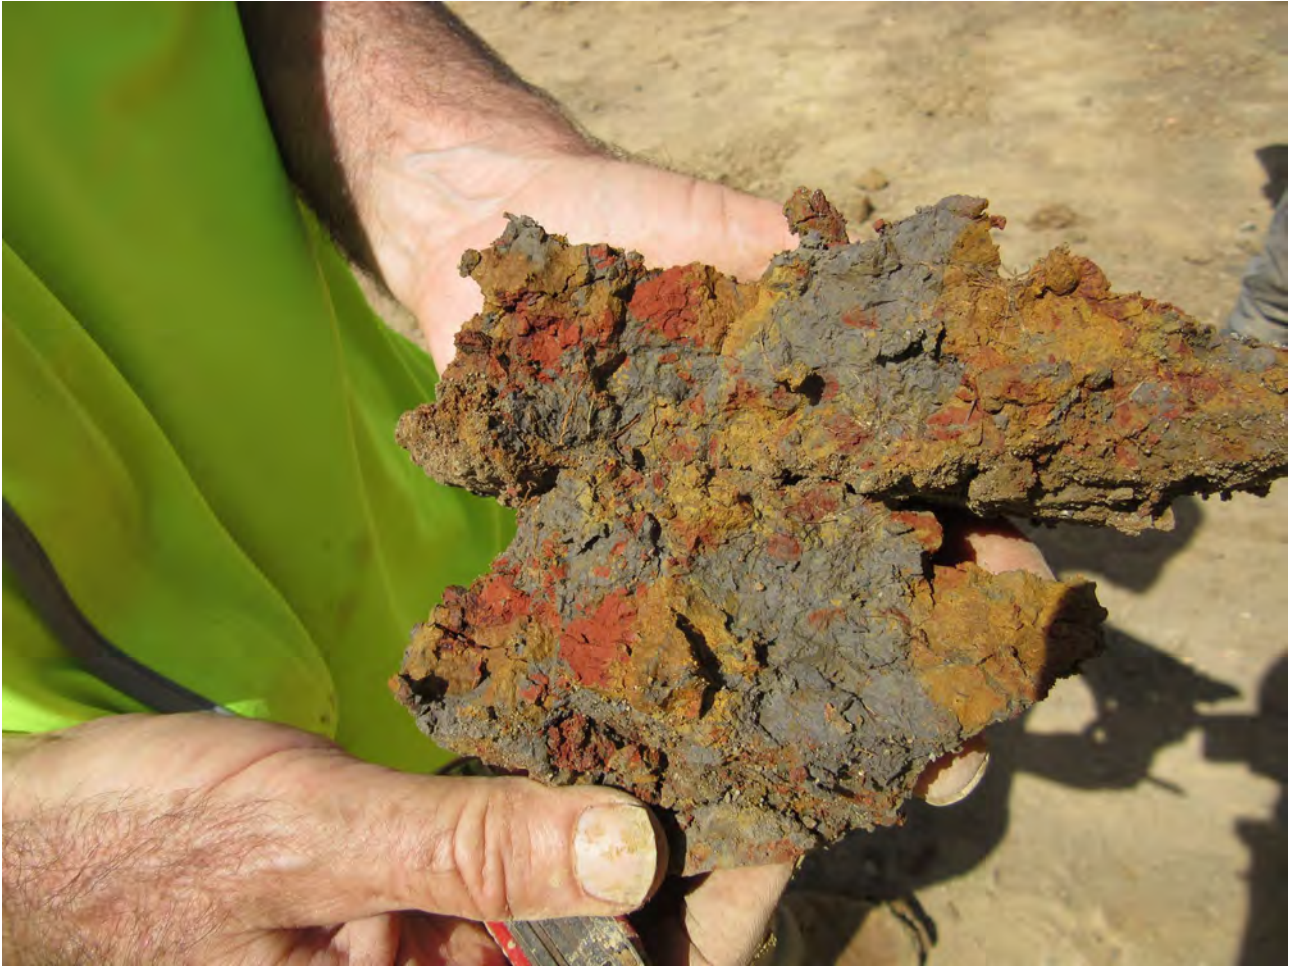
Photo 5: The mottled grey dense clay of the IIC horizon from site 3, showing yellow brown mottles that are seen within the gradual transition to with the overlying IIB horizon.

The IIB horizon in its natural state has a moderate to very high phosphorus sorption capacity, is less acidic (pH 6.3 to 6.5), and it contains more carbon, nitrogen, and exchangeable cations (with calcium being dominant) than the underlying mottled clay (IIC horizon); it is also slightly less dense and impermeable. The upper surface of the IIB horizon is not horizontal; it slopes down gradually from the south east to the north west, indicating that it may have formed within the upper portion of the underlying red and grey mottled clay (the IIC horizon, see photo 5).

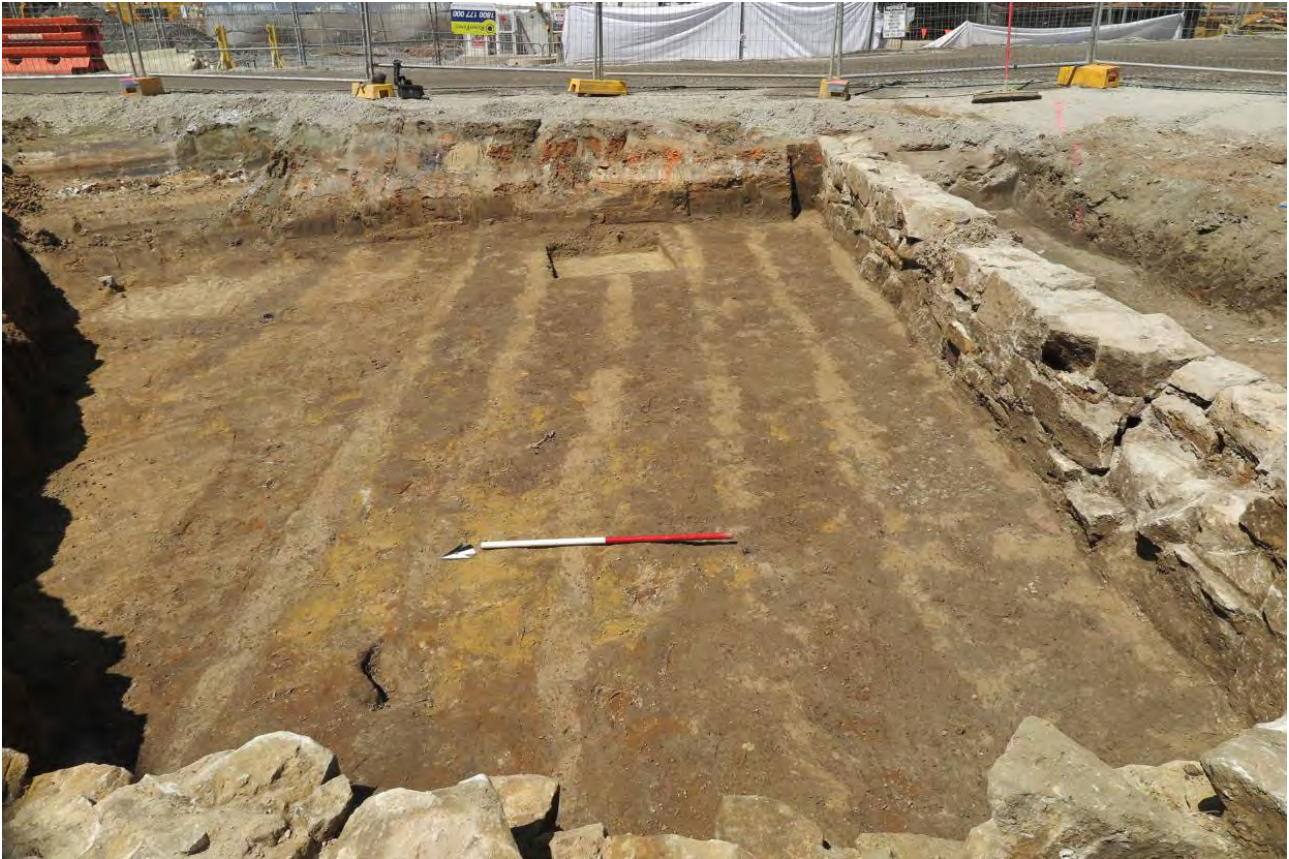
Photo 6 (Casey & Lowe P/L): These furrows or plough lines, which date back to the 1830's, were found when the concrete roadway of Civic Place was carefully removed. This is near the old drainage line where the topsoil was once thicker, and higher in organic matter and nutrients, than on the slightly more elevated ground to the southeast. The drab yellowish grey soil appears to be from the A₂ or B horizon, with the darker, greyer soil, containing a mix of surface A₁ horizon and the upper part of the underlying A₂) in between (possibly once formed up into raised beds).

The alluvial layer thickens in the lower part of the 3PS site (at site 2 for example), while on higher ground near the old library the darker upper part (A_1 horizon) seems to thin out and appears to have been eroded away. On the eastern boundary at site 1, the lower part of the topsoil (the A_2 horizon), a pale or a drab yellowish grey colour, appears to have been close to the soil surface during early settlement because it has been partially affected by cultivation, changing its physical features as well as its chemical properties (see photo 6).

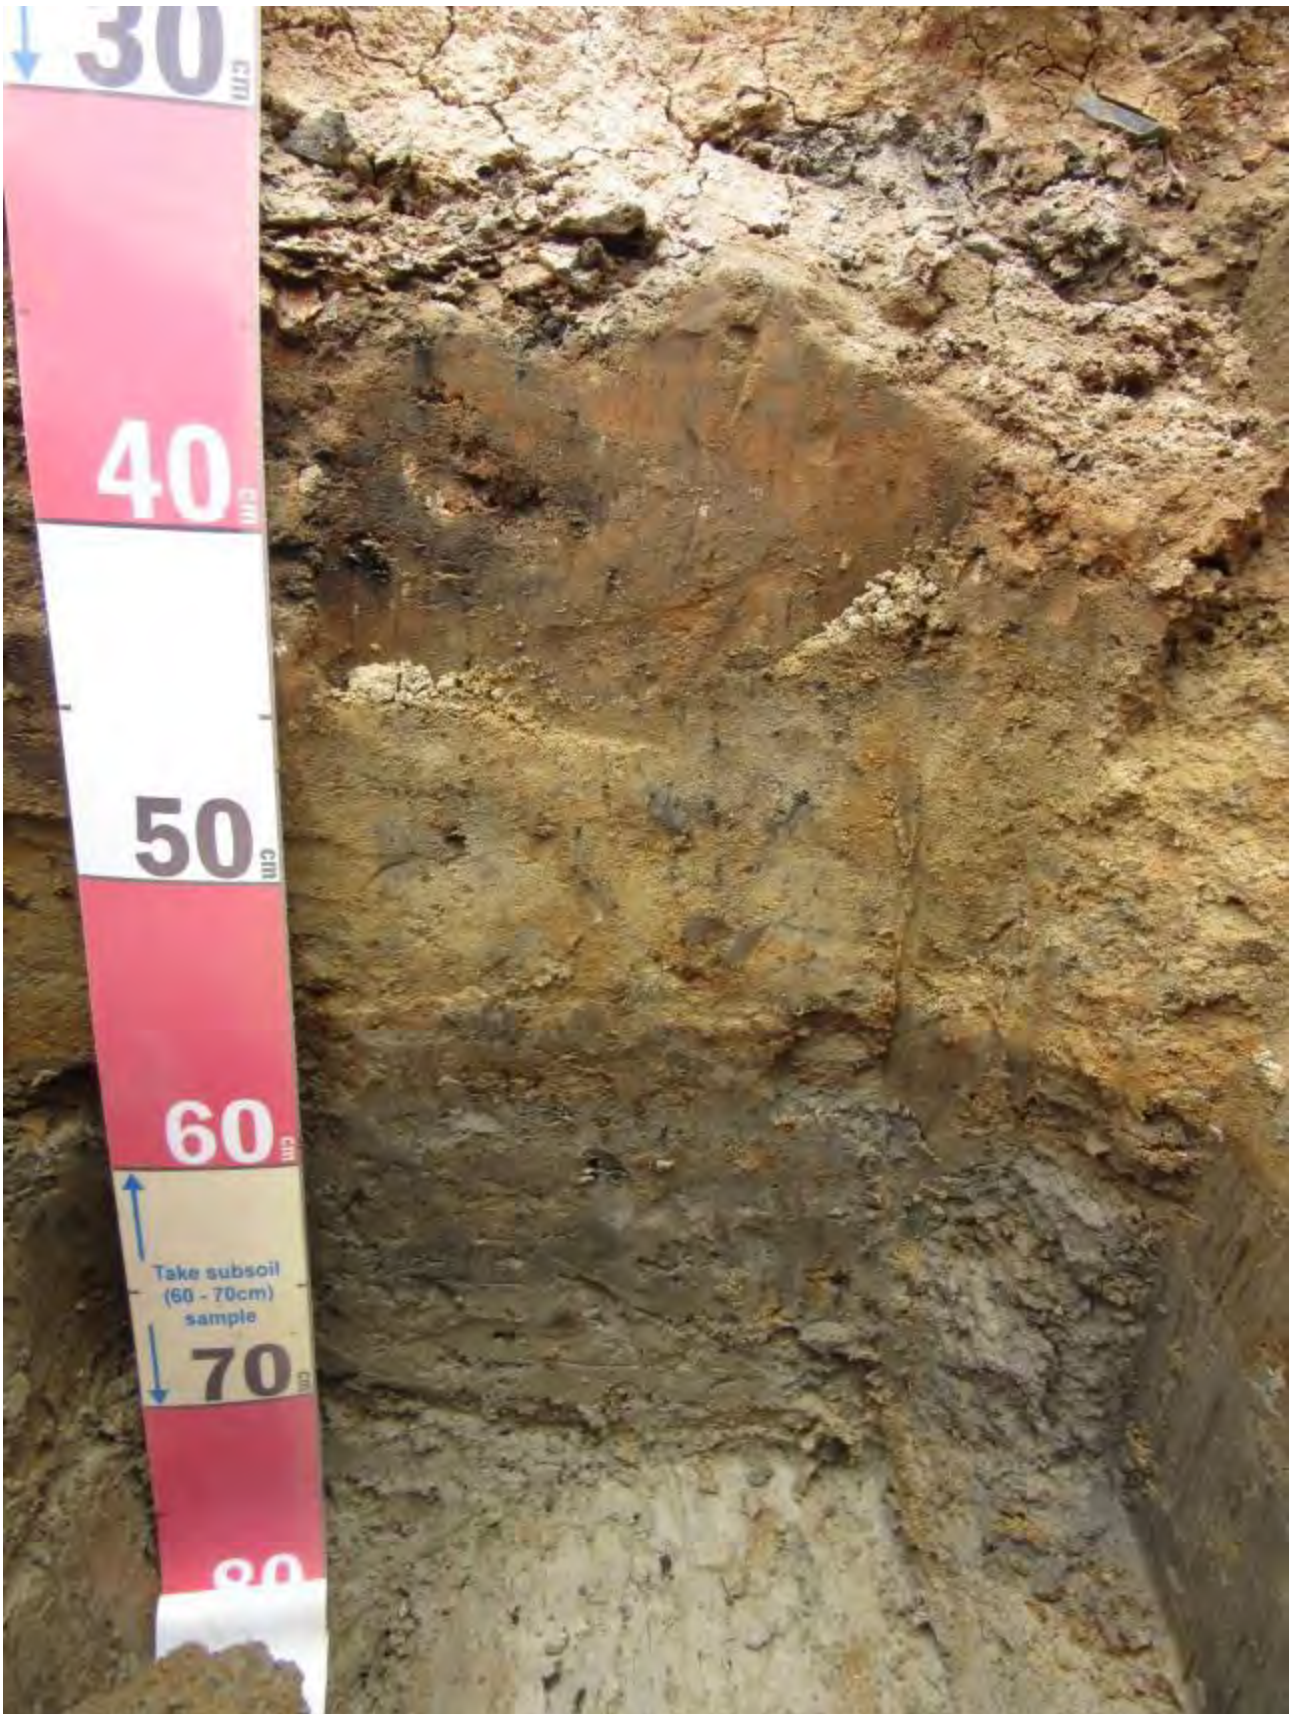
Photo 7: The Casey & Lowe test trench 18 soil profile has dark clayey fill covering another fill layer of yellowish light brown sand (between 45 and 55 cm depth) that has protected the grey historic topsoil underneath it. On the floor of the pit is a pale grey silty light clay, the A₂ horizon of the original profile. Its chemical properties have remained unaffected by British settlement.

The best preserved natural profile was seen in the Casey & Lowe test trench 18 close to Macquarie Street (photo 7). The original soil surface, quite low-lying here, only 9.14 m AHD, was protected by burial under a layer of sand about 15 cm thick that appeared to have been spread early in the colonial period. The sand had the highest pH of any sample tested (pH 7), possibly produced by runoff from lime-washed dwellings nearby. It also contained specks of charcoal and an elevated calcium content, suggesting fireplace ash deposition (the sandy fill has not been contaminated with heavy metals, suggesting it was buried early, prior to the 20th cent.). Residues leached from the ash in the sandy fill appear to have also boosted the calcium level in the otherwise undisturbed historic topsoil underneath.

-test trench 18 (see photo 7): sampled 4/12/15, located about 10m from the Macquarie Street footpath and about 12m from the former roadway of Civic Place

The planting lines/furrows found under the roadway (photo 7) are probably not from this very early period of cereal cultivation. Alternatively they may be later relics of cultivated raised beds, consisting of humus-rich topsoil scooped out of the intervening furrows and heaped up in between. Raised beds are commonly used by vegetable growers in backyards and market gardens, particularly where temporary waterlogging is a problem. Given their proximity to the former drainage line this kind of farming technique seems likely.

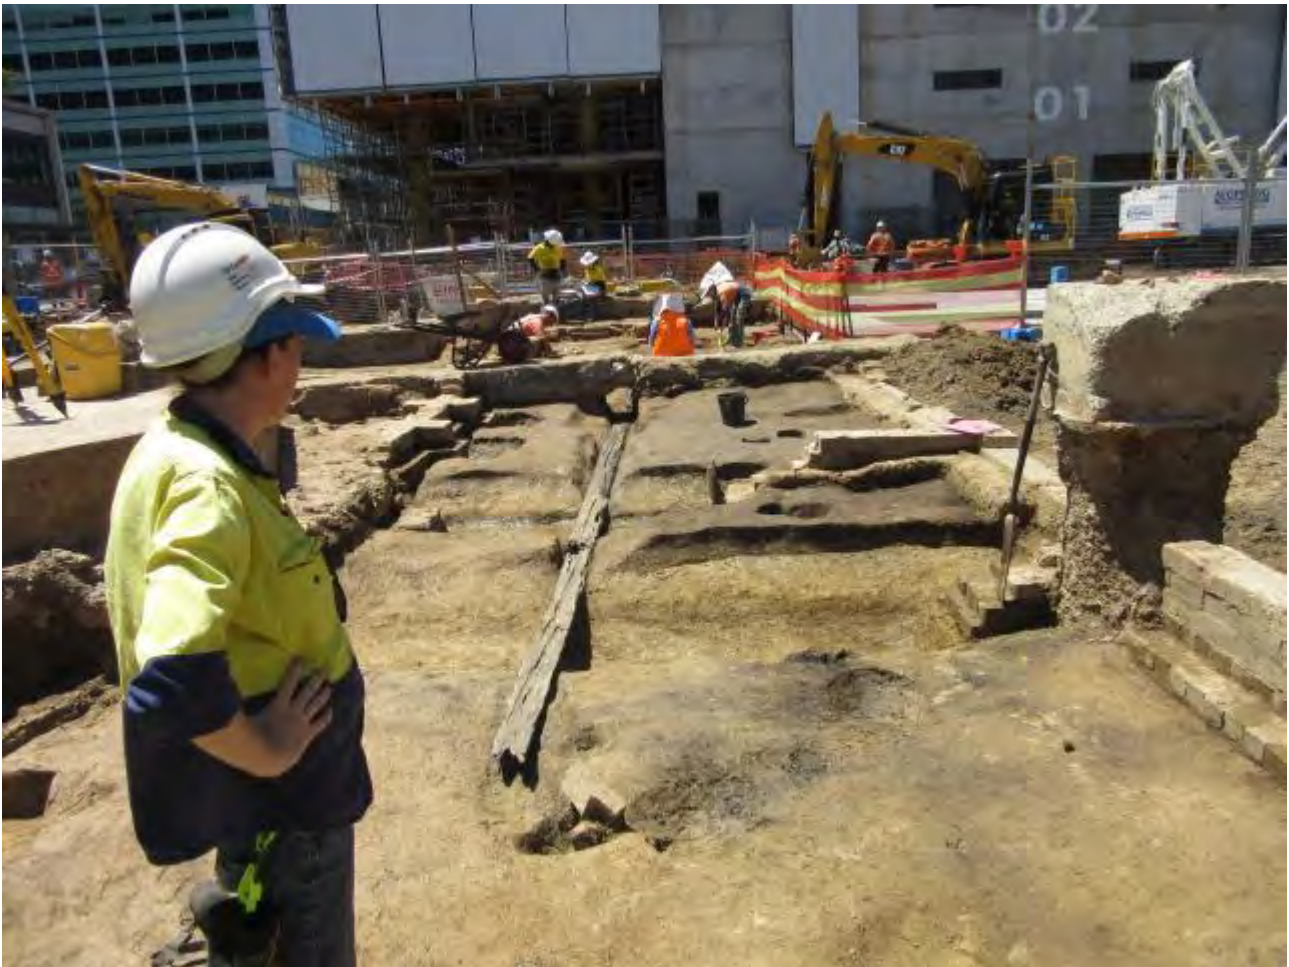
Photo 9: The profile sampling location at site 5 is in the centre, near the leaning spade. The grey historic topsoil becomes very pale underneath (the A₂ horizon). Below this the profile gradually changes to a pale yellowish grey light clay (B horizon). A similar grey historic topsoil was seen at test trench 18 (photo 7) buried under a layer of sandy fill (which was not present at site 5) that protected the test trench 18 topsoil from nutrient enrichment. It is possible that the nutrient-rich material at site 5 was applied prior to 1822; it may have also been enriched by household dust that fell through gaps in the wooden floor of the house.

The alluvial layer at site 5, about 35 m from the drainage line, is thick enough (30 cm) to have three distinct components. Preserved under an early house (see photo 9) is the dark A₁ horizon 10-15 cm thick covering a very light grey A₂ horizon (5-10 cm thick), with a light yellowish grey layer (B horizon) underneath containing abundant rusty mottles.

Patches of the dark historic topsoil were found here, preserved beneath the remains of a c.1822 house (photo 9). The boundaries between horizons were more gradual at the site 5 profile. The light clay in the 3 horizons above the dense clay IIB horizon was friable and distinctly sandy, a difference arising most likely from the change to an alluvial soil parent material.

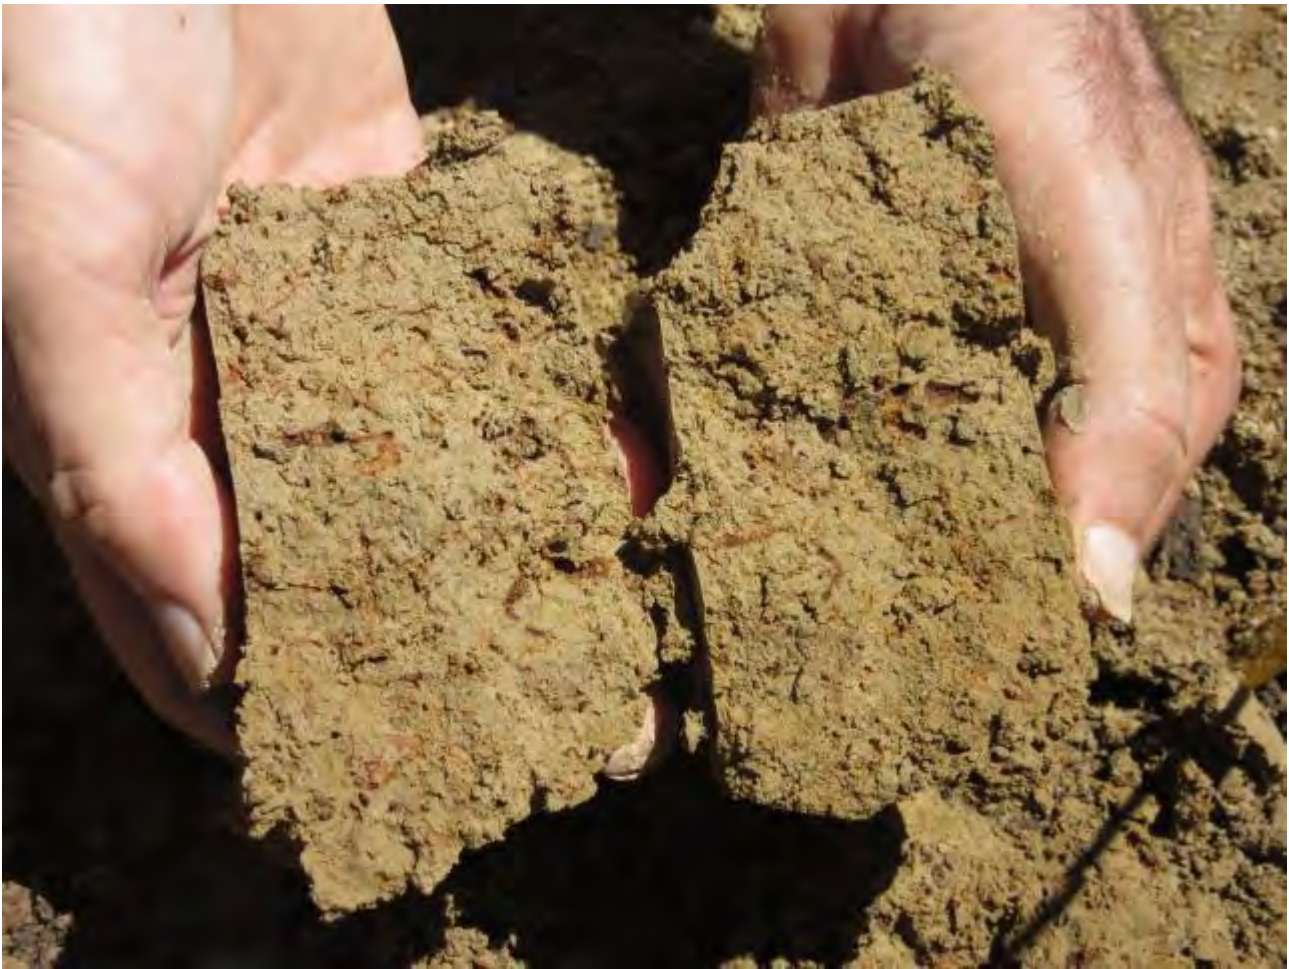
Photo 10: The yellowish grey alluvial B horizon of the site 5 profile has rusty coloured mottles along old root channels. These are a natural feature of a horizon within the root zone that is prone to intermittent waterlogging; in this profile it shows that the underlying dense clay (IIB horizon) has low permeability.

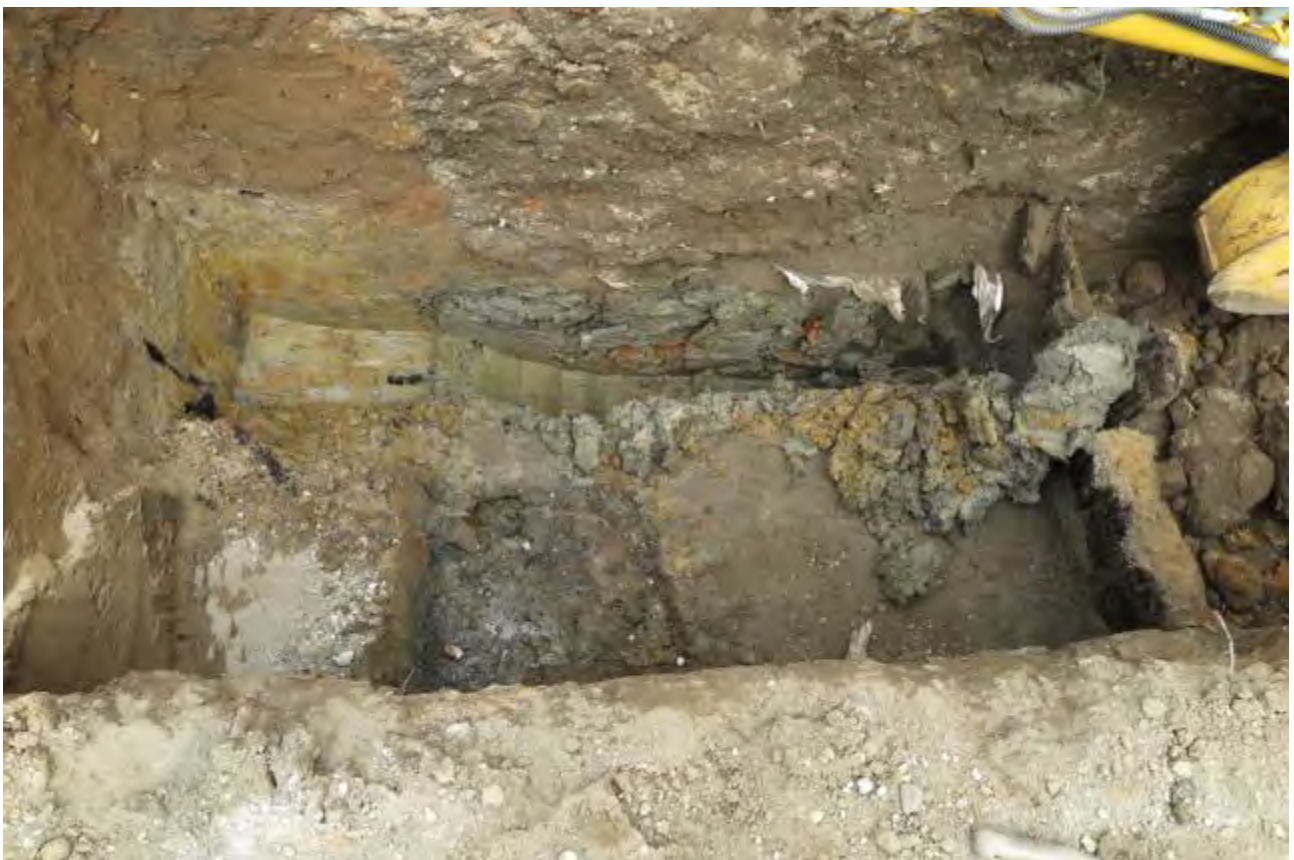
Photo 12: Grey creek line clay above mottled clay (Casey & Lowe photo)

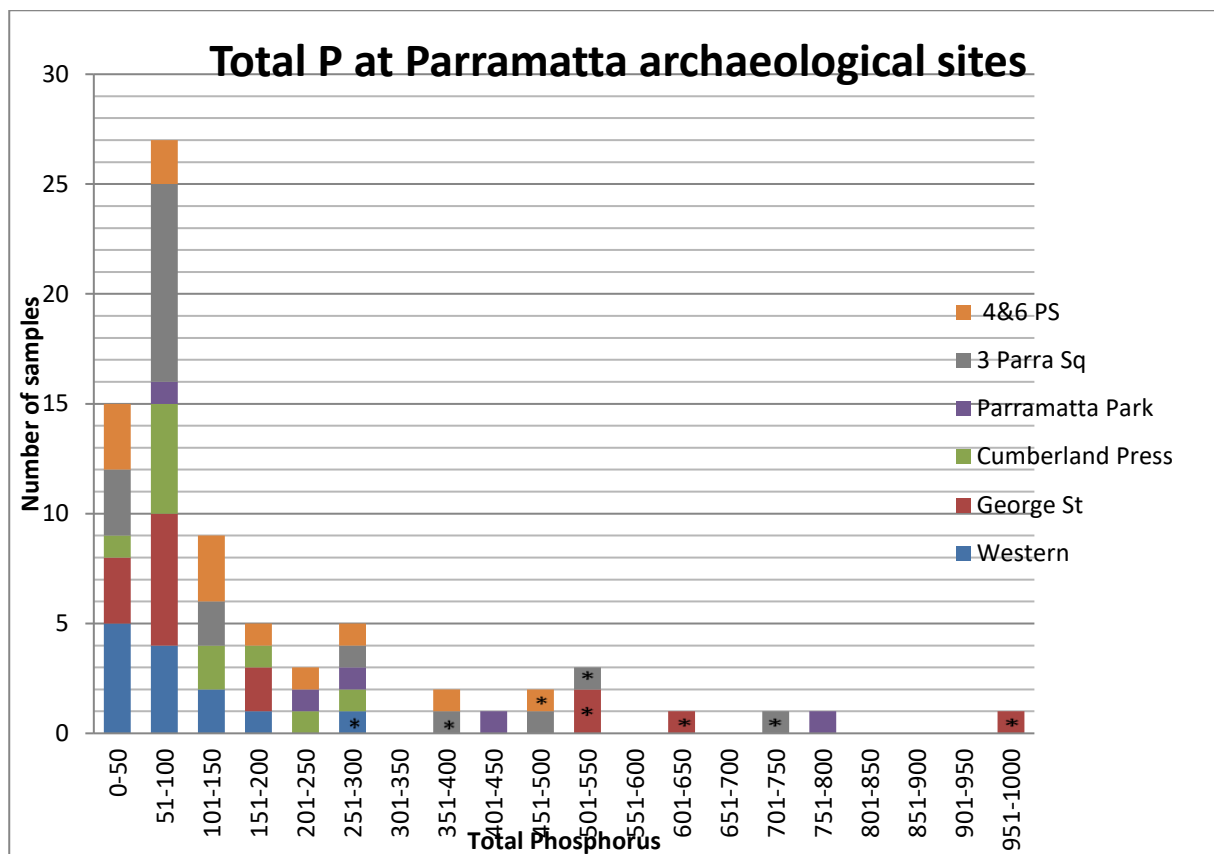
Figure 2: Total phosphorus concentrations (mg/kg) in 64 soil samples from six archaeological sites in Parramatta (P'matta Square 4 & 6, P'matta Square 3, P'matta Park, Cumberland Press, 184-188 George St and Western Sydney Stadium); * denotes samples which also had a high level of plant-available phosphorus (Colwell test >50 mg/kg) ie well above natural background, almost certainly boosted by phosphorus.
